ULPIA TRAIANA SARMIZEGETUSA: *EXTRA MUROS* 23 EXCAVATIONS 1982—1984.  
AN INTERIM OPINION

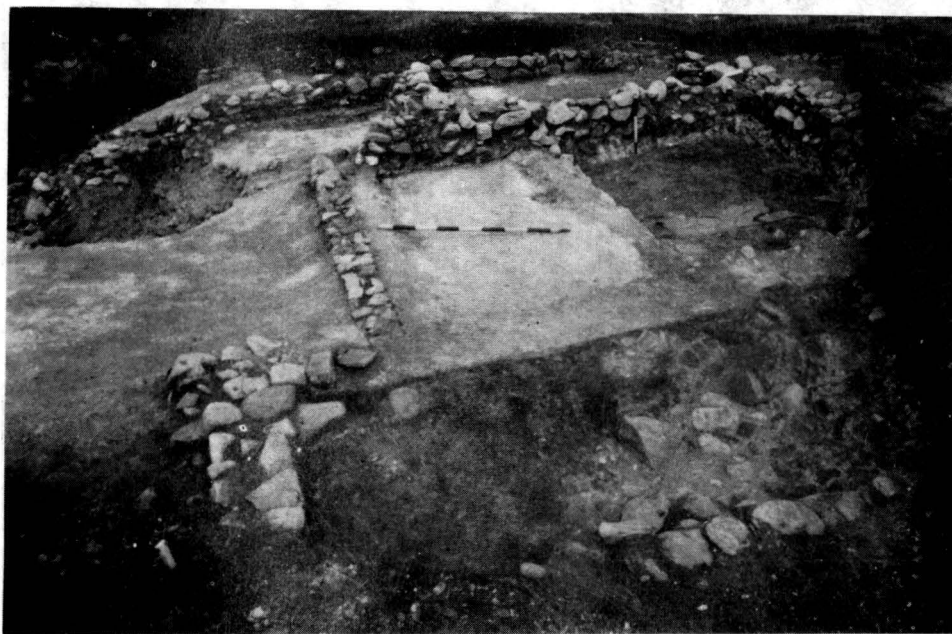
Fig. 6. Before the removed of the concrete floors.

After a period of dereliction the site was given a new lease of life and the second part of phase III marks a period of rebuilding. The foundations of walls 2 and 49 are topped by new mortared stone walls and a series of concrete floors laid on pitched stones throughout the building. The construction of the concrete floors and the plastering of the internal faces of the new stone walls appears to indicate a period of considerable affluence for the site of EM 23 — that this period lasted for a long time is suggested by the fact that the internal walls of the building were replastered at least twice and in the case of wall 49 three times (fig. 6,7).

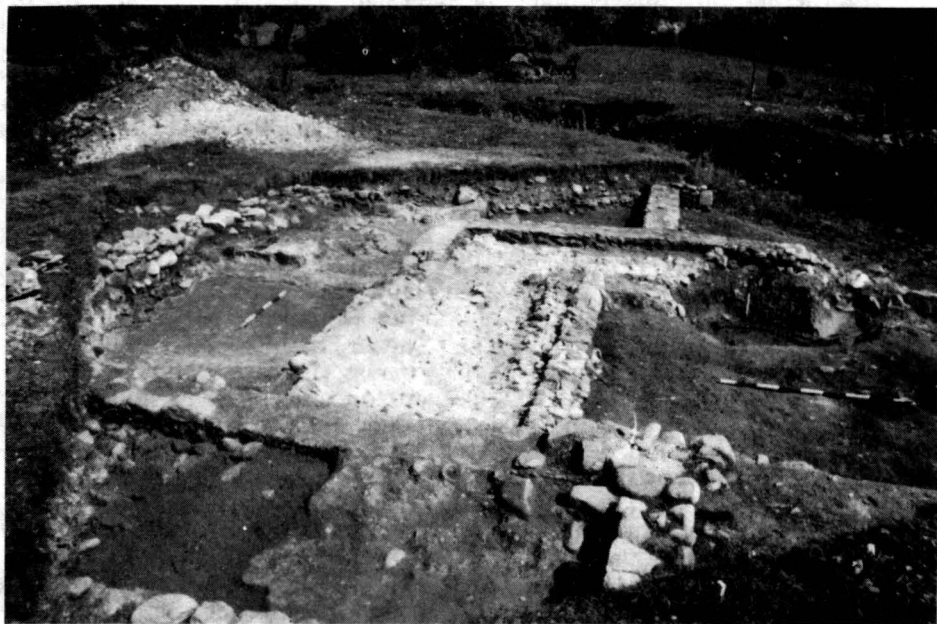
Fig. 7. After the removed of the concrete floors.
