ASPECTS CONCERNING THE INTERIORS OF THE “VOIVODAL PALACE” FROM TURDA

Abstract: The Voivodal Palace of Turda is the most valuable monument of civil medieval architecture in the town and the only palace with surviving parts that date from the late 15th century and the beginning of the next.

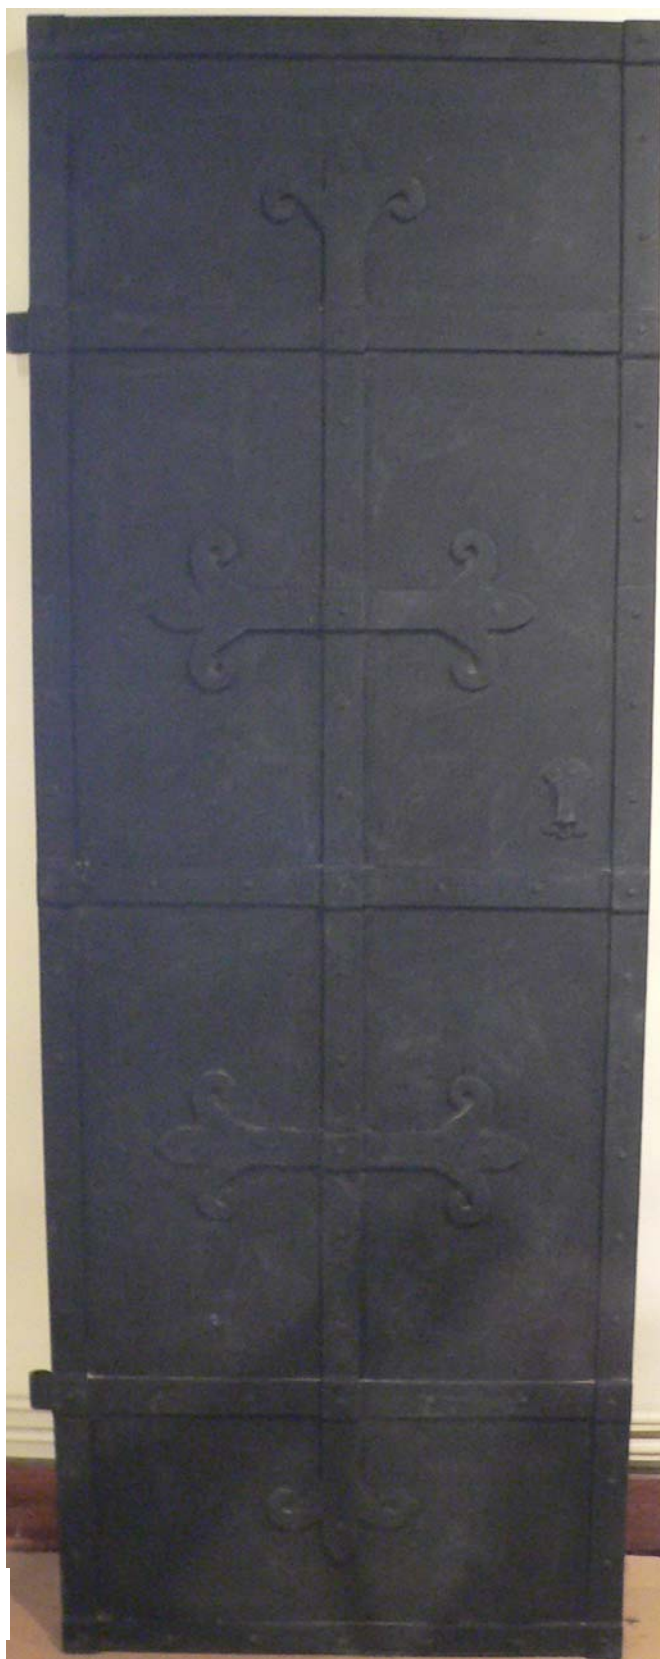
Fig.1

From the first landing of the old staircase, at the mezzanine, one could go out into a gazebo (according to information from the 19th century), which, during the renovations of 1913, was replaced with an enclosed extension, provided with four windows and door. The second landing of the staircase led (on the northern side) to an entrance fitted with a beautifully ornate metal door, which allowed access to the small

attic of the building (the single-storey wing - Figure 1). Both the staircase and the entrances to the extension and, respectively, to the attic have been decommissioned.

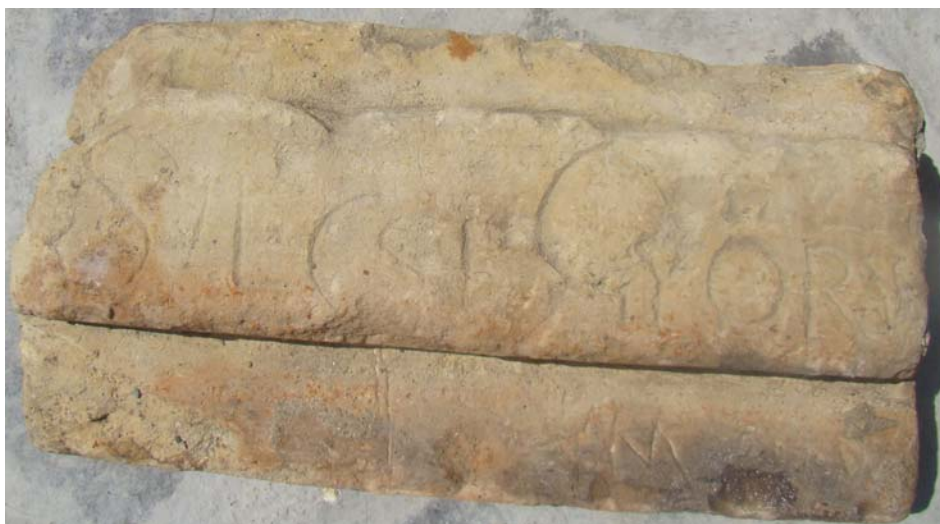
Fig.2

The rooms were divided width-wise at some point. The walls that had an arch opening were most likely annexed during the renovations of 1818. Built of stone and brick, they were dismantled in 1998. When one of the walls was removed, there were found two fragments of limestone platband, one of them being engraved. The text, which contained a person's name, should be attributed to the master mason's insignia, which were common in the medieval period (Figure 2).

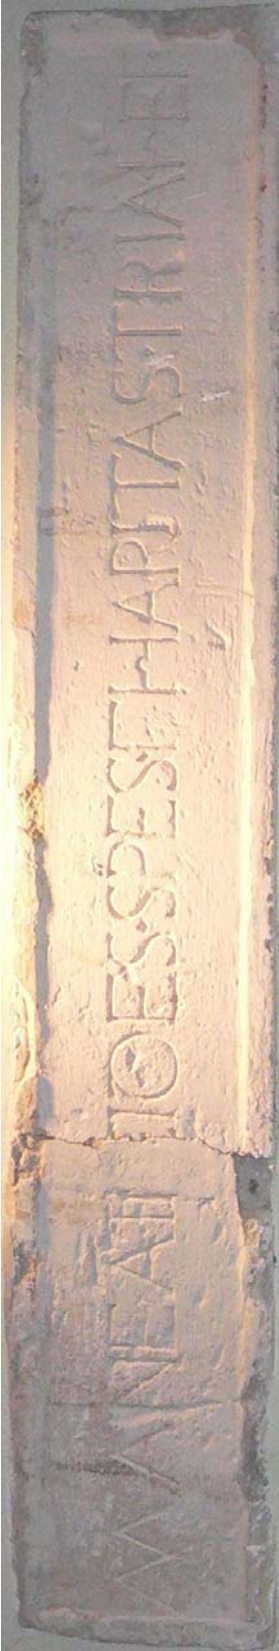
Fig.4

Another entrance fitted with an ornate metal door was located at the intersection of the eastern and northern walls of the hallway. The entrance opened at the beginning of last century was on the second landing of the old staircase and allowed access to the attic of the one-storey wing of the building. A stone inscription written in medieval Latin and recently deciphered is mounted on the eastern wall of the hallway (Figure 4).

MANEĀ[AN]T • [F]IÓ[D]ES • SPES • CHARITAS • TRIA • HEC[HAEC]

The inscription is original and definitely belongs to this building. Such inscriptions often appeared in medieval public buildings in many parts of Europe. Its text presents a biblical psalm from “St. Paul’s First Letter to the Corinthians,” chapter 13³⁷.

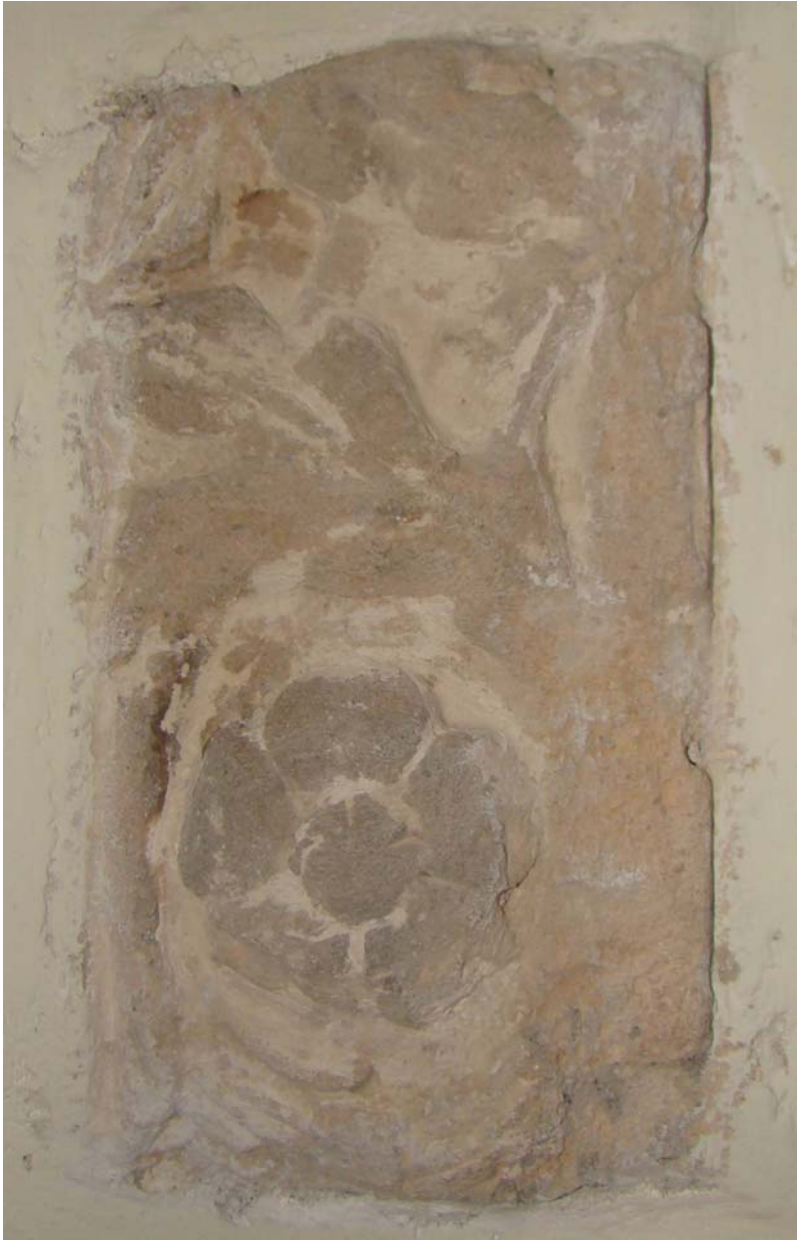
Fig. 4. Medieval inscription - the hallway upstairs.
