RESCUE EXCAVATION IN THE SITE “TIMIȘOARA – SQUARE 700” CITY BUSINESS CENTRE, BUILDING D

*Mircea Mare, Alexandru Szentmiklosi, Andrei Bălărie**

I. Introduction

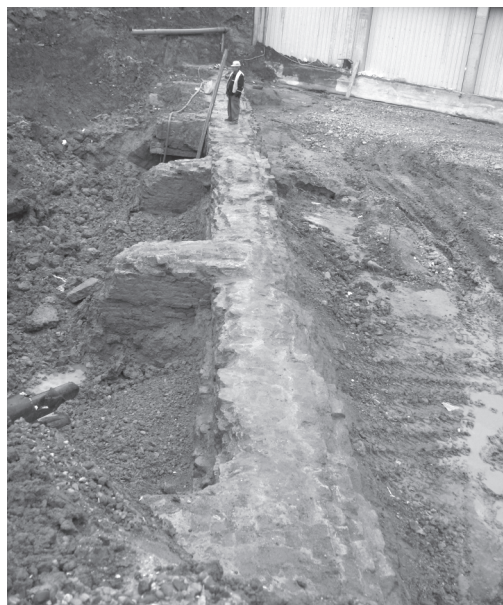
Pl. II. 1 – Fundația contraescarpei contragardei I; 2 – Profil prin fundația contraescarpei contragardei I; 3 – Substructura de lemn a contraescarpei. / 1 – The counterscarp foundation of counterguard I; 2 – Profile through the counterscarp foundation of counterguard I; 3 – The counterscarp wooden substructure.

In the exterior side of the counterscarp, six counter-forts with trapezoidal plan, perpendicularly displayed on the wall (Pl. II/1) were discovered. The dimensions of the uncovered counter-forts were: length of sides – 1.25–1.43 m, length of short base – 1.06–1.20 m, length of long base – 1.10–1.30 m. The preserved height was between 1.30 m and 1.50 m.

Every pair of beams had both ends cut out on 30cm in length and 10 cm in thickness to get bound with the next pair of beams, which had the same section type, but the other way round. (Pl. II/1). There were found no additional fixation elements, such as nails, cramps or other metal pieces. In the spot where the sleepers were to be fixed, the superior part of the beams was cut out in a rectangular or trapezoidal shape.

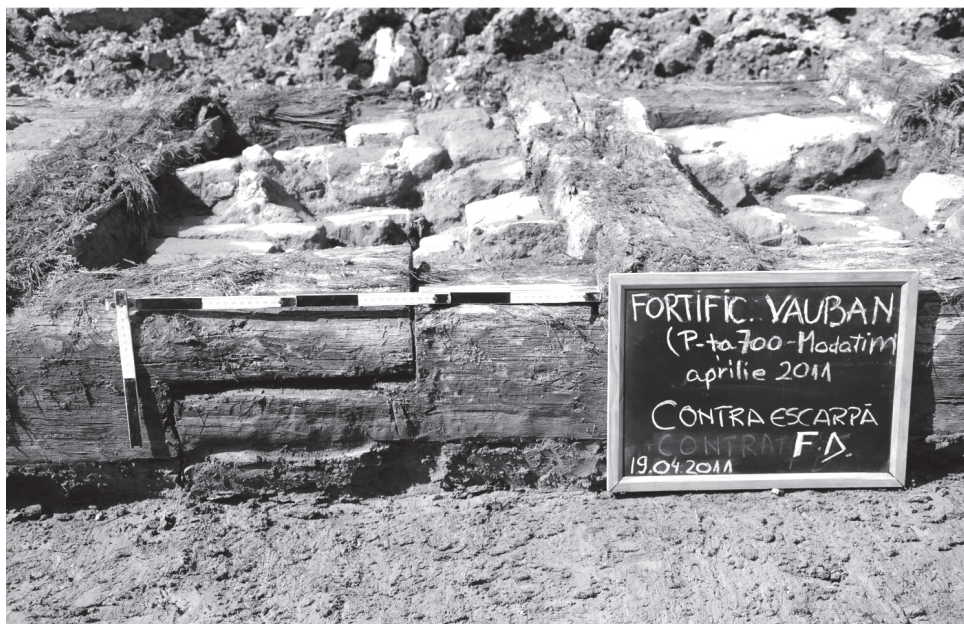
1

Pl. III. 1. Sistemul de îmbinare a lonjeroanelor contraescarpei; 2. Decupajul pentru fixarea uneia dintre antretoazele contraescarpei. / 1. The system of the counterscarp longitudinal beams joining; 2. Cutting out for fixing one of the counterscarp sleepers.

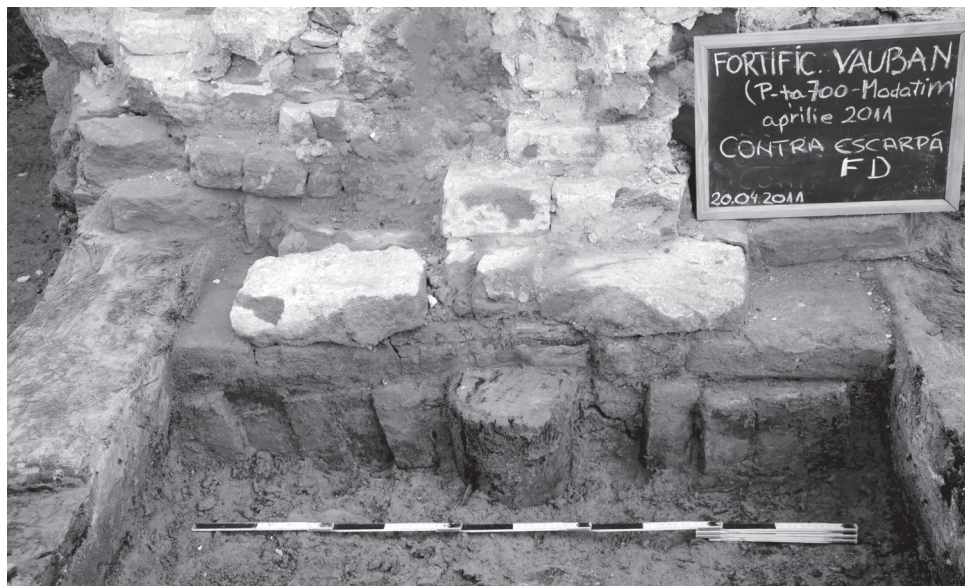
1

Pl. V. 1. Profil prin fundația contraescarpei, dispusă pe substructura de lemn; 2. Piloții de susținere a substructurii de lemn a contraescarpei. / 1. Profile through the counterscarp foundation on the wooden substructure; 2. The pillars to support the wooden substructure of the counterscarp.

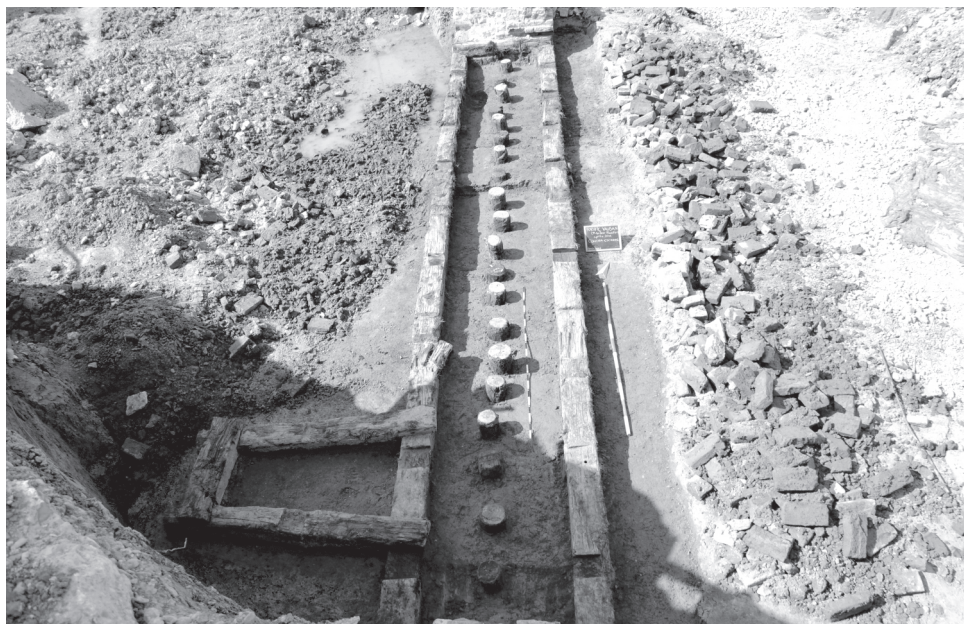
1

Pl. VI. 1. Lonjeroanele substructurii de lemn a contraescarpei; 2. Contraforturile de la contraescarpa contragardei I. / 1. The longitudinal beams of the counterscarp wooden substructure; 2. The counterforts of the counterscarp of counterguard I.

Between these two lateral rows of long pillars, from beneath the longitudinal beams, there is one row of central pillars, shorter ones (Pl. VI/1). Most of them

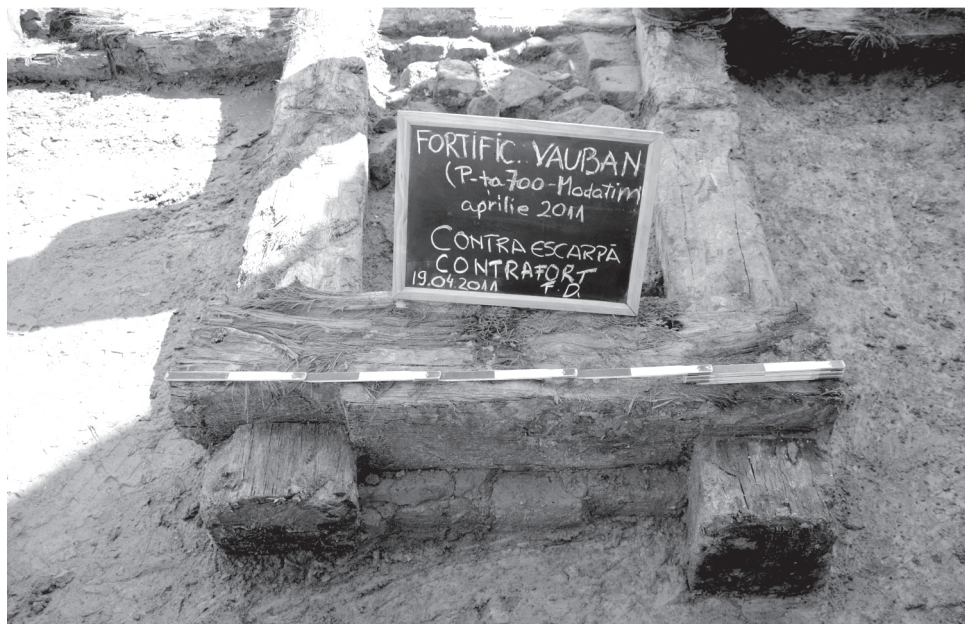
1

Pl. VII. 1. Detaliu cu îmbinarea antretoazei cu lonjeroanele contraescarpei; 2. Fundația de cărămidă a zidului de escarpă a contragardei I. / 1. Detail on the counterscarp longitudinal beams and sleepers joining; 2. The brick foundation of the scarp wall of counterguard I.

This short beam had both ends cut out at the bottom, on a length of approximately 0.20 – 0.25 m and a thickness of 0.10 m, in order to be pressed into the cracks cut into the long sides it superposed. (Pl. VII/1)

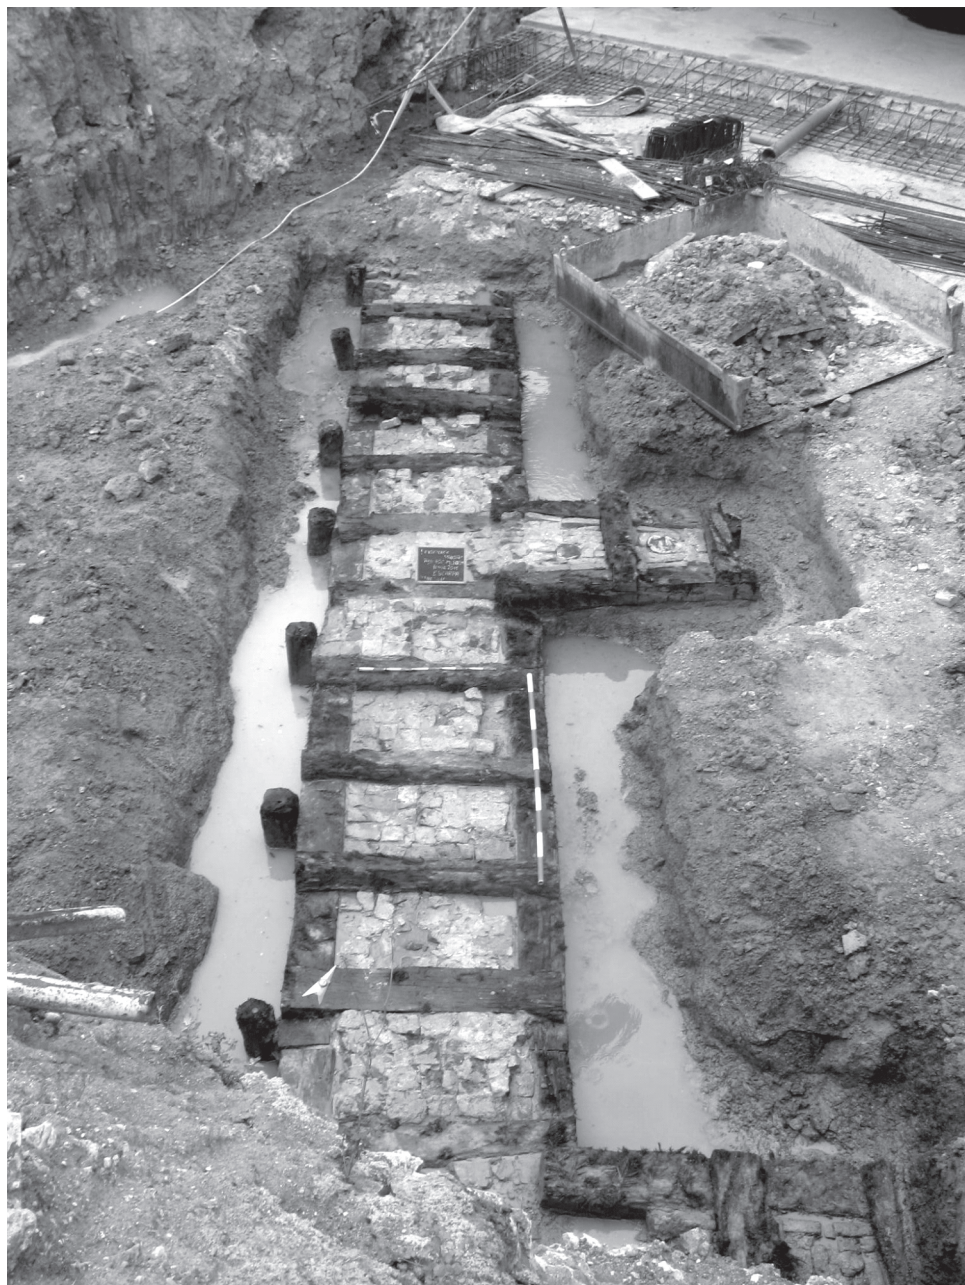
Pl. VIII. Substructura de lemn a zidului de escarpă a contragardei I. / *The wooden substructure of the scarp wall of counterguard I.*

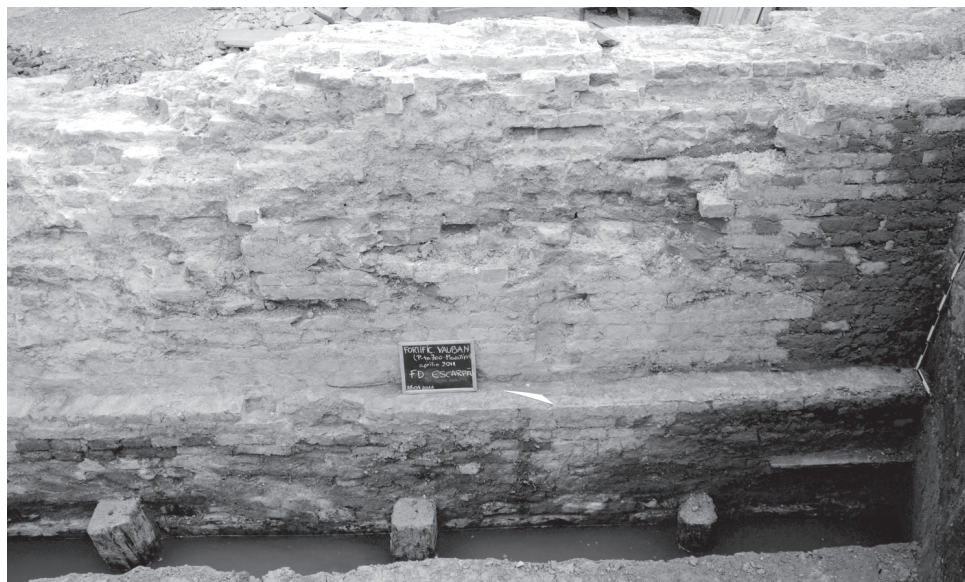
1

Pl. IX. 1. Pilonii masivi de fixare a substructurii de lemn a zidului de escarpă a contragardei I; 2. Contrafortul zidului de escarpă a contragardei I. / 1. The massive pillars to fix the wooden substructure of the scarp wall of counterguard I; 2. The counter-fort of the scarp wall of counterguard I.

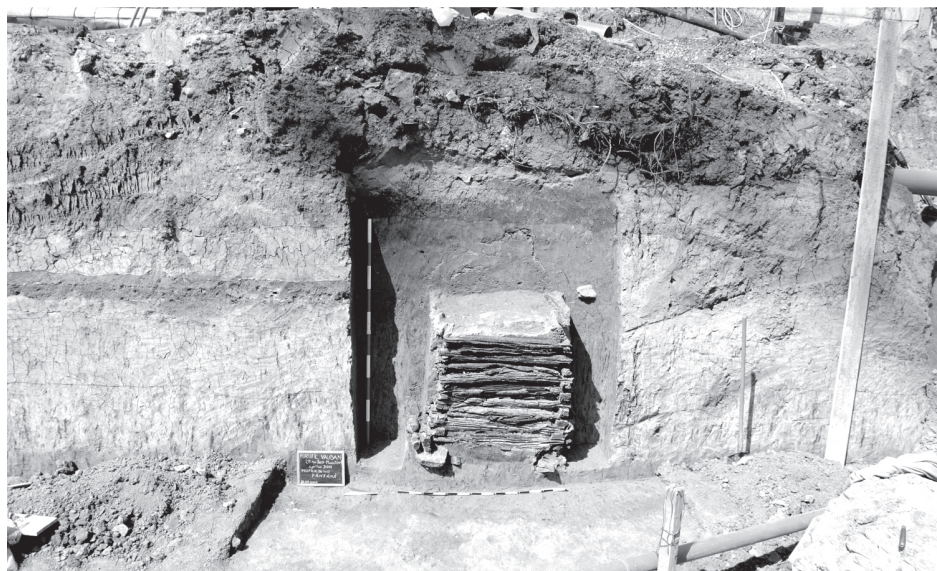
1

Pl. X. 1. Fântâna din lemn aparținând perioadei otomane; 2. Detaliu cu sistemul de îmbinare a pereților din lemn. / 1. The wooden well belonging to the Ottoman time; 2. Detail on the wooden walls joining.

On finishing the western profile of the excavated profile for the building's foundation (Pl. X/1), the wooden structure of a rectangular well was revealed. In order to fully study it, an opening cassette was made in order to make possible the next stage, that of emptying the well shaft of its filling. The integral research of the well allowed a general outlook on the materials used and its construction system.

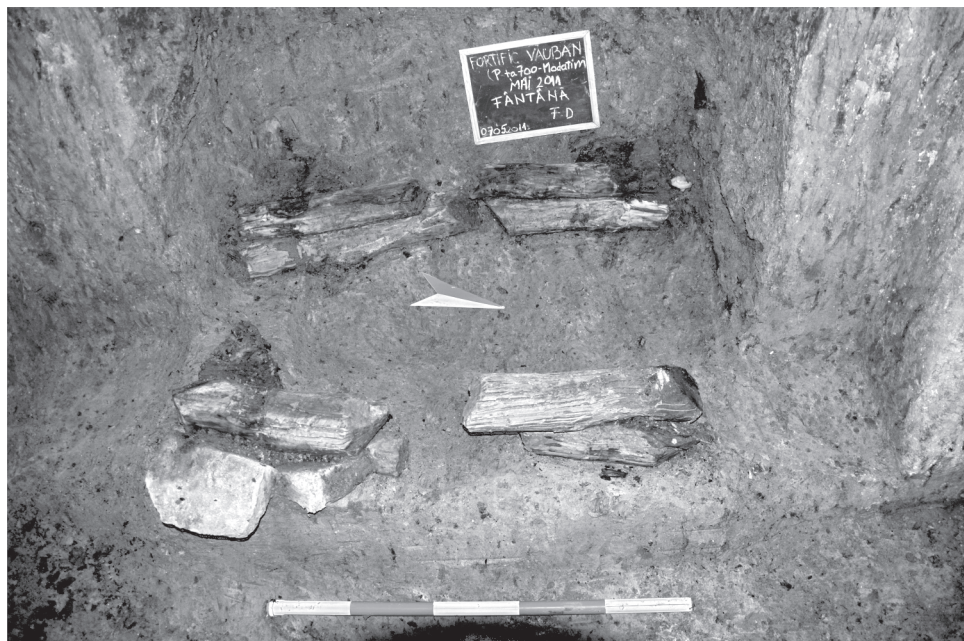
1

Pl. XI. 1. Baza fântânii de lemn; 2. Pereții dublați pe lateral, la baza fântânii. / 1. The base of the wooden well; 2. Outside laterally doubled walls, at the well base.

After the pit had been dug into the yellow clay, stones used as foundation for the wooden structure's corners (Pl. XI/1) were displayed. The whole wooden

structure formed by joining the boards was built upon four pairs of small size hubs (Pl. XI/1) and the corners of the well had been reinforced with some stones fixed in the exterior of the construction. At the base, wooden structure was reinforced by doubling it outside, on all sides, with hubs split on their length, most of them untrimmed, still wearing their bark (Pl. XI/2).

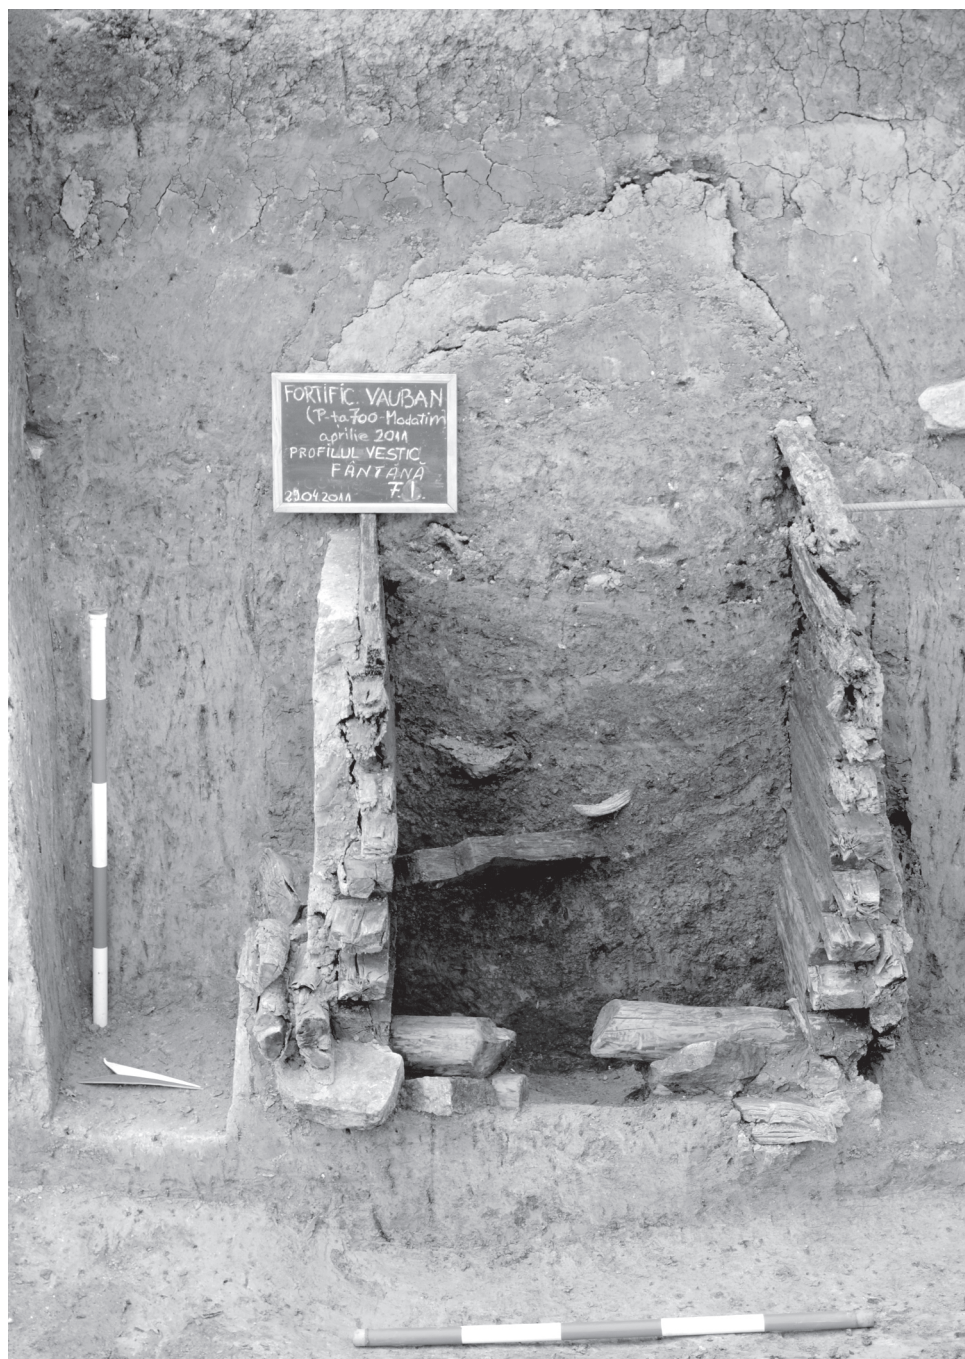
Pl. XII. Stratigrafia umpluturii fântânii. / *Stratigraphy of the well inside filling.*

Several layers of filling were found, nine in number, marked from A to I, starting with the upper edge of the well.

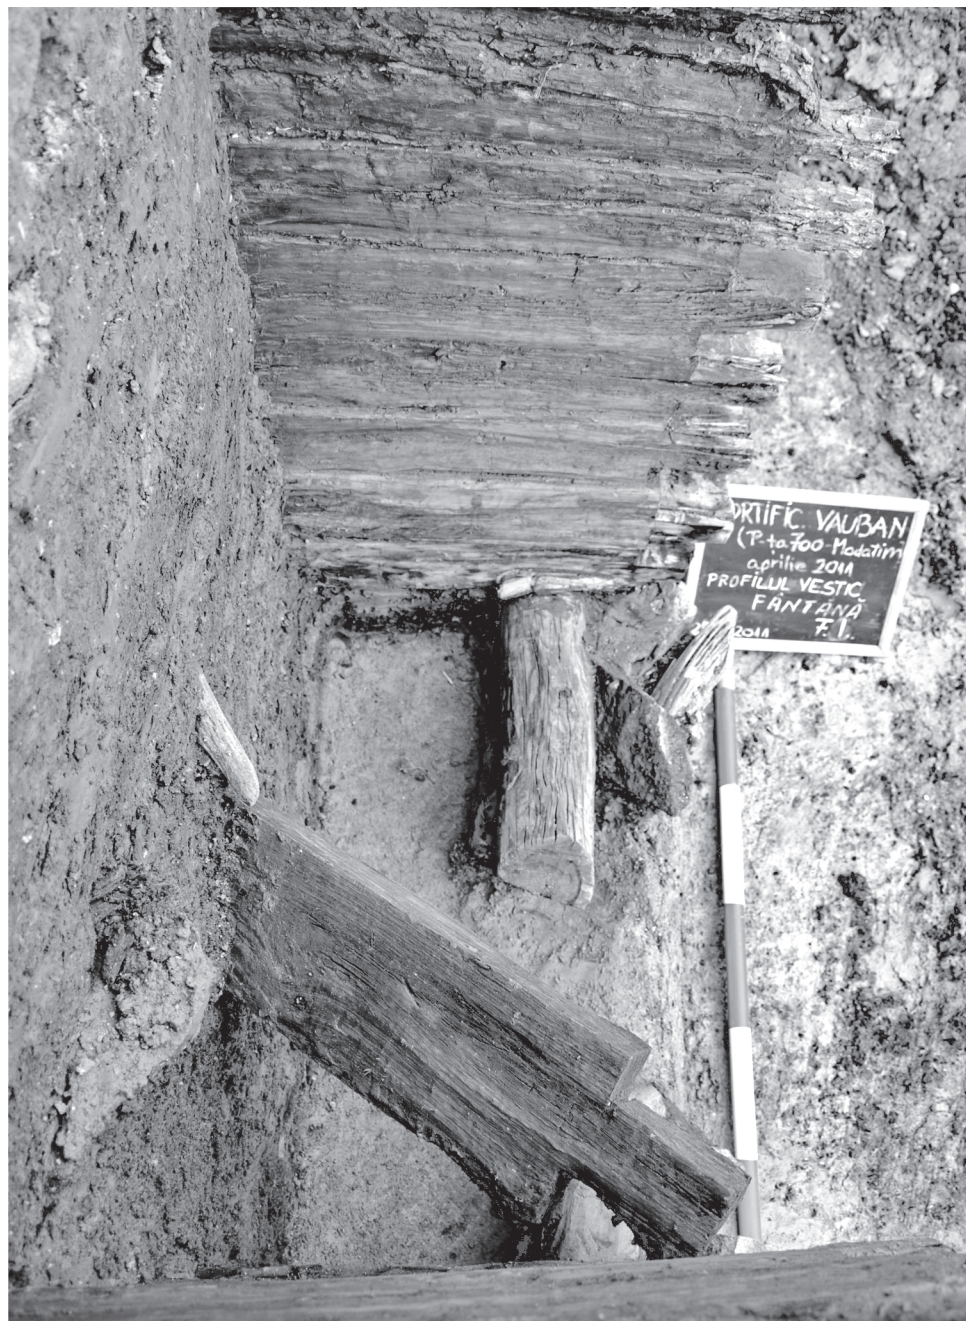
Pl. XIII. Detaliu cu bârna căzută din peretele fântânii. / *Detail on the detached board from the edge of the well.*

At the base of level C was discovered the upper end of a board detached from the edge of the well. (Pl. XIII). In the same spot, there was also found an agglomeration of highly fragile tree branches. When taking out the filling, it

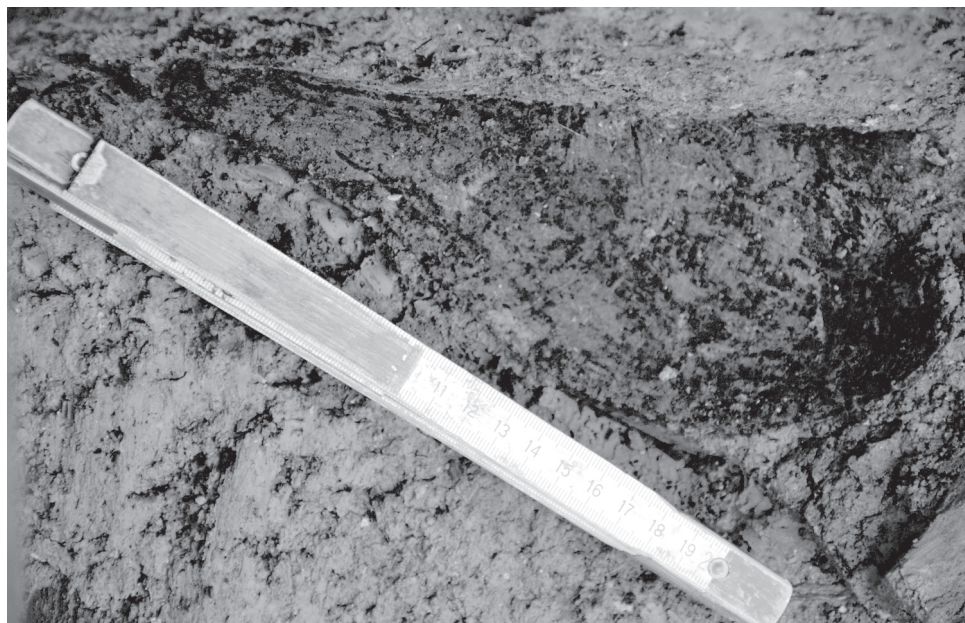
1

Pl. XIV. 1. Talpa unei încălțăminte din piele descoperite în umplutura fântânii (lentila C);
2. Profil prin șanțul de apărare (la vest de contragarda I). / 1. The leather shoe sole that was
found in the well filling (lens C); 2. Profile through the defence ditch (west of counterguard I).

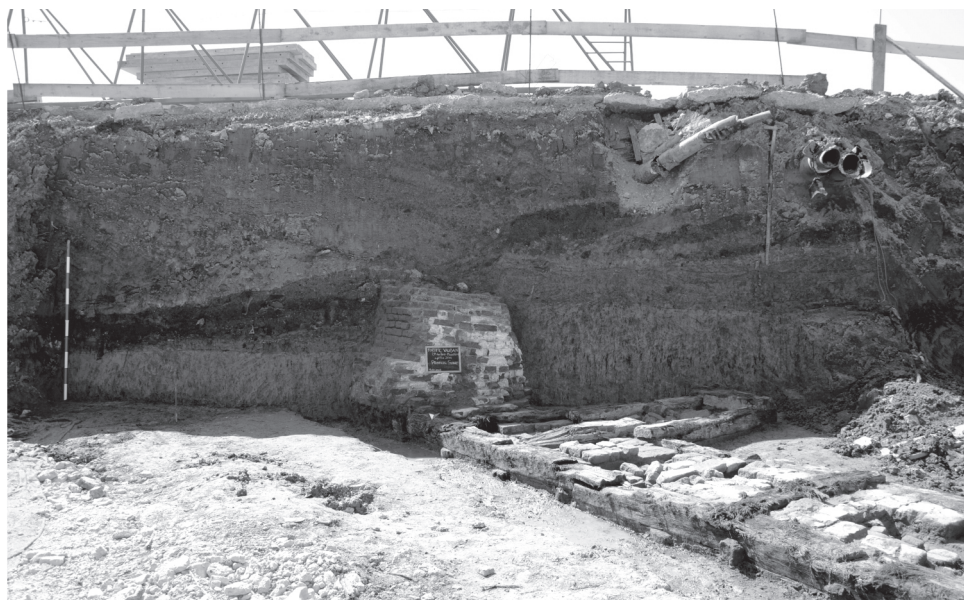
1

Pl. XV. 1. Profilul șanțului de apărare a contragardei I și nivelurile de amenajare a *glacis*-ului; 2. Profilul vestic al perimetrului cercat arheologic (în *glacis*). / 1. Profile of the defence ditch of counterguard I and the *glacis* fitting out levels; 2. The western profile of the archaeologically investigated perimeter (in *glacis*).

Thus, only a few relevant profiles could be found and they have been documented both graphically and with photos. (Pl. XIV/2, Pl. XV/1–2).
