PREVENTIVE CONSERVATION WORKS *IN SITU* ON POTTERY KILNS FROM XIVTH CENTURY IN VORNICENI (REPUBLIC OF MOLDOVA)

Cristina Georgescu

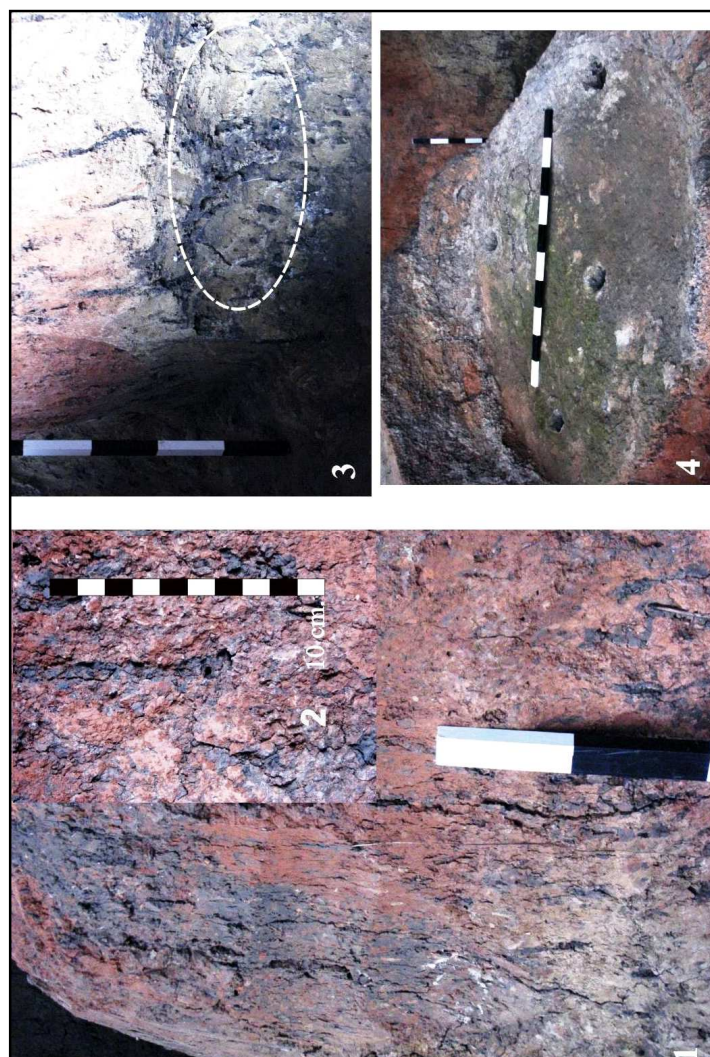
The burying conditions, once the ovens stopped being used, eventually led to a mechanical and chemical balance between the ovens and the new environment¹¹. There was a change in the humidity of the material, the structure of the ovens weakened; the roots of plants worked their way inside the walls of the ovens, causing fissures to appear. The entomofauna transits or nests in galleries inside these fissures, just like in old canals left open. New generations of annelids, gastropods and insects took advantage of these galleries and carried in fresh humus. (fig. 3/1, 2). The reverberation plates of the two ovens suffered less from the movements of the entomofauna. This phenomenon is due to the different kind of mechanical treatment (compacting) applied to them during construction. The humus is a fertile soil, rich in soluble salts, black and very permeable; it also carries animal galleries (fig. 3/3). The differences between the permeability of the two types of soil increased the degradation processes.

The sudden change in the aforementioned parameters at the moment of the uncovering, then their permanent variation from day to night and from season to season rapidly affected the state of conservation of the two ovens. The canals filled with humus reacted differently than the burned material, given their higher permeability. Differences in humidity and capillarity as well as in the relative humidity of the environment, determined the pulverulent material to detach in slices and suffer different forms of biodegradation.

Fig. 3. Vorniceni-„Gura Văii”. Active biodegradation:
 1 – humus that the entomofauna brought to the walls
 after the ovens had been abandoned, fissures in the wall caused by this action;
 2 – humus that the Annelids brought into the walls through canals;
 3 – humus that small animals brought into the walls of the ovens;
 4 – active biodegradation of bryophite (moss)
 on the surface of the reverberation plates, proof of high humidity.

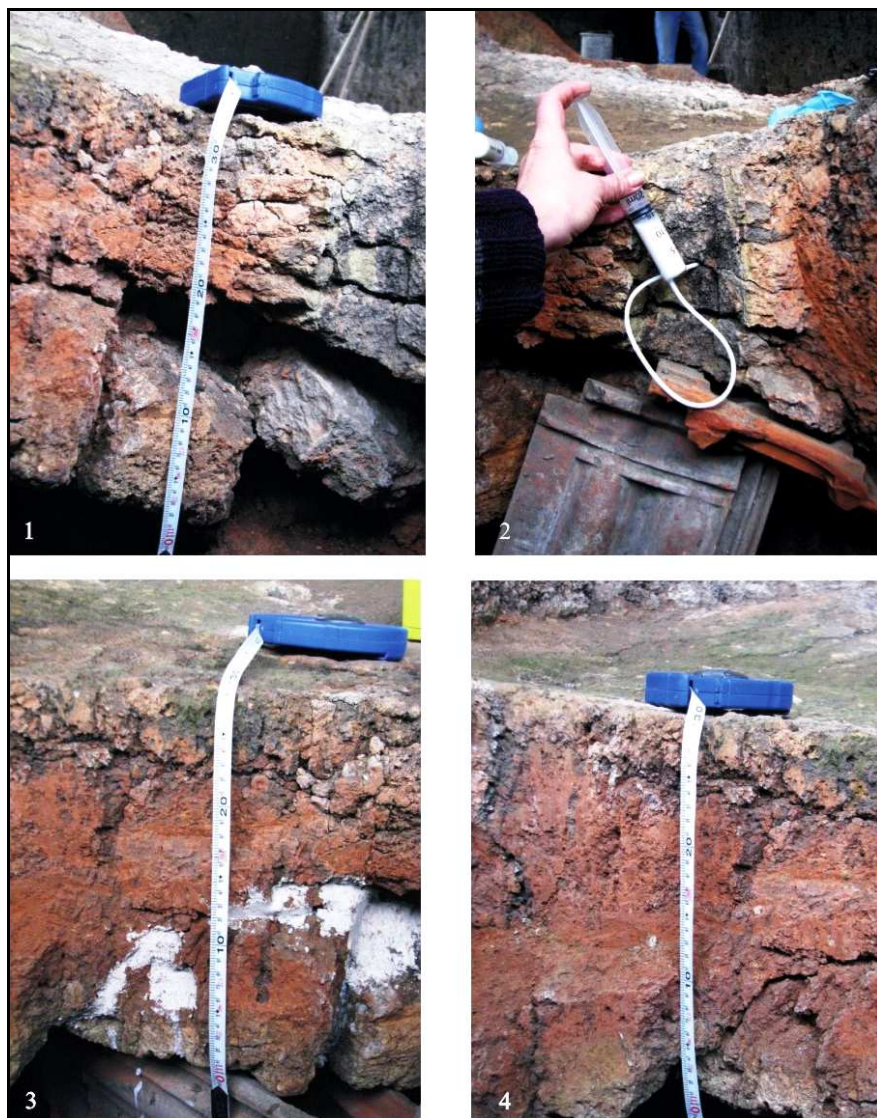
Fig. 5. Vorniceni-„Gura Văii”.

Intervention of consolidation of fissures on the reverberation plate (oven no. 1):

1 – image before intervention; 2 – injecting fissures in depth;

3 – under the level luting; 4 – luting at the same level with chromatic integration.

4. Consolidating the walls of the ovens, the delimitations of burnt soil that mark the openings used for the fuel feed and the holes with ceramic fragments. It was proceeded to filling the canals and the gaps (fig. 5/1) by injecting calcium caseinate and fluid lime mortar (fig. 5/2). In that which regards gaps, they have been supplementary insured using props before making the injections.

5. Completing the missing parts with mortar made of lime / sand / burnt soil and calcium caseinate (fig. 5/3) and completing the missing parts on the chromatic integration level.
