THE TURKISH BATH FROM ORYAHOVO – THE FIRST STUDIES

*Evgeniya Naydenova**

Abstract: In this article we present the results of the researches from 2019-2021, covering an area of almost 85 m². From the exterior plan of the bath, the Eastern wall and a small part of the Southern wall have been revealed. The remains of the Northern wall are completely missing. In the South-Eastern corner of the bathroom a room floor was found which has been rendered with a grey and pink waterproof mortar. Underneath were partially uncovered four hypocaust channels. There is evidence of an internal wall construction up to 1.15 m in height with a North-South orientation. Its Eastern face is crossed by three other hypocaustic channels with brick arches. The floor of the room was sustained by pillars. Another important result of the researches was the discovery on the inner Eastern wall of a deep flue niche. According to an Ottoman register, the bath was built in the XVIth century. Most probably it was abandoned at the end of the XVIIIth century or at the beginning of the XIXth century.

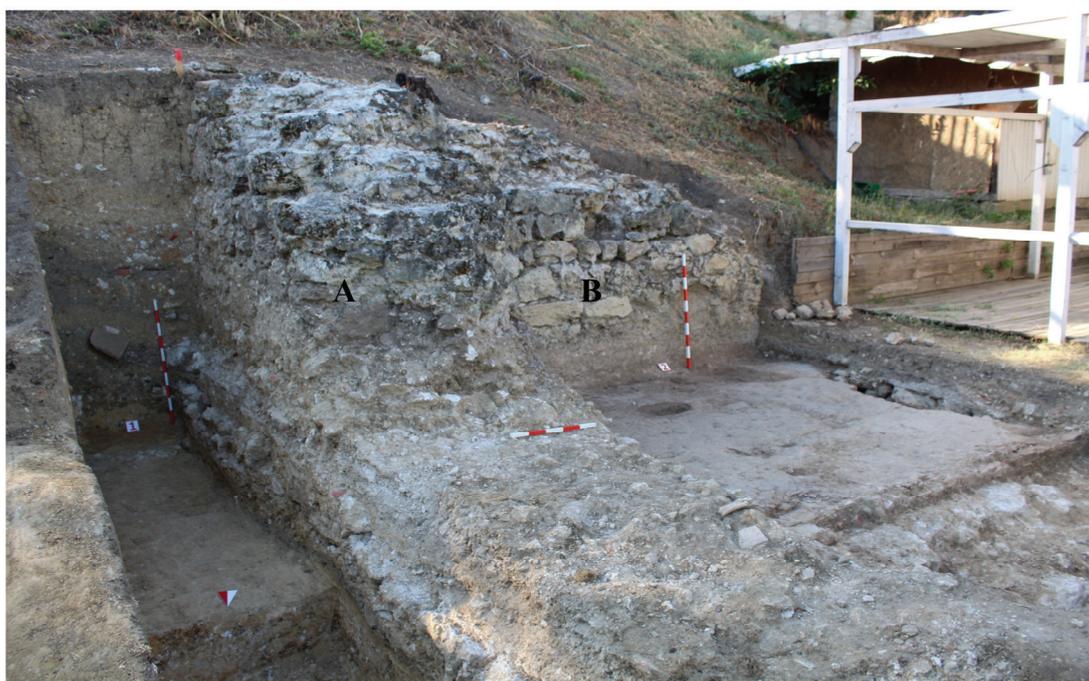
A - Eastern wall, B - Southern wall

The Eastern wall has a surviving superstructure only at the South-Eastern corner of the building (**Pl. 1/1 A, 2/1**). Here the superstructure rises to a height of 2.20 m and is 1.40 m thick. At its outer face two stone belts of roughly dressed stones are distinguished, separated by a single course of flat stones. Plaster of yellowish clay covers its lower half. The solder is made of mortar mixed with pebbles. The joints are filled with small stones and pieces of bricks. A levelling mortar layer follows beneath the superstructure. It gradually makes an indentation of 10 cm outwards - a banquette. The maximum retained height of the substructure is 1 m. It treads on sterile yellow clay soil and is traced in a Northern direction up to 9.30 m long. Its outer face is constructed of large and medium sized rough stones (**Pl. 1/3**). The joints between them are filled with small stones, pieces of brick and mortar solder. Medium and small sized rough stones, mortar and rubble were used for the infill. The North-Eastern corner has been completely demolished. The remains of the wall end in large treated stones of almost regular rectangular shape, which mark a width of 1.60 m³. Field observations show a stepped construction of the bathhouse foundations, in keeping with the slope of the ground. The till consists of various clay overlays and limestone rock formations (**Pl. 1/3**).

At this stage of the studies, only a small part of the superstructure, 1.50 m high and 2.70 m long, has been uncovered from the southern wall (**Pl. 1/1 A, 2 a, b**). A brick arch is visible at the Western end. There is no information on its purpose at present. The inner faces of the superstructure of both walls are mainly built of large roughly dressed stones, with only the lower part of the superstructure using medium and small sized stones (**Pl. 1/2 b**).

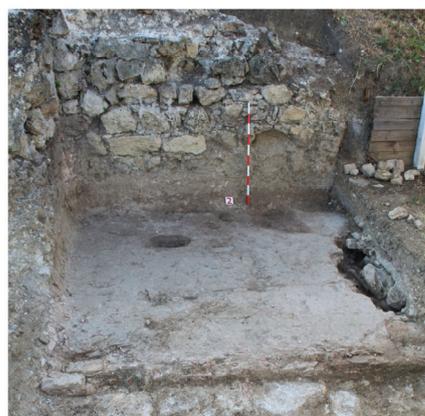
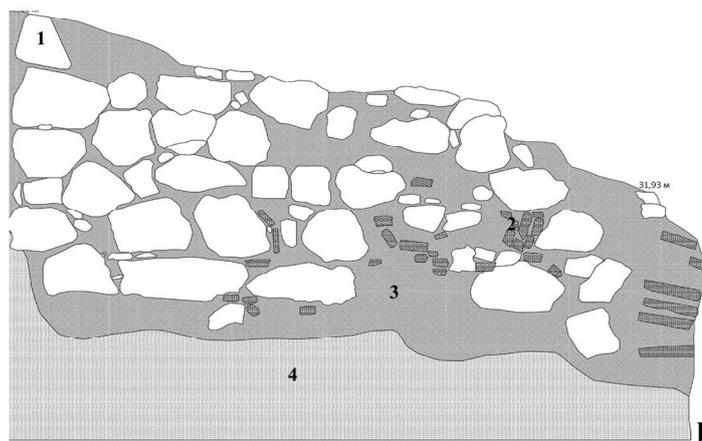
2

Inner face of southern wall

In the South-Eastern corner of the bathroom a room floor was found which has been rendered with a grey and pink waterproof mortar (**Pl. 1/2 a**). In the remaining work area (**Pl. 2/1**), both North and West, the floor is entirely missing. However, the exposed sub-floor space provides important information. There is evidence of an internal wall construction up to 1.15 m in height with a North-South orientation which continues beneath the site of the restaurant. The wall is 1,60 m thick. It has the same thickness as the substructure of the Eastern wall, from which it stands at a distance of 4.30 m. The inner face of the wall is exposed to the East, with a total length of 4.50 m (**Pl. 2/2**). The construction comprises alternating brick and stone bands from bottom to top, bonded with white mortar. The brick belts consist mainly of two courses of bricks. The stone belts reach a height of up to 0,20 m. They use large treated limestones to form the outer faces and rough medium and small stones for the infill. Pieces of brick fill larger joints. Preserved traces of mortar solder are found in some places (**Pl. 2/2**).

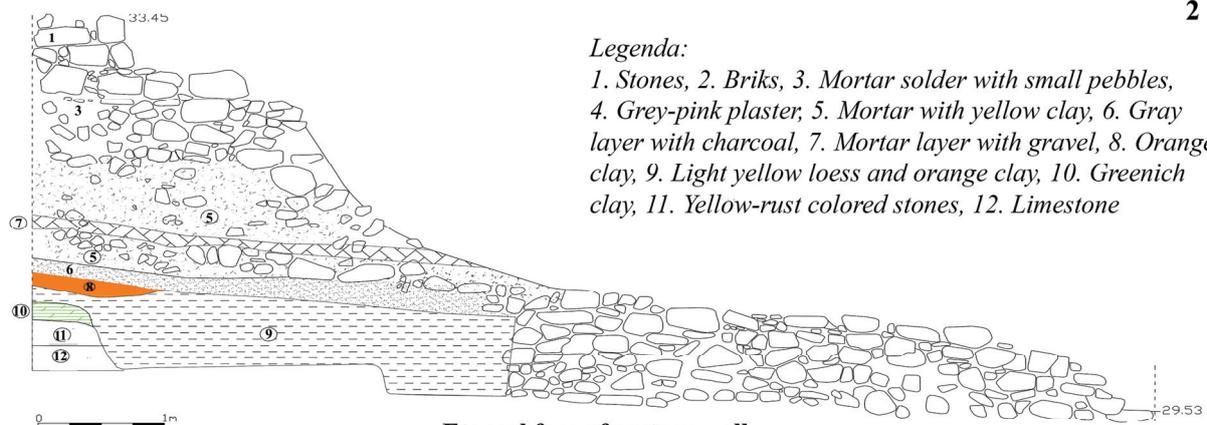
3

External face of eastern wall

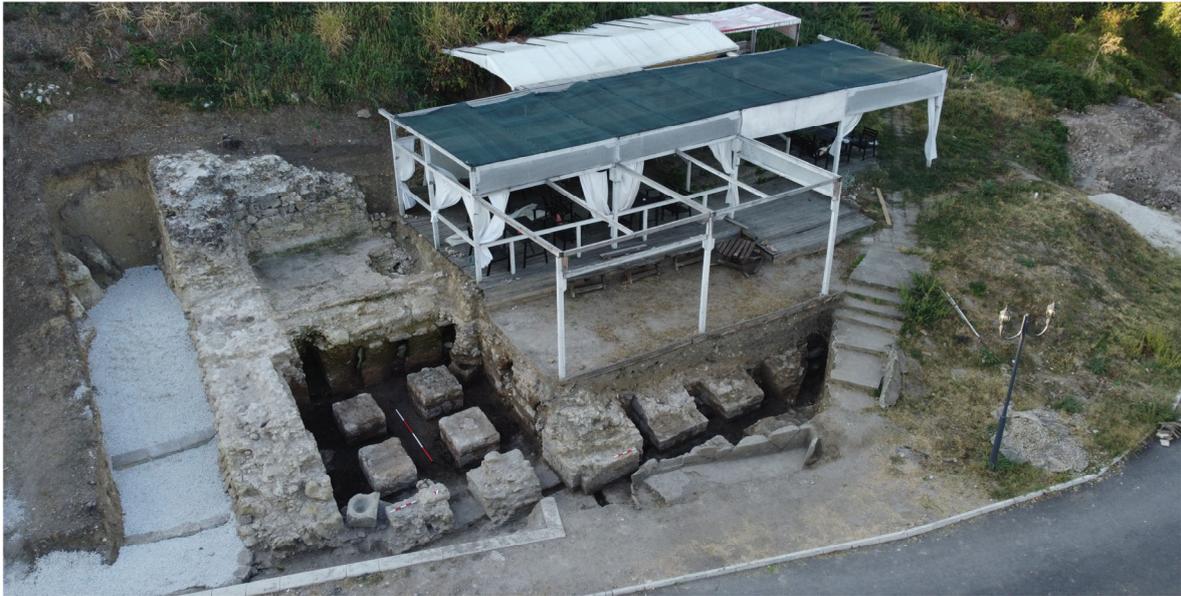
1

General view of the surveyed area.

The inner wall separated two rooms with underfloor heating. To the West and East of it, mortar-plastered pillars were uncovered, warm air with the smoke from the furnace circulated between them (**Pl. 2/1, 2**). This is evidenced by accumulated soot and ash at their base. The pillars supported the floor of the rooms. Among the charred destructions removed were many fragments of stone slabs from the floor above them (**Pl. 3/2**). The pillars are irregular rectangular in shape and

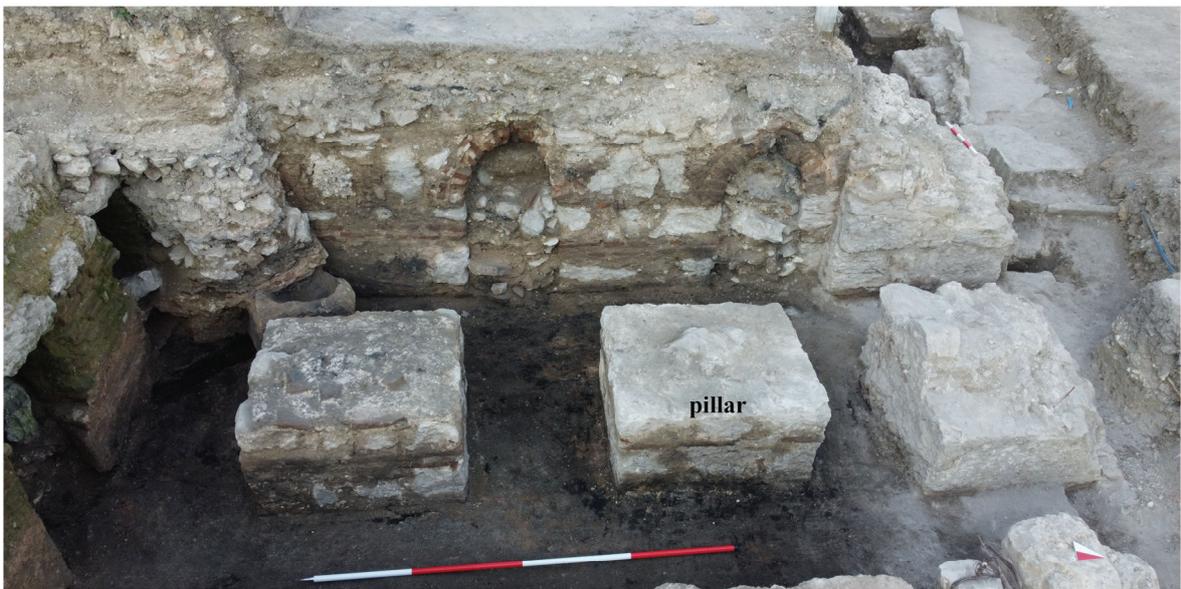
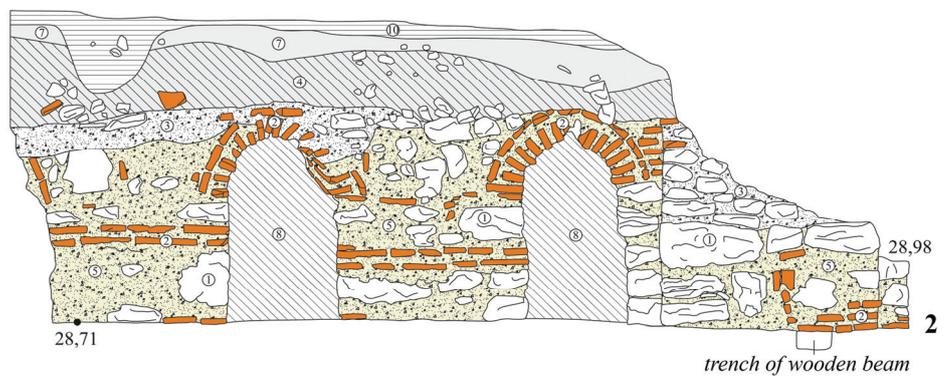
Eastern face of the wall with openings of channels and brick arches

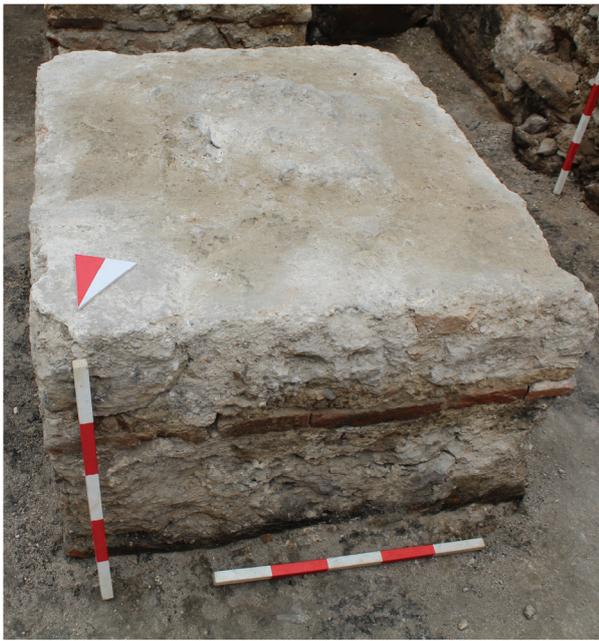
1

Pillar

measure between 1.15 and 0.75 m. Their surviving height varies from 0.20 m to 0.65 m (Pl. 3/1, 3). They were built of stone belts, bricks in one or two courses and white mortar solder. The pillars step on a mortar level which is covered with the aforementioned soot and ash.

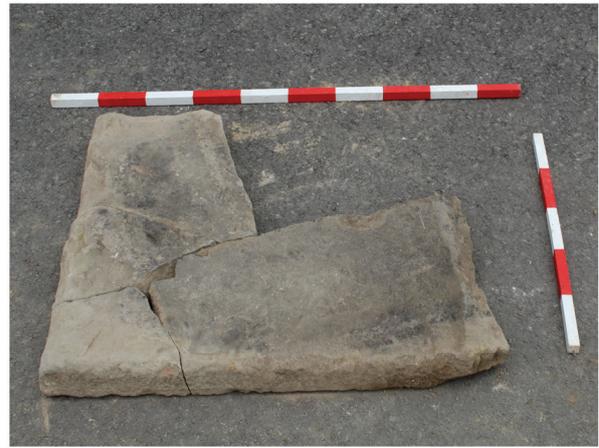
2

Stone slab

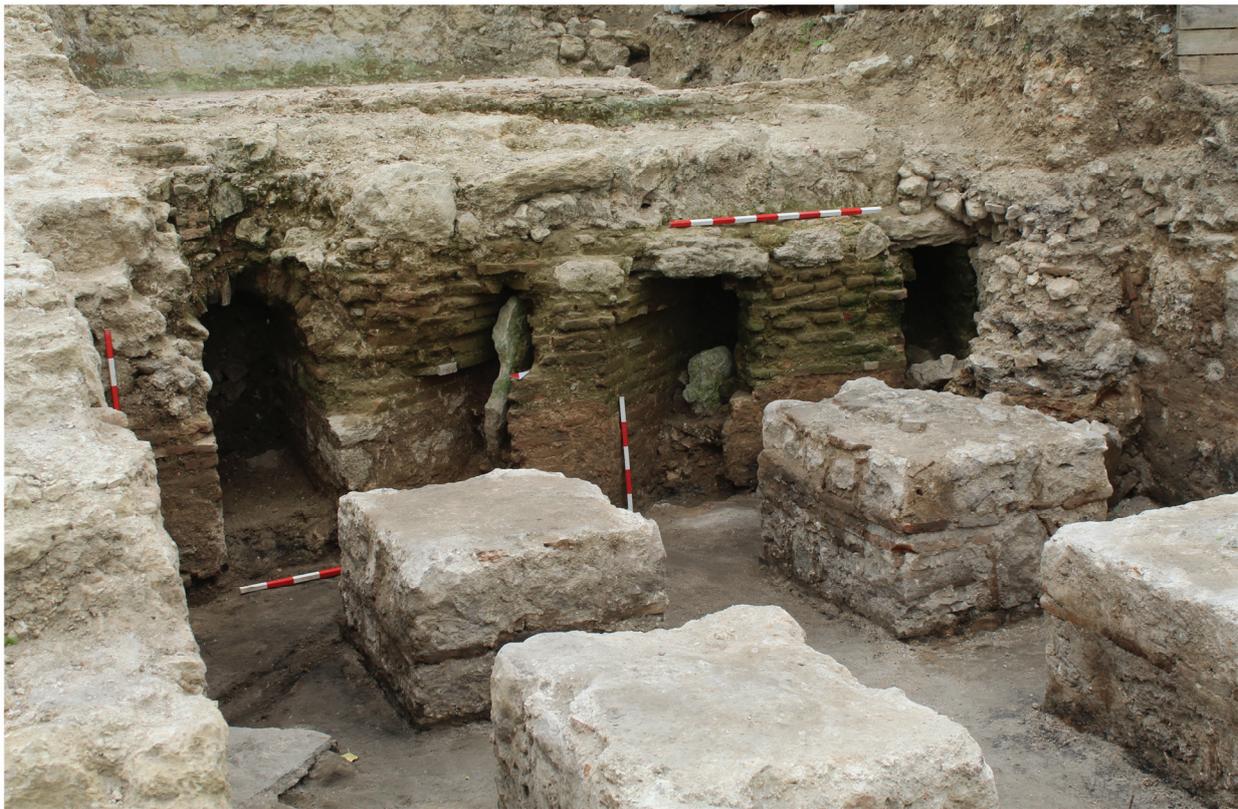
3

Ducts under the floor of the mortared room

The heating system also includes individual ducts between 0.30 and 0.60 m wide, which, according to building tradition, must be connected to the furnace. Four ducts of this type were partially explored under the floor of the mortared room at the South-Eastern corner of the bathroom (Pl. 3/3). They are enclosed by brick walls nearly 1 m high. The other three channels taper in height and are covered with thick stone slabs and bricks from the floor construction. The walls in between follow a Northeast-Southwest orientation. Three other hypocaustic channels with brick arches at their openings cross the Eastern face of the inner wall (Pl. 2/2). They have a maximum height of 1.18 m. They are filled with debris and shall be explored next year. A brick arch completes the channel to the West of the inner wall.

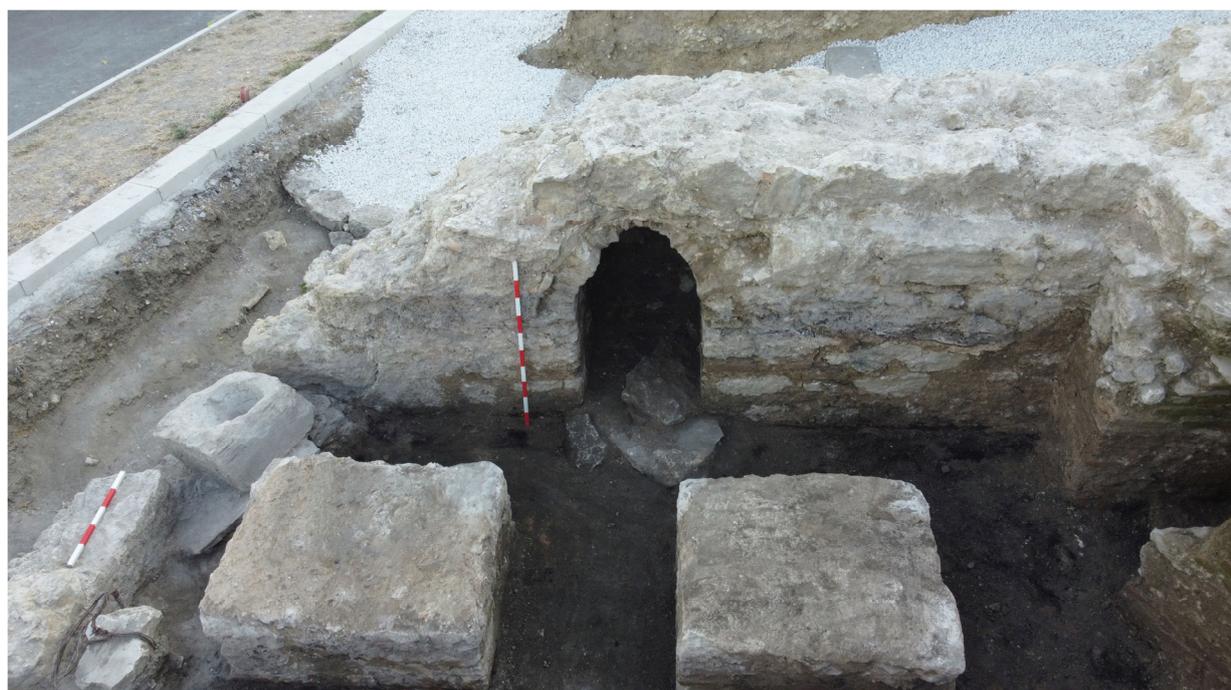
1

Inner face of the Eastern wall and a deep flue recess

Another important result is the discovery of the inner face of the Eastern wall and a deep flue recess (niche) with an arch in its construction (Pl. 4/1). The construction technique was the same as for the inner wall - made of bricks and 0.60 m wide. A channel with a diameter of 15 cm runs upwards from the niche, the opening of which is found under the removed embankment above the wall (Pl. 4/2).

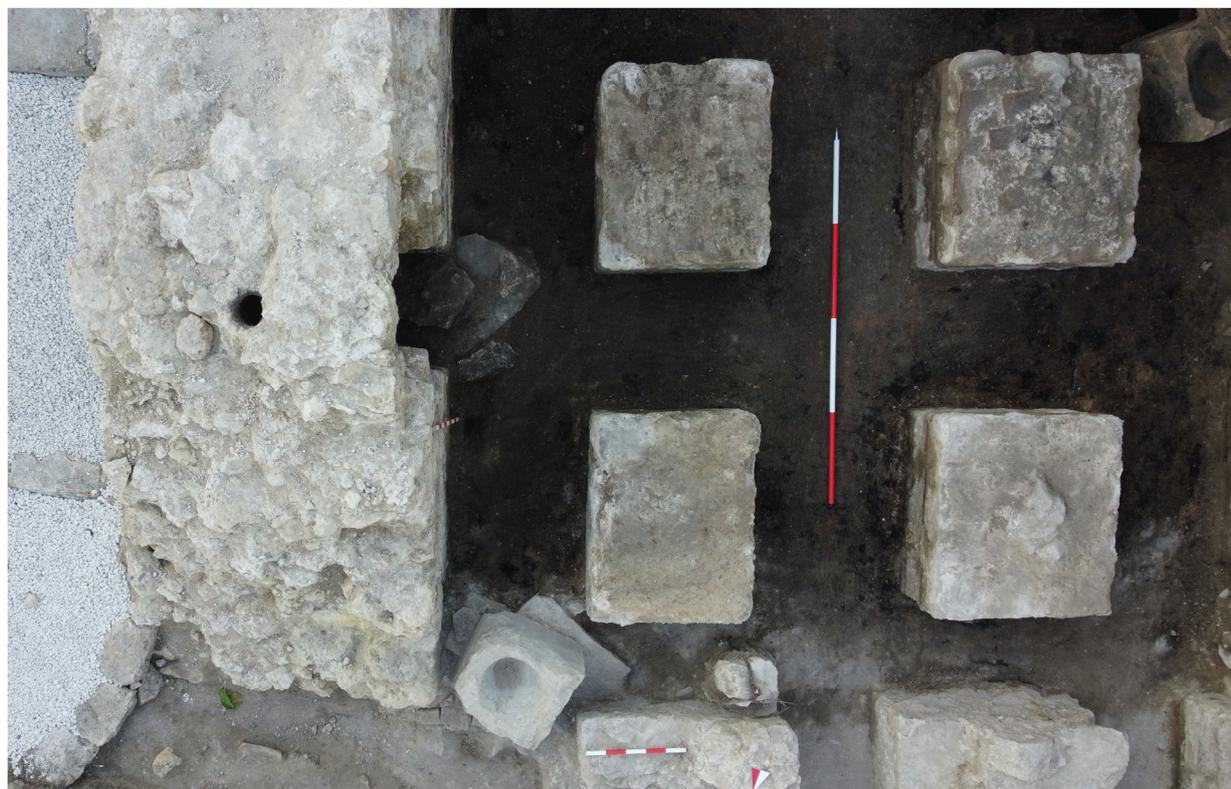
2

The Eastern wall and a flue channel in its construction
