Excavations at the Medieval Fortress in Feldioara/Marienburg, 2007

ALEKS PLUSKOWSKI, ADRIAN IONIȚĂ, KRISH SEETAH

Abstract: The report presents the results of the excavation that took place in 2007 at the medieval fortress of Feldioara/Marienburg. The primary objective was to obtain samples of environmental data – animal and plant remains – from identifiable, transitional contexts, assessing the ecological impact of the castle's construction. Five trenches were opened at the fortress site, yielding prehistoric (Neolithic, Bronze Age, Hallstatt, La Tène) and medieval pottery, a few metal objects, animal bones and a coin issued during the reign of Carol Robert. In one of the trenches was re-identified the wall dating from the first phase assigned to the Teutonic Knights.

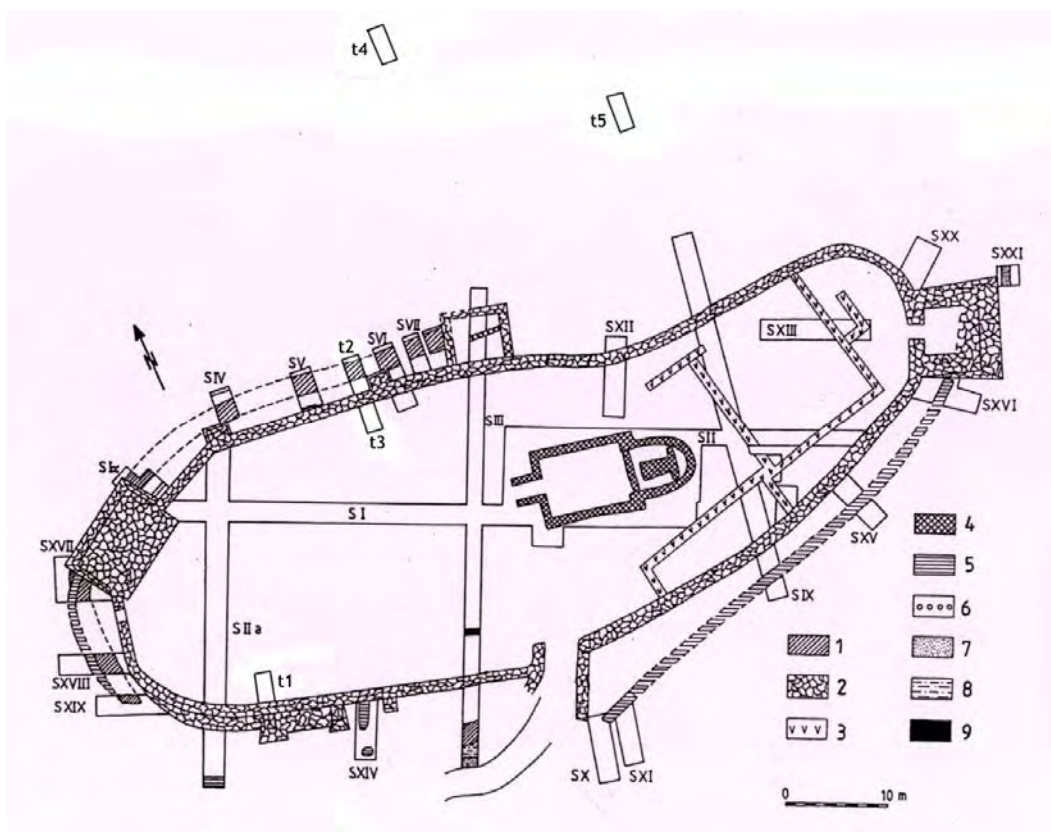
Fig. 1. Map of Feldioara fortress showing identified phases, previous excavation trenches and 2007 trenches (t 1–5) (aft. Ioniță *et al.*, 2004).

The method of excavation was spit-digging due to the unclear and mixed stratigraphy at the site. Trenches were numbered 1–5 (Fig. 1) and context numbers assigned within each one. For the sake of clarity these have been incorporated into the key numbers for each profile (see below). Identifiable ceramic fragment counts were provided for each context, sub-divided according to prehistoric (Neolithic, Hallstatt, Bronze Age, La Tène) and medieval

Two trenches were opened within the area enclosed by the walls of the fortress, and one just outside the northern wall next to a 14th century buttress (Figure 1).

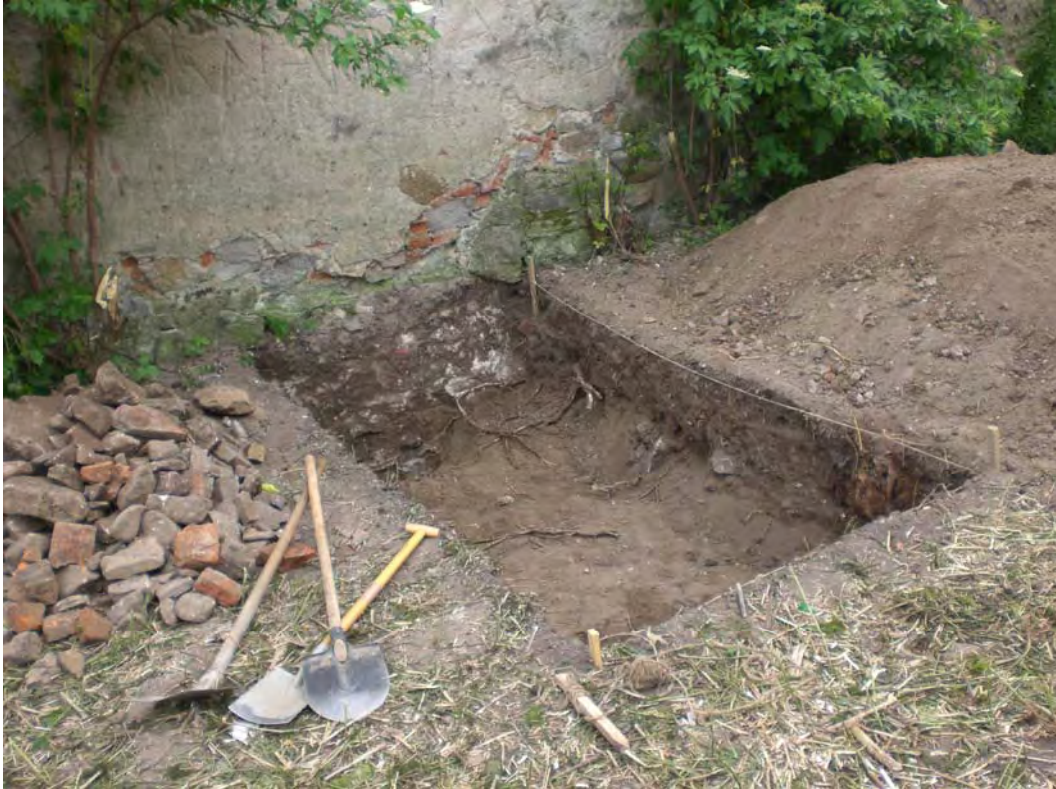
Fig. 2. Trench 1; flecks of rubble are clearly visible in the west profile.

The first trench (3 m long and 1,5 m wide) was positioned on a north-south axis parallel to the fortress wall. The aim of this excavation was to establish whether the later medieval wall had used the earlier 13th century wall as a foundation, and if this was the case, to obtain samples from both earlier and later medieval contexts. Four distinct contexts were identified, but all consisted of heavily mixed material relating to the reconstruction of the fortress wall; underneath the topsoil was a level of mixed material consisting of refill from earlier excavations, including small fragments of brick and stone (Fig. 2–3).

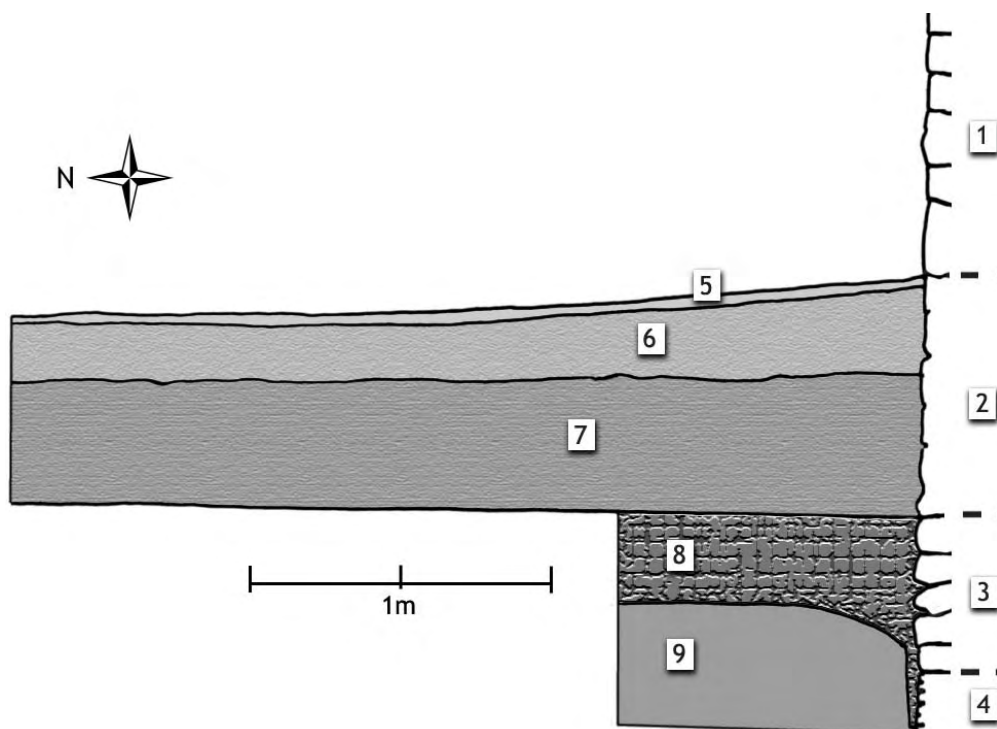
Fig. 3. Trench 1 east profile. Key: 1: Wall consisting of brick, stone, mortar and crepe; 2: wall consisting of white mortar, brick, river stones and volcanic tuff (re-used from other parts of the castle); 3: wall consisting of arranged river stones; 4: wall of unarranged stones set in high quantities of mortar; 5: top soil; 6: mixed grey soil from earlier excavations, including fragments of brick and stone; 7: reconstruction level consisting of fragments of white mortar, stones, bricks, tiles and grey soil; 8: construction level of adjacent wall (3) consisting of grey mortar, fragmentary bricks and stones; 9: natural clay.

Underneath was a thick reconstruction level dating to the most recent phase of restoration (18th century), with larger fragments of bricks, stones and numerous ceramic roof tiles. There were thick seams of white mortar, which were found on the corresponding part of the fortress wall uncovered in the trench. A 1 × 1 m step was taken by the wall revealing a construction level of fragmentary bricks and stones, as well as grey mortar. The construction level dipped into a narrow foundation trench, which cut into the natural yellow/grey clay.

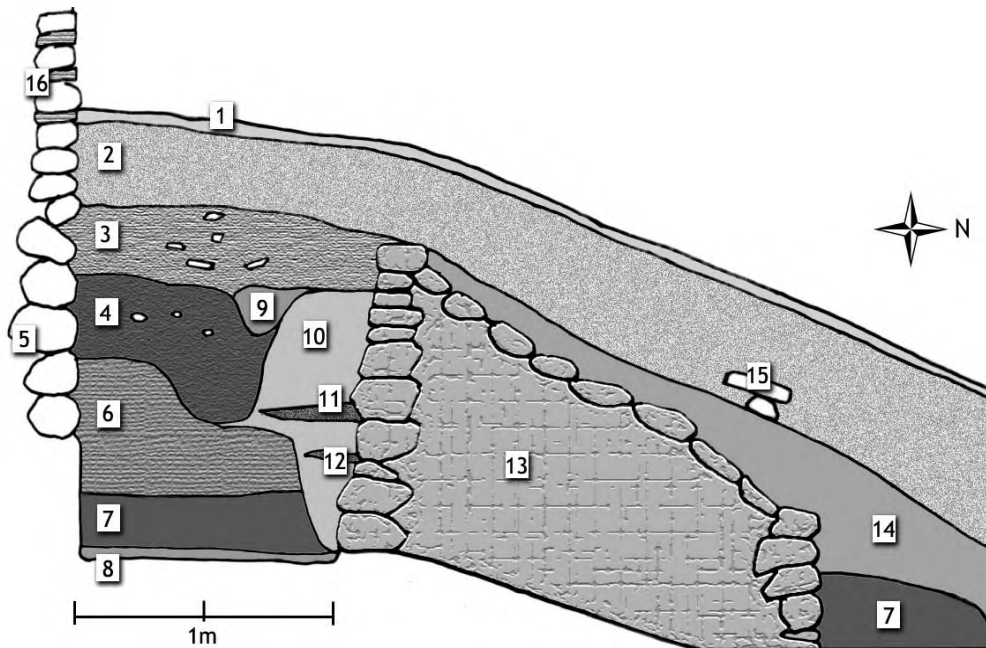
Fig. 4. Trench 2 west profile. Key: 1: top soil; 2: demolition and reconstruction level (late medieval); 3: construction level consisting of mortar, small stones and grey earth (14th century); 4: ditch refill with flecks of burned earth and flecks of white mortar (dated between 13th century and first phase of reconstruction, but material is mixed); 5: wall foundation consisting of irregular stones with heavy mortar, few brick fragments (14th century); 6: brown soil with flecks of burned earth (La Tène); 7: yellow/brown soil (Neolithic) [2]; 8: natural clay; 9: white mortar fill; 10: brown soil, softer than (6) with small fragments of burned earth (mixed material); 11: construction level consisting of mortar, related to „Teutonic” wall (13); 12: white mortar fill; 13: „Teutonic” wall, consisting of a foundation of 5 rows of large, irregular stones and 5 rows of smaller, more regular-shaped stones; 14: grey soil with fragments of mortar; 15: brick from late-medieval demolition level; 16: alternate rows of brick and stone (late medieval or early modern reconstruction).

The first trench suggested that locating undisturbed phases – particularly 13th century contexts – inside the fortress would be extremely difficult. Previous excavations on the northern side of the fortress had revealed parts of an earlier wall which had been linked to the occupation of the Teutonic Order. We supposed that a trench cutting across this earlier wall would uncover both earlier and later contexts more suitable for sampling. However, whilst a section of the “Teutonic” wall was located and completely uncovered (Fig. 4–5), its associated contexts were heavily disturbed. In total, 8 distinct contexts were identified.

Underneath the top soil, a late medieval demolition/reconstruction level contained fragments of mortar, stone and brick. It touched the top of the demolished remains of the “Teutonic” wall on its southern side, 36 cm below the topsoil. The wall was almost entirely covered by a grey earth layer flecked with fragments of mortar and small stones, which appears to have been linked to the construction level of the 14th century fortress wall.

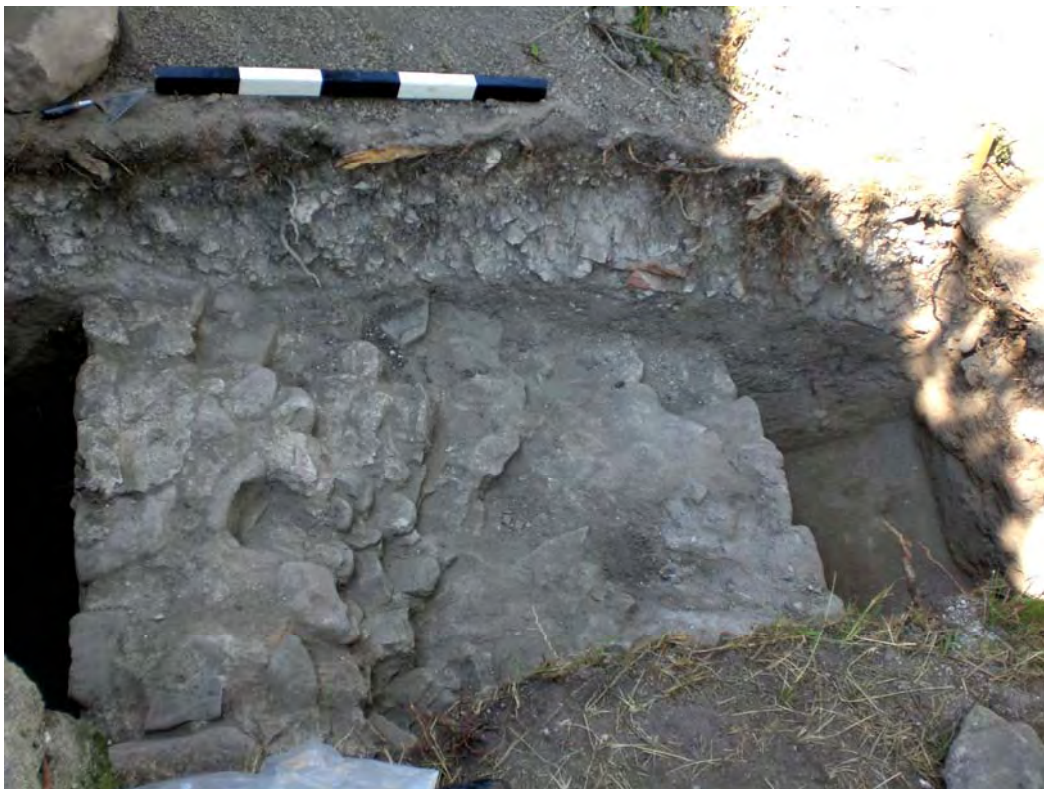
Fig. 5. The view of the “Teutonic” wall, looking down from the east side of trench 2.

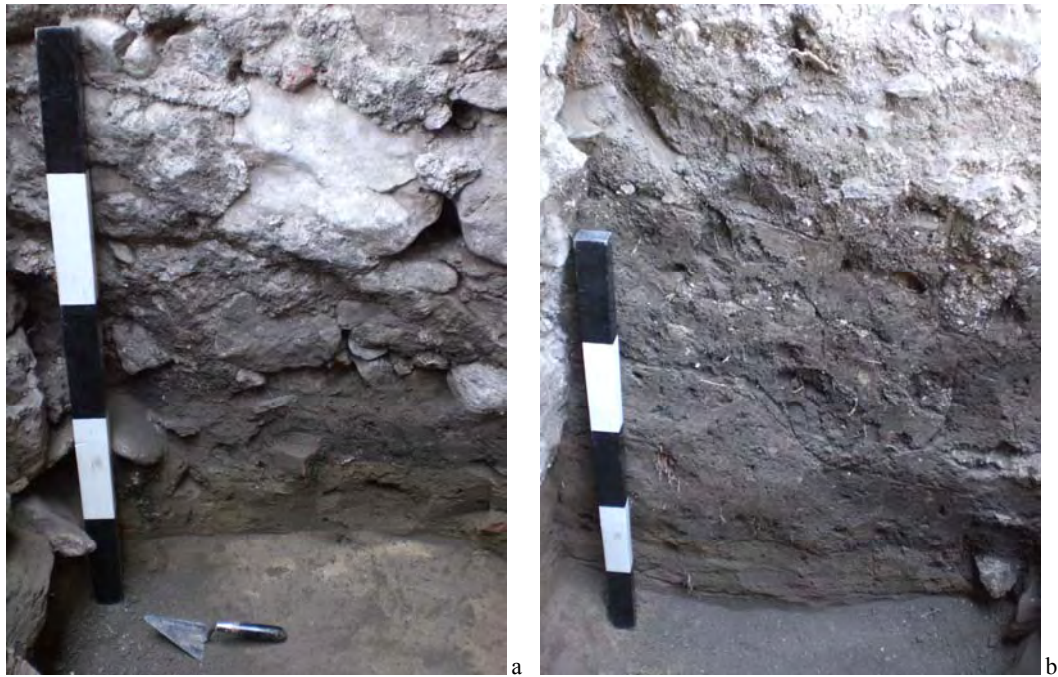
Fig. 6. The east (a) and west (b) section profiles of trench 2 on the south side of the “Teutonic” wall.

The layers on either side of the “Teutonic” wall had been significantly disturbed by the various phases of demolition and reconstruction. When the fortress was reconstructed in the 14th century, the “Teutonic” wall appears to have been largely demolished, and the new wall constructed at least 1 m back, perhaps because the slope was becoming unstable. During this process the area between the two walls was heavily disturbed. There was also evidence for animal disturbance. Two distinct, thick cylinders of dark soil cutting vertically through the layers on the west side of the trench appear to have been made by burrowing animals, rather than tree roots.

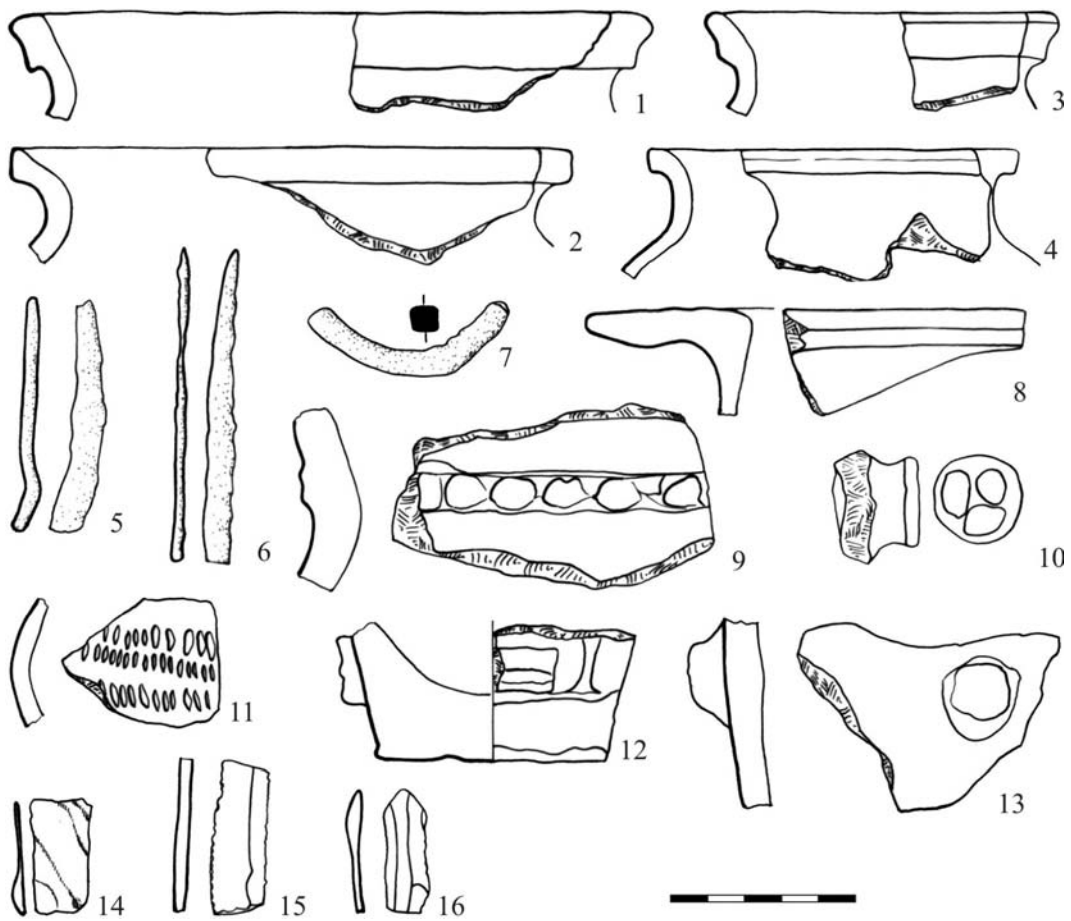
Fig. 7. Trench 2; 1: Ceramic from 13th century; 2–3: Ceramic from 14th century; 4: Ceramic from 15th century; 5–7: Metal from Medieval Period (?); 8–10: Ceramic from La Tène; 11–12: Ceramic from Bronze Age; 13: Ceramic from Neolithic; 14–16: Flints from Neolithic.

Ceramics, lithics and metal. (Fig. 7) Context 3 contained 32 fragments of La Tène and Neolithic ceramics, a single fragment of bronze age pottery, a fragment of iron possibly deriving from a knife (but this could be from La Tène or possibly medieval) and four small fragments of Neolithic worked flint. Later medieval ceramics numbered 9 fragments. Context 4 contained 56 fragments of mixed prehistoric material (Bronze Age, Hallstatt, Neolithic), and four fragments of later medieval ceramic. Context 6 contained 59 fragments of predominantly La Tène pottery, with a couple of Neolithic ceramic fragments (and some fragments of worked flint), two dated to the later medieval period and one potentially earlier medieval fragment. Context 7, resting just above the natural clay, contained 87 fragments of prehistoric pottery, two of which were dated to the Hallstatt; the rest being Neolithic. A small fragment of worked flint was also recovered. Context 10 contained 177 prehistoric ceramic fragments, mostly La Tène but also some Neolithic. Later medieval ceramics numbered 6 and there was also a fragment of iron which could not be assigned a date. Despite being able to identify (re-) construction layers, the ceramic content of the contexts in trench 2 indicated that all had been mixed, largely as a result of the medieval phases of building and re-building.

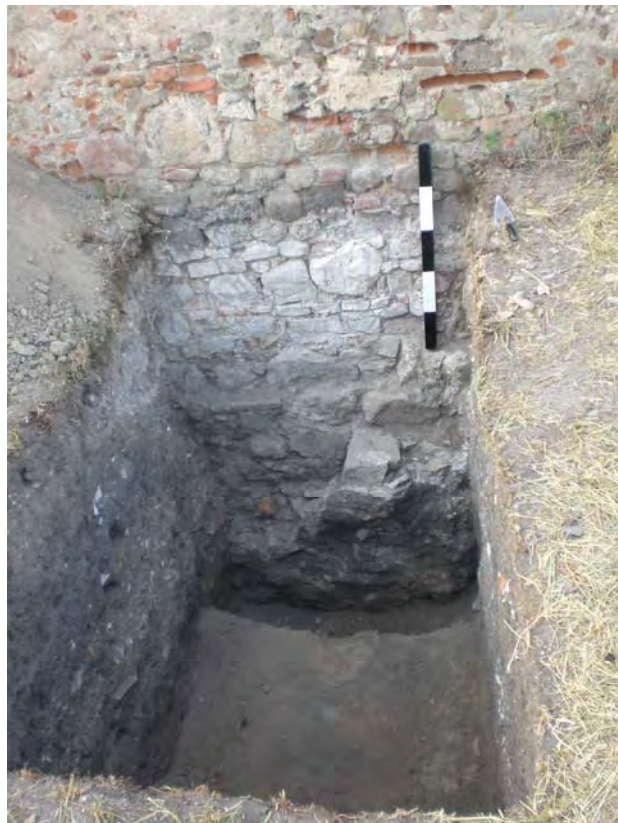
Fig. 8. The north profile of trench 3.

Although the individual layers could in some cases be linked to the phase of construction and re-construction, their fills contained a mixture of ceramics, the result of digging and re-filling from the same deposits. As such, there were no pristine layers – the lowest part of the late-medieval wall foundation penetrated the Neolithic level (Fig. 8–9).

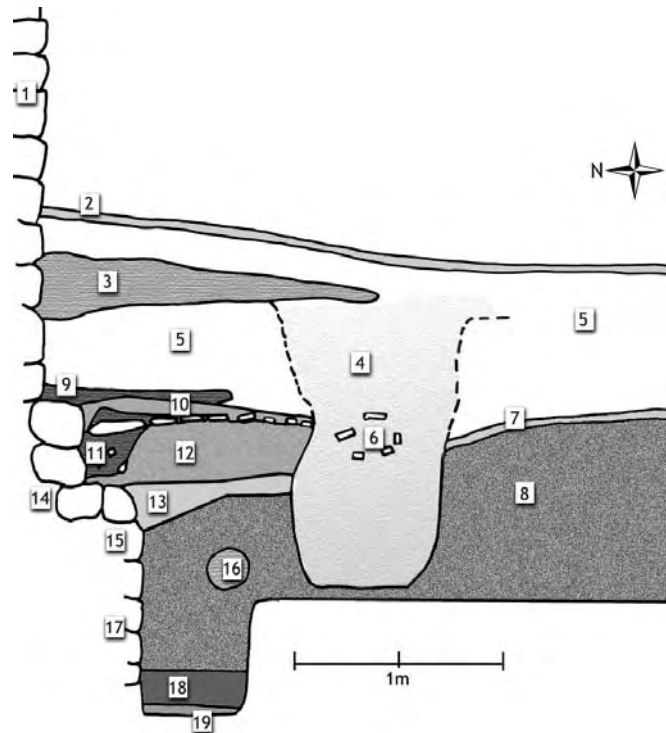
Fig. 9. Trench 3 east profile. Key: 1: wall consisting of brick, stone and volcanic tuff (modern reconstruction); 2: top soil; 3: fragments of mortar, stone and brick (modern reconstruction level); 4: brown/grey soil with flecks of burned earth, fragments of tile, brick and mortar; 5: grey soil with small fragments of mortar, brick and stones (medieval); 6: concentration of tiles, bricks and mortar; 7: construction level consisting of white mortar and small stones; 8: brown soil with burned flecks (La Tène); 9: mortar and small stones; 10: demolition and construction level consisting of mortar and tile fragments; 11: ditch with tiles, clay, mortar and small stones (mixed material); 12: stones, mortar and brick fragments (late medieval); 13: construction level consisting of mortar, small stones and grey soil; 14: foundation for (1), consisting of rows of brick, large irregular stones and mortar; 15: possible steps consisting of large, angular stones protruding 30 cm from wall; 16: lens of yellow clay with flecks of burned earth; 17: foundation for (15) consisting of mortar, stones and brick; 18: yellow/brown soil (Neolithic); 19: natural clay.

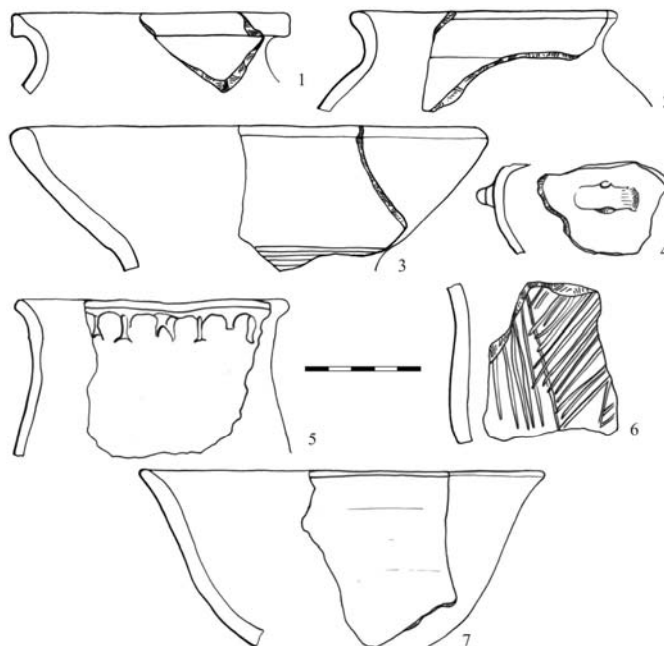
Fig. 10. Trench 3; 1: Ceramic from 14th-15th centuries; 2-3: Ceramic from La Tène; 5-6: Ceramic from Bronze Age; 4, 7: Ceramic from Neolithic.

Ceramics. (Figure 10) 810 fragments of pre-historic pottery were predominantly dated to the Neolithic, but also included examples from the Hallstatt, Bronze Age and La Tène periods. One example dated to the 4th century, 63 fragments of ceramic could be dated to the late-medieval period (14th–17th century). There were also tiles scattered throughout the profile, dating to the 18th century as well as four fragments of modern ceramics. 18 were unidentifiable. In the medieval trench away from the fortress wall (5, south of feature 4), four late medieval fragments of ceramic were identified, and one fragment was unidentifiable.

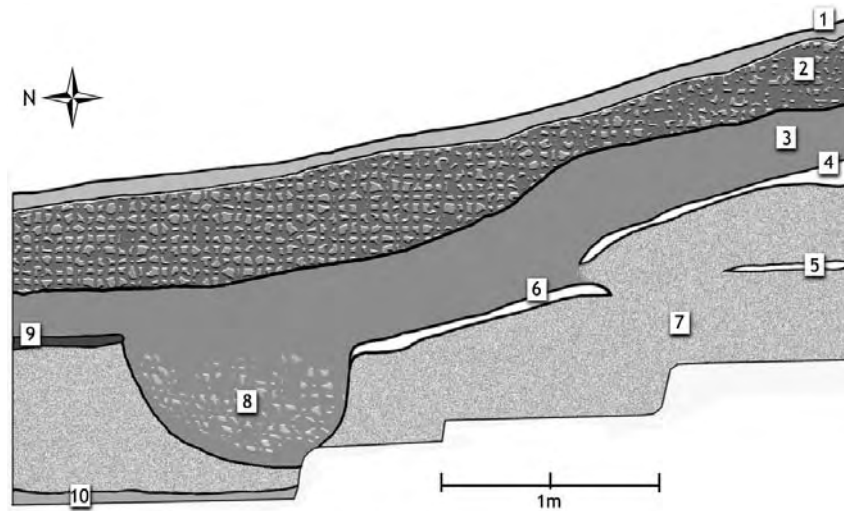
Fig. 11. Trench 4 east profile. Key: 1: top soil; 2: fragments of brick, tile, stone, mortar and thick roots (interpreted as recent degradation from top of mound); 3: grey soil with small stones and flecks of burned earth (late medieval); 4: demolition/reconstruction layer consisting of packed mortar and stones; 5: small fragments of mortar; 6: mortar level, possibly a continuation of (5); 7: grey soil with small particles of mortar (14th–15th centuries); 8: ditch cutting into (7), grey soil with concentration of mortar fragments; 9: small stones, orange/grey soil; 10: brown soil with mixed prehistoric ceramics.

This trench was located in the north-western side of the fortress, with its southernmost end touching the current base of the mound. The topsoil was uncovered to reveal a 30–40 cm layer of debris from the most recent phase of reconstruction, consisting of large fragments of brick, tile, stone and thick roots. This lay on top of grey earth level with flecks of burned earth, with late-medieval ceramics. This level appears to have reached the base of the trench where it lay on top of a thin prehistoric context, but it was dissected by a clear layer of white mortar and stones, presumably relating to one of the phase of reconstruction. In the northern most side of the trench this mortar layer had been cut by a ditch containing burnt earth and fragments of mortar (Fig. 11). All of these layers contained late-medieval ceramics, and the lowest layer contained prehistoric fragments. It is likely these were derived from the demolition and construction debris at the top of the fortress, which had mixed and unearthened material from multiple occupation phases. The chronological relationship of the earliest phase identified in this trench was confirmed by the find of a silver coin of King Carol Robert, recovered at a depth of 1,20 m. This was a fragmentary example of the „*parvus type*” (bearing a „*fleur de Lis*” design, and the letters KARULI on its avers side) dated to c. 1330³ (Fig. 12/11). The

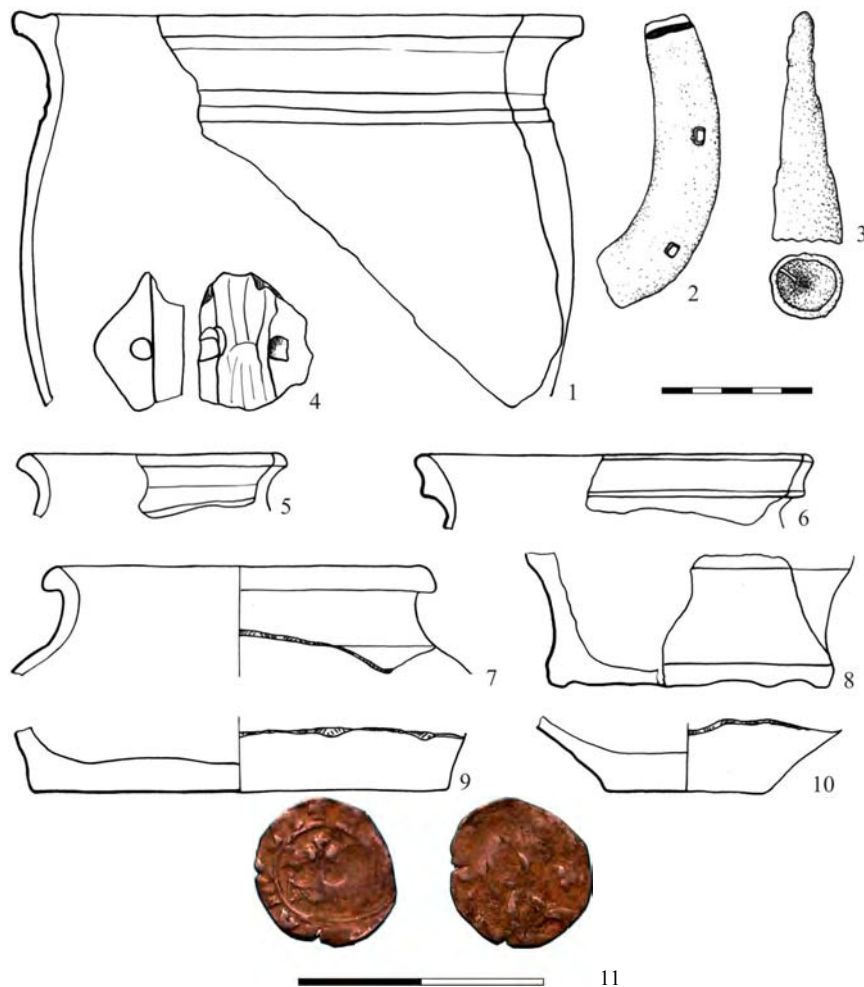
Fig. 12. Trench 4; 1, 8: Ceramic from 16th century; 2–3: Metal from Medieval Period; 5–7: Ceramic from 15th–16th centuries; 9: Ceramic from 14th–15th centuries; 4, 10: Ceramic from Neolithic; 11: Coin of King Carol Robert.

Ceramics and metal. (Fig. 12) 190 fragments of prehistoric pottery were recovered from contexts 1, 2 and 3 – mixed in with other material in 2 and the base of 3. Later medieval ceramics numbered 215, and there were also two fragments of potentially earlier medieval pottery (12th–13th century), but their dating could be confirmed. Fragments of 18th century red tiles from the roof of fortress were present in context 2. 20 ceramic fragments were unidentifiable. In addition to the early-14th century coin (see above), a few iron objects were recovered from this trench and tentatively dated stylistically; nail (late medieval), the end of a spear (medieval) and a fragment of horseshoe (late medieval-early modern).

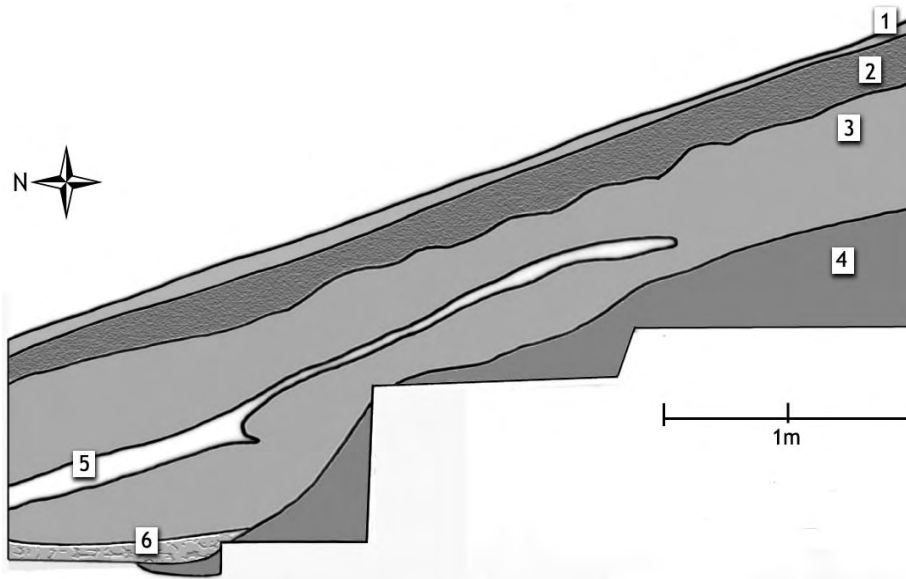
Fig. 13. Trench 5 east profile. Key: 1: top soil; 2: fragments of brick, tile, stone, mortar and thick roots (interpreted as recent degradation from top of mound); 3: grey soil with small particles of mortar (late medieval, possibly 15th century); 4: yellow sand with small stones; 5: demolition/reconstruction level from significant re-building of fortress (possibly 15th–18th century); 6: brown soil with mixed prehistoric ceramics.

The last trench was opened on the north eastern side of the base of the fortress mound, located higher up the mound than trench 4. Underneath the top soil, was a 20 cm thick layer of fragmentary brick, tile, stone, mortar and roots, representing the rubble from the most recent phase of reconstruction in the fortress. This covered a thicker layer of grey earth with small particles of mortar and late-medieval ceramic fragments. This layer was thickest at the northernmost side of the trench where it covered a prehistoric level (Fig. 13).

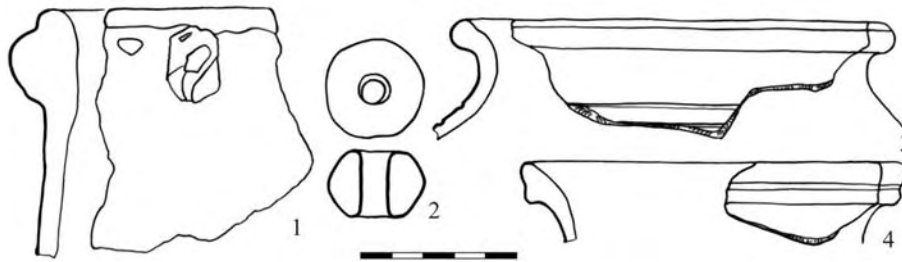
Fig. 14. Trench 5; 1: Ceramic from Bronze Age; 2: Spindle whorl from Medieval Period; 3: Ceramic from 15th century; 4: Ceramic from 14th–15th centuries.

Ceramics. 40 fragments of prehistoric ceramics were recovered from context 6, and 39 late medieval fragments were recovered from context 3. A single ceramic spindle whorl was recovered from trench 5. Its dating was difficult to verify due to the similarities between La Tène and medieval forms, more over the context contained both prehistoric and medieval pottery. The object was recovered from a transitional horizon between the lowest medieval level (context 4; 15th/16th century) and the prehistoric level (context 6). 10 ceramic fragments were unidentifiable (Fig. 14).
