EXCAVATIONS AT THE EASTERN GATE OF THE BĂNEASA ROMAN FORT

EUGEN S. TEODOR, EMIL DUMITRAȘCU

Keywords: Roman fort, tower-gate, wooden fortification, arms, brooch

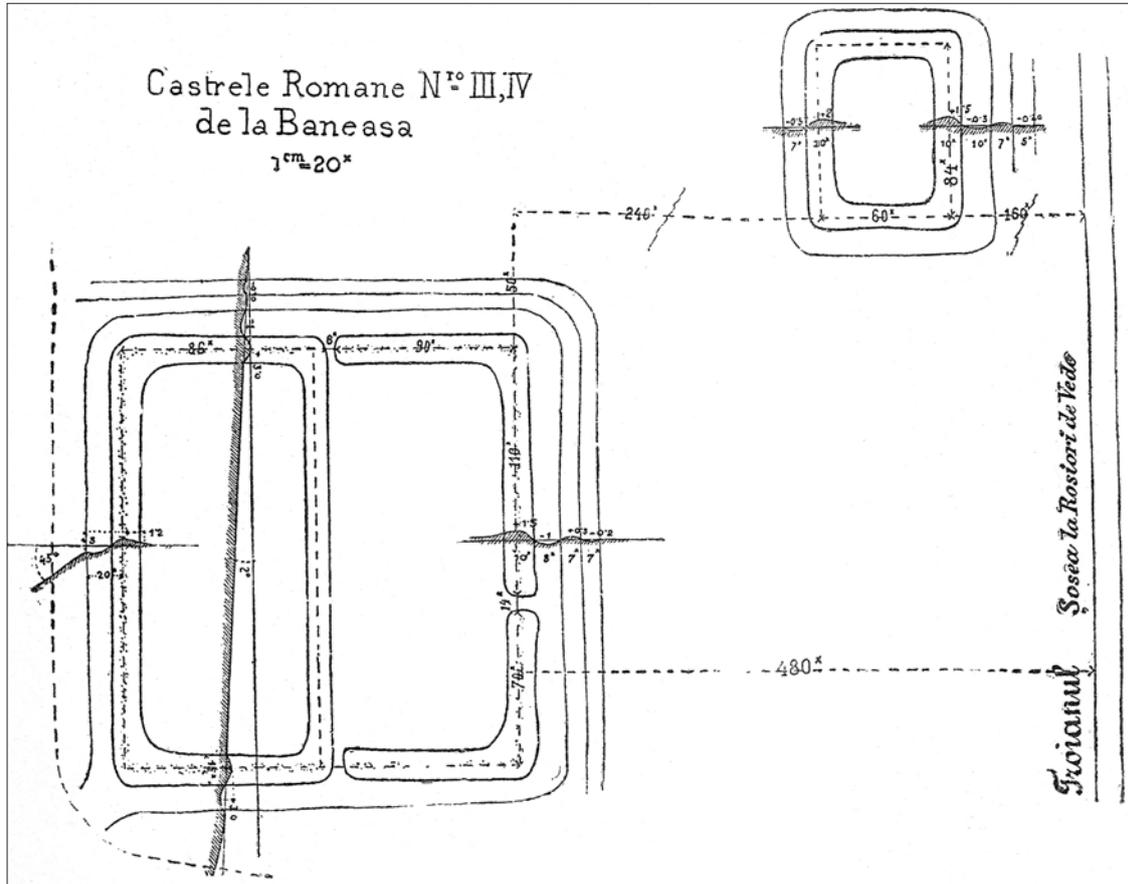
Figure 1. The fort and the fortlet at Băneasa, as rendered in Tocilescu 1900, 131, fig. 74. Heights in meters, lengths in passes (0.76 m). Not at the original scale.

The oldest rendition of the fort is due to the field research made by Grigore Tocilescu and Pamfil Polonic in the late 19th century (Figure 1).³ Rather a sketch than a proper plan, the drawing is yet important, as the authors saw the field in a preservation status much better than today, before intensive agriculture. As the middle rampart is an addition from the second phase, it is suggested a camp oriented towards south, with *porta decumana* at north and *porta principalis praetoria* at south. A third gate would be located on the eastern side, at two fifth closer to the southern corner, being – in this scenario – *porta principalis sinistra*. A fourth gate, westward, is less expected, as the terrain is quite steep. Not all the details proved eventually right, as, for instance, the second defensive ditch towards east and north; at least at the north-eastern corner the second ditch is absent, as showed by excavation⁴

Another important detail at the Fig. 2 is the northern gate, where the ditch is discontinuous, corresponding to the plan from the Fig. 1. If that gate was located on the centre of that side, then what we are seeing is only the eastern half of the opening, the other half becoming the ditch of the second phase. Not the same thing is happening at the southern side, where the gate is not that clearly visible.

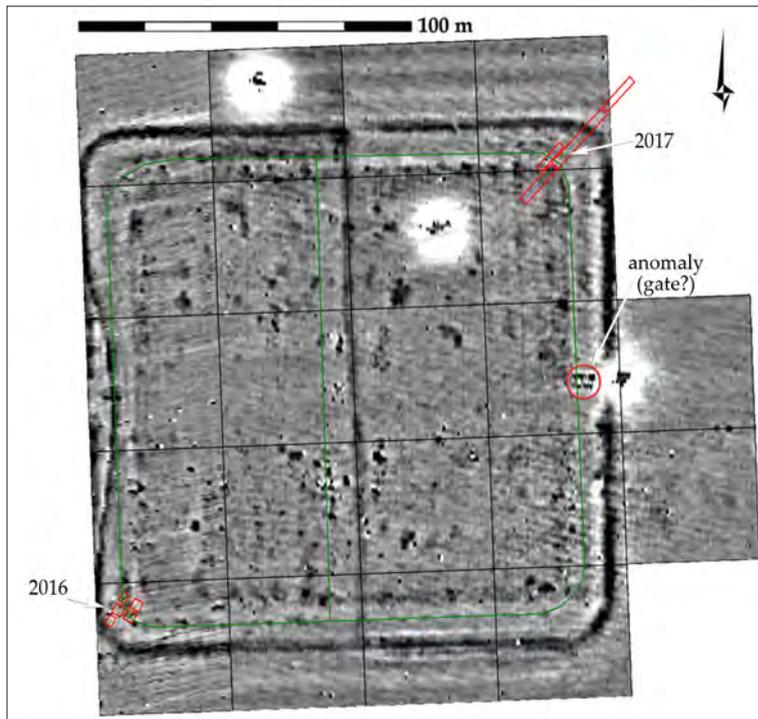
Figure 2. Magnetometric data at the larger fort at Băneasa (Dan Ștefan 2016-2017). Red: archaeological trenches in 2016 and 2017 and the anomaly at the eastern gate; green: the ridge of the rampart (established on a detailed terrain file); large white anomalies – power poles.

About in the same time was finished the task for magnetometry, performed by Dan Ștefan (Figure 2). Some observations are needed here. First of all, the curved dark line from the western edge is the limit of the terrace, due to the advanced erosion (compare with Fig. 1); the extremities of the original ditch are still in place, but the middle is lost. The defensive ditch is the most visible feature from this fort, all around, as it ended in fire (phase 1) and the ditch is filled with burned matters. The studied surface is then split by a second darker line (under the middle grid line), which is the defensive ditch of the second phase; the rampart of that phase is not visible in magnetometry, but it is still very clear in the topographical survey, being located west of the later ditch (see the green line).⁷ This late rampart has not been burned, therefore the place was deserted on other reasons than a siege. The only other notable thing on this work is a darker frame, well visible but with interruptions, more or less parallel with the early rampart, about 6-7 m inside, and it is most likely the alignment of the inner buildings, consumed by fire. The contrast between the burned adobe and the natural ground signal is so strong that no other structure is visible; for instance, the buildings of the second phase are probably missing from the picture. The only area relatively free of burned matters is the grid in the left side of the central area, located on the same axis with the strong ‘anomaly’ which is the eastern gate, as the reader shall see in this paper. This clear area from the central-left side of the fort could be the location of *principia*.

The geophysical depiction did not show a gate at the two thirds of the eastern side, as suggested by Tocilescu and Polonic, but at the centre. The picture is glared by a power pole standing just outside the ditch, at the middle of the eastern side, but just meters west of it is visible a strong anomaly. That place became our target for the excavation campaign for the summer 2018.

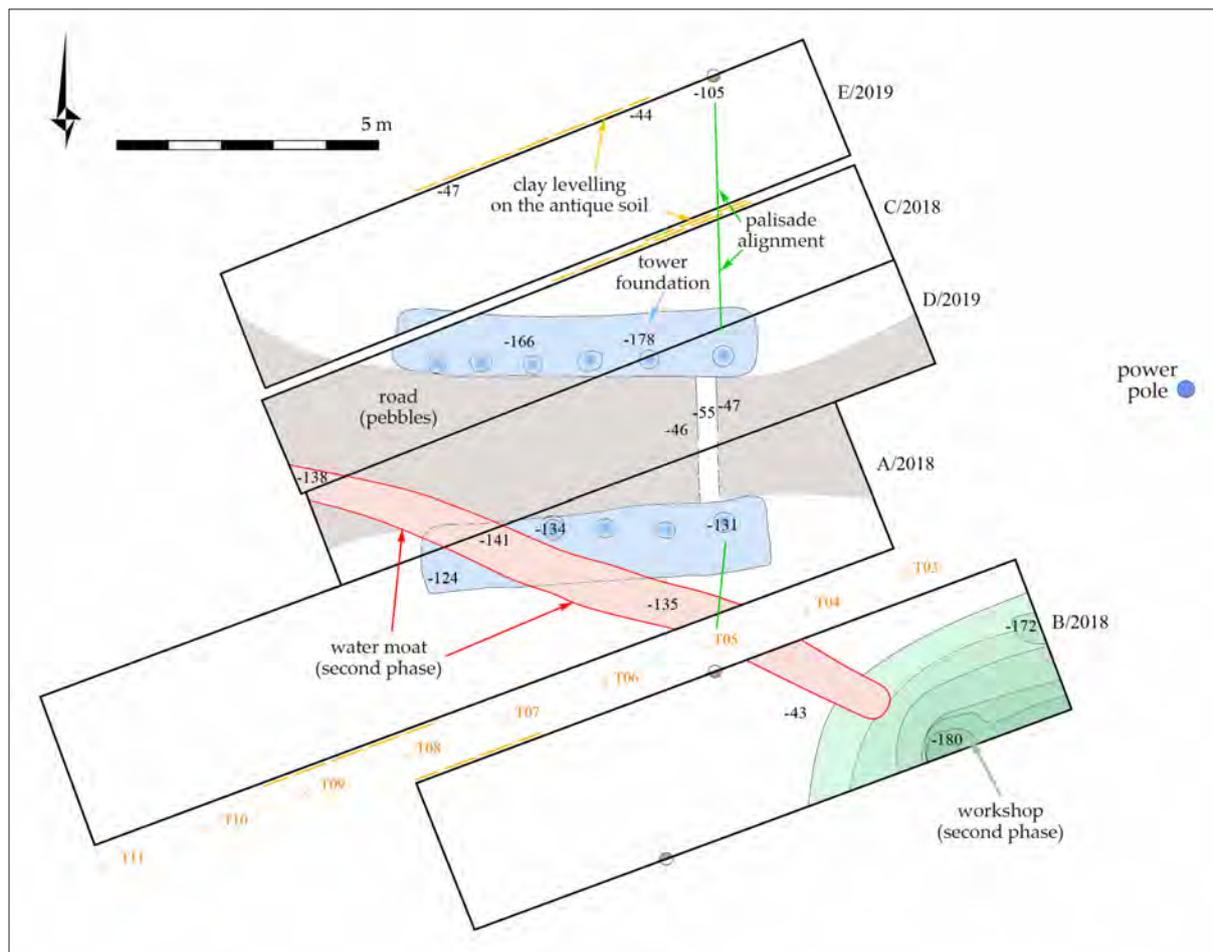
Figure 3. General plan of the excavations made at the eastern gate.

The technical grid is shown (at the Fig. 3) between the trenches A and B, the marks generating an irregular grid, having the length of 2 m and the specific width for each trench (3 or 2 m), regressing towards east-northeast. The grid has the origin at the electric pole, heading WSW 250°.

The southern foundation of the tower is cut, at its western side, by a ditch deeper than one meter, crossing the excavation from northwest to southeast; two of the pillars, numbered 5 and 6, were disrupted (see again Fig. 3). The upper part of the context is cut everywhere by the ploughed layer, the moat being obviously the latest intervention in the area, before modern agriculture. The widest part – around 85 cm – is the central one, both ends in the picture being narrower, 59 cm at northwest, and 68 cm near the rounded end from the southeast. The sides are near vertical, with flat bottom at about -1.35-1.4 m from the present day surface, meaning that in absolute altimetry it is slightly tilt towards south, as the entire area. Its eastern end is rounded near a large pit (in green at the Fig. 3). In gross lines, this pit could be nothing else than the former defensive ditch closing at the gate. As suggested by the magnetometry (Fig. 2), the line of the defensive ditch would cross the area at the half way between the electric pole from our days and the burned tower-gate of the fort’s first phase. The expected depth of the defensive ditch is over 3 m, but this is obviously only the rounded end towards the pebble road. The former military ditch, left unused after the fire, received other use, as suggested by the two small pits made inside, one near the southern section of the archaeological trench B, and other near the eastern section of the same. Both smaller pits were filled with what is commonly named ‘garbage’ in archaeology: broken pottery, a few animal bones, also some small finds. Some metallic objects were lost here, possibly within the first phase, when the ditch was constantly and naturally filling up.²⁸

We have collected very few pottery sherds and only from the left-rear part of the tower, at the western end of the trench E (Fig. 3), mixed with the debris of the tower (burned adobe, at least 15 cm thick, the ‘isolation’ put on the wooden walls). Obviously the food supply of the squad was all deposited in that corner. Other a few sherds were collected at the opposite part of the digging, in the refuse pit named (at the Fig. 3) ‘workshop’, but all those are remnants of the second phase of the Roman site.

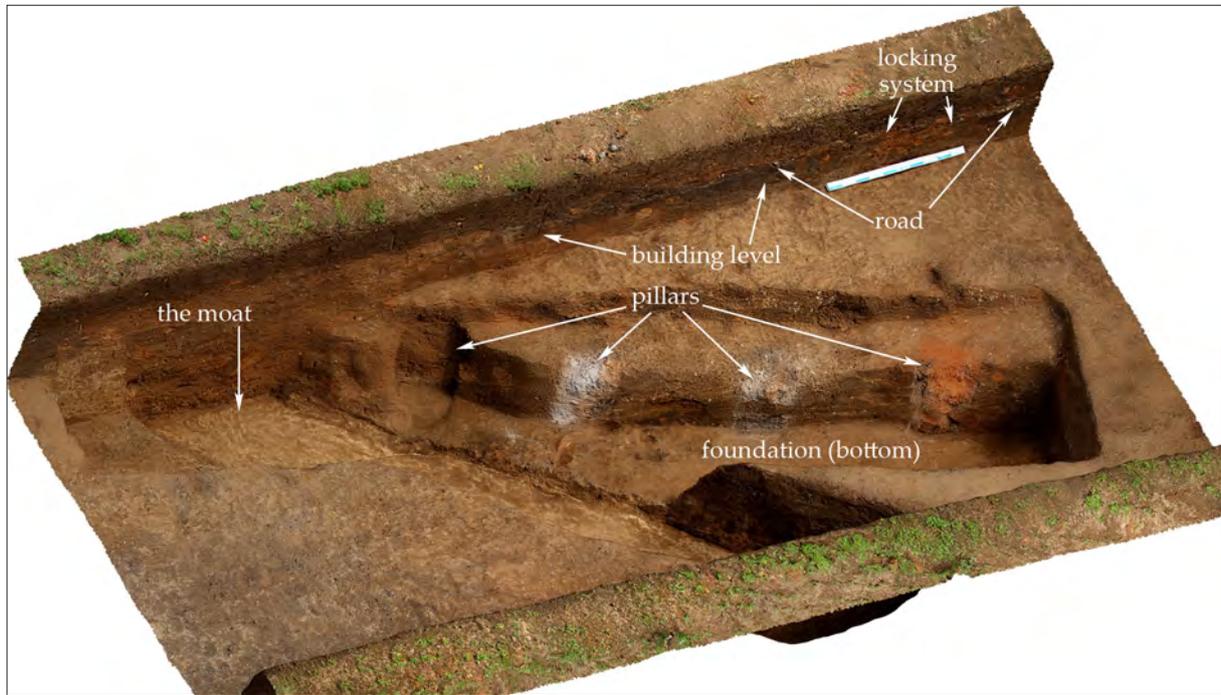
Figure 4. Trench A, photogrammetry, oblique view towards north. The scale in the picture has 1 m.

The diameters were taken at about the half way between the antique ground level and the base of the foundation (more or less that represented into the Figure 4), therefore the location and the size of the poles could be affected by the processes connected with the fire and the collapse of the building, in which some of them were slant. The tilt is obvious for the pillar 4 south, but could be supposed also for cases in which the difference between the two measured diameters is rather large (pillars 3, 5 and 6 north, pillar 2 south). All of them were burned to the bottom, turned into ashes, having bits of burned adobe fallen inside (see the first from right at the Fig. 4).

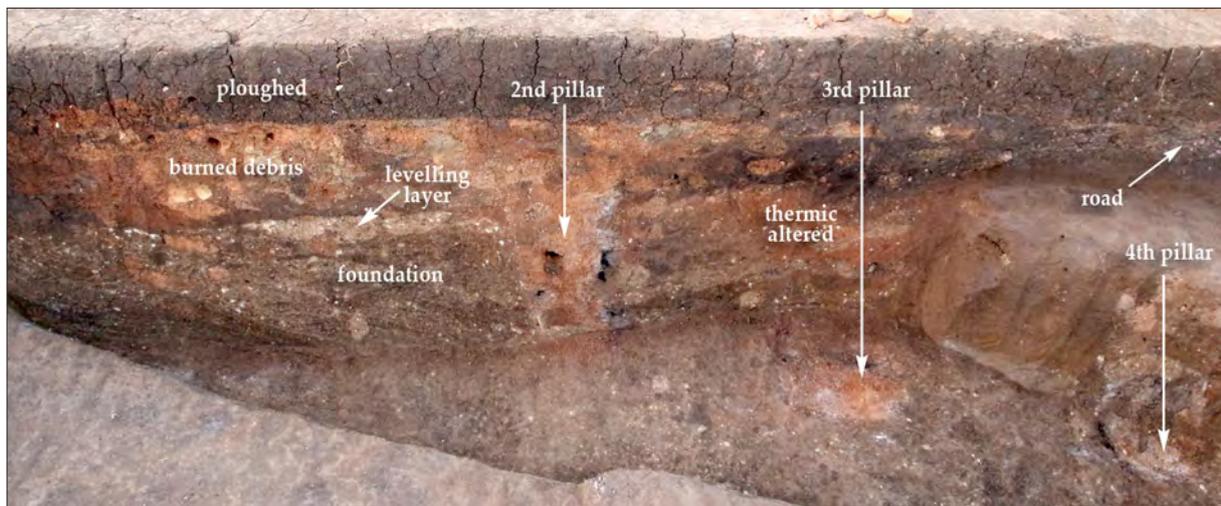
Figure 5. Trench C, snapshot heading south.

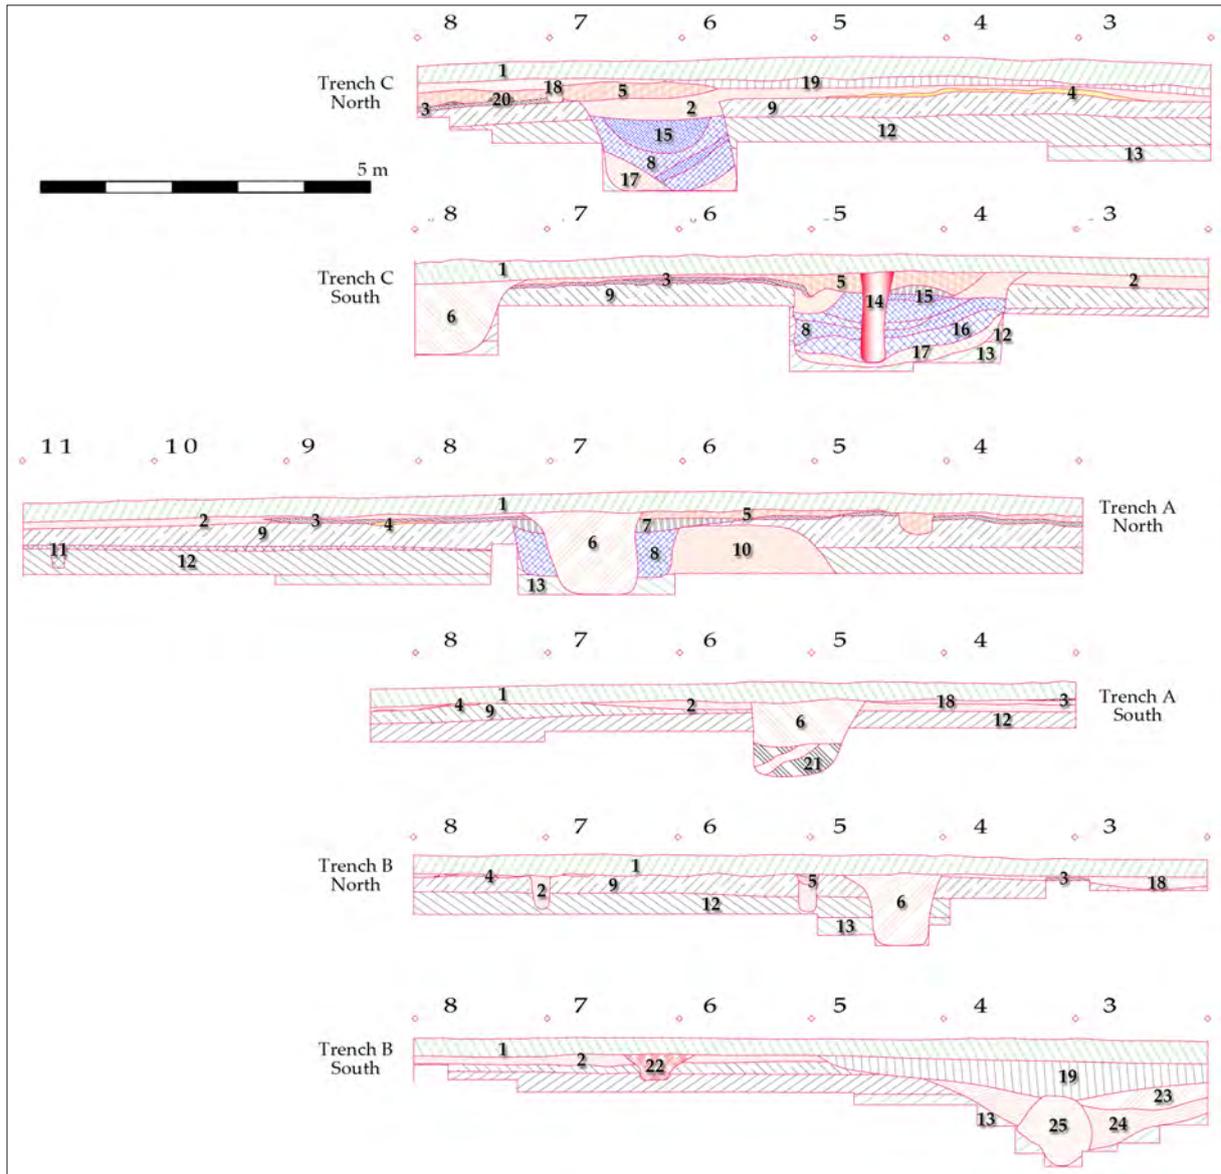
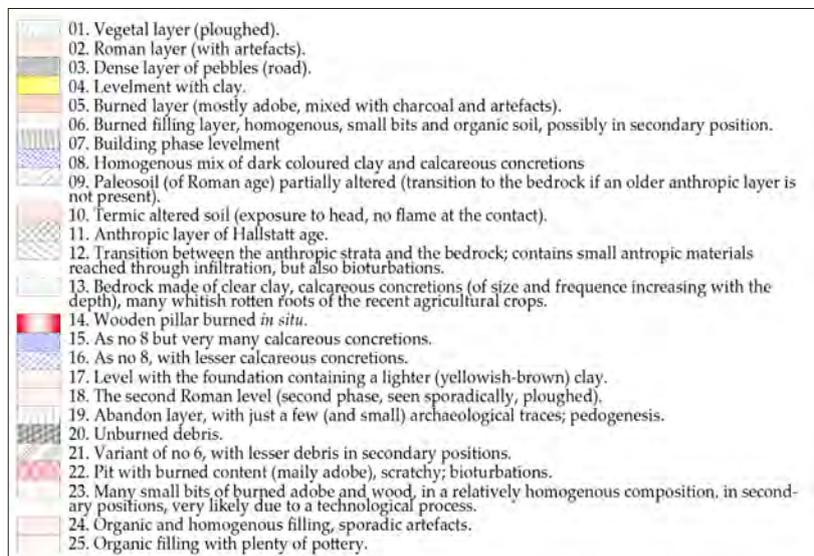
Figure 6. Stratigraphy of the archaeological trenches from 2018. Note that all southern sections are rendered in vertical mirror. See also Figure 7, for the legend of the layers.

Figure 7. Legend of the drawings from the Fig. 6.

Another interesting thing on the stratigraphic drawings is the situation from the southern section of the trench C. As already said, the northern foundation was dug about 18 cm deeper than the southern foundation. This error was partly resolved by refilling the pit on a height of 22 cm, compressed later by the heavy burden of the building to only 7 cm (see the layer type 17 at the Fig. 6, second row, fifth unit grid). An error in horizontality, about 10 cm, is still there. Concluding this, although the two foundation pits seems very similar, there are though some irregularities, as the base line, the type of filling or the rhythm of the pillars. As regarding the last, one can observe that the two rows of pillars do not stand exactly face to face. As the drawings were performed using photogrammetry, it is unlikely that those unfitted facts could be due to a clumsy archaeological record. The lack of precision could be due to the difficulty of rising 6 pillars about 10 m height (if not more), left them in a large open pit, and positioning them tight until the foundation was filled and dry. This was unprecedented and there was no clear procedure to make it right.

The same scenario has been repeated in 2018 and 2019: strongly burned tower-gate, but no palisade poles clearly seen around, though much effort was paid for. In the reconstruction of the fort, as proposed here at the Fig. 2 (where the green line is the palisade line), the burned tower-gate is protruded in front of the palisade; unfortunately, in those areas of the excavation no pits occurred, large or small. Due to this crisis – where the palisade is?? – we have watched attentively any possible hint, as the levelling layers of clay, normally made in the intense traffic areas *behind* the palisade. The distribution of those areas are marked at the Fig. 3 with yellow dashed lines, but the value of this set of data is partially compromised by the fact that parts of the antique ground level were upper, being ploughed (see Fig. 6, Trench A South to Trench B South).

There have been found just a few pits having the right shape and dimensions to be a post-hole. One of them is located on the northern section of the Trench B, being cylindrical, 57 cm deep and 27 wide (see again Fig. 6, Trench B North). The pole was not burned, rather recovered, but in the upper layer of the later filling there are clear remnants of the fire from around. Another cylindrical pit at the northern section of the same trench, at the grid line 7, is a bit smaller (51 x 27 cm), but its stratigraphical relationship with the clay levelling is cut by the plough. This hole could mark a first phase plan of the palisade (no traces of fire were found in the filling), matching our initial hypothesis that the tower-gate was protruding the palisade, but no other clue came to confirm it. A third pit, located on the southern section of the Trench B, has wrong dimensions (39 x 43 cm) and the wrong location to be part of the palisade. A fourth pit was found on the northern section of the Trench E, near the grid line 3,²⁶ was

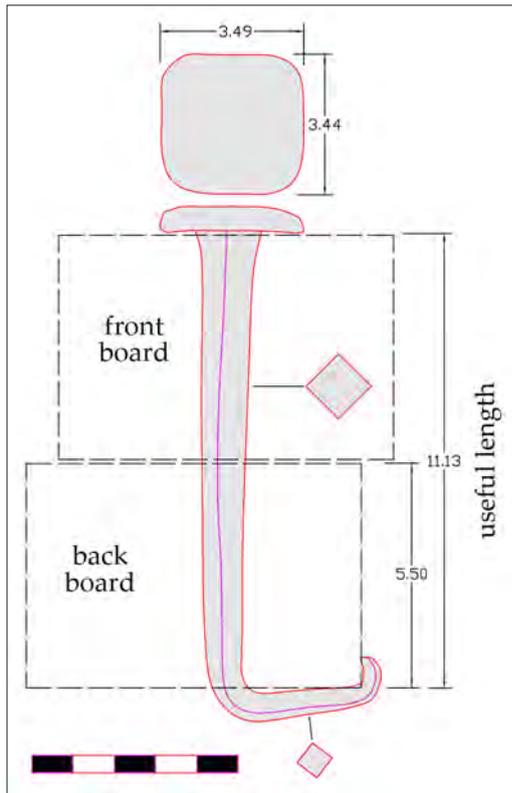
Figure 8. The gate nail ID 411 (2019) and the proposed scheme of use.

¹⁹ A calculation working only in the hypothesis that the nails were pushed on the middle of the boards. This is hazardous... The nails were not all driven perpendicular, as the first bent is not always in the right angle (as the case at the same Fig. 8), therefore such calculations are only indicative.

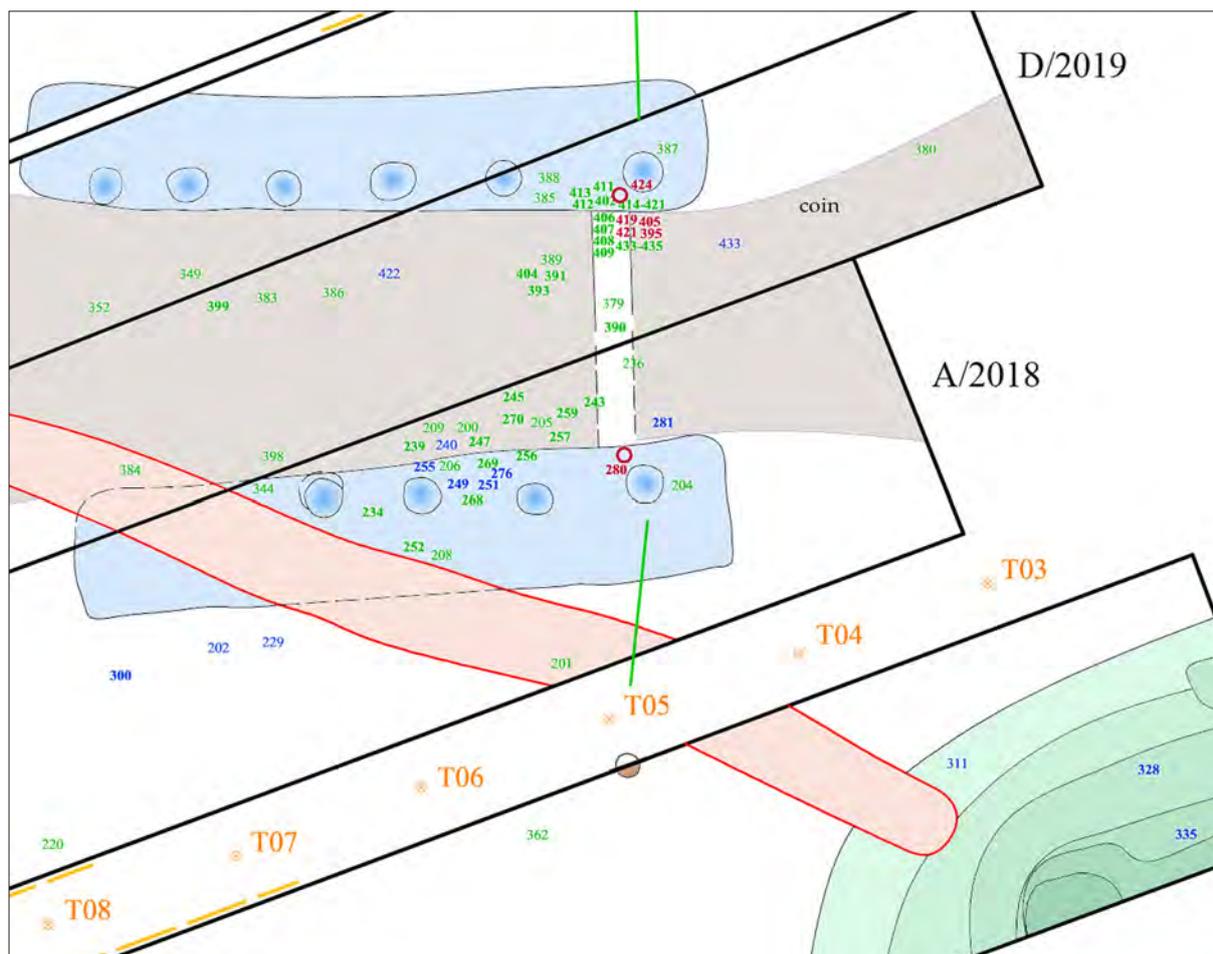
Figure 9. Distribution of some metallic artefacts. Legend: green – gate's nails; dark red – elements of the locking system; blue – weapons and military equipment; bold – below the ploughed layer; normal – in the ploughed layer (in secondary positions).

Roman times ground level, near the first pillar of the southern foundation and aligned to the back of it (see '280' at the Fig. 9). Allegedly it was suppose to be connected with the gate. In the next campaign we have also found something somehow similar, in a symmetrical position from the northern side of the gate. Notably below the ground level (0.75 m, or 0.3 m below the antique surface) were standing, together, an iron cylinder (93 mm external diameter, 77 mm inner diameter, 75 mm in height), in vertical position (see 424 at the Fig. 9), containing an unusual nail, with a very large head (round, 57 mm in diameter) but having a relatively short shaft (54 mm), with a rectangular section and a tip still very sharp, with the point upwards (Figure 10). These were making the lock system of the gate. The side wooden shaft of the gate, with round section about 7 cm in diameter,¹⁷ has had a strong nail in its lower end, in order to protect the wood from cracking when smashing the edges of the iron cylinder. The weight of the gate was not standing all on this shaft, because the gate was resting in a shallow ditch, U-shaped, made between the iron disc (ID 280) and the cylinder (ID 424). The recess on which the gate is resting is 2.35 long, 0.38 m wide and 7-8 cm deep, connecting the iron disc from south by the iron cylinder from north, defining the width of the gate. The two iron implements on which the lateral shafts of the gate were standing (in closed position) are aligned (between their centres) at 10 cm afar of the eastern (front) edge of the recess, and 28 cm afar of the western (back) edge. Consequently, the gate was resting in the front side of the recess, but at its back would be a gap about 20 cm wide. Although no material witness was found (except the straight and sharp edge of the pit), we can 'fill' the gap with a

One single coin was found in these two campaigns, laying on the road, in front of the gate (Figure 18; see again Fig. 9 for location). It is a denarius minted for Caracalla in 213,⁵⁹ staying in the small gap between 208 and 223, as are dated all the other 5 coins found in the excavation.⁶⁰ This is securely dating the first phase of the fort after 200 and before 225 (or so).

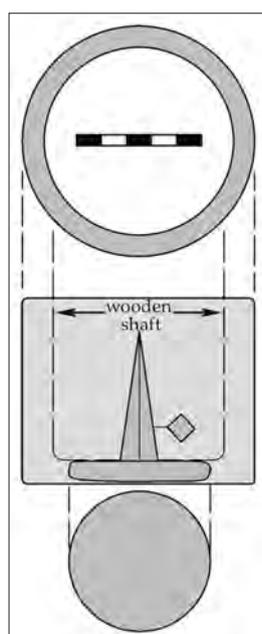
Figure 10. The iron implements found at the bottom of the northern shaft of the gate.

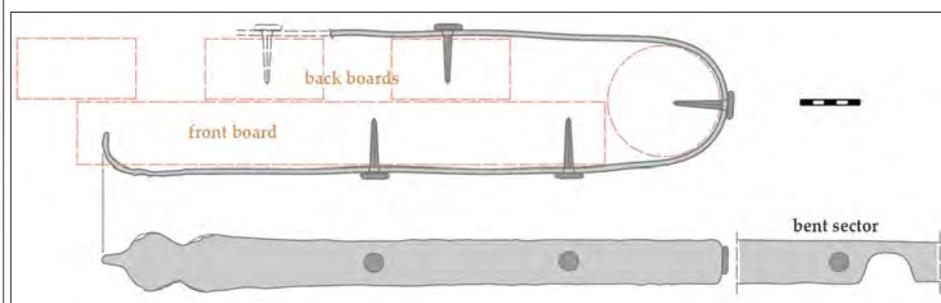
Figure 11. Iron sheet found at the northern side of the gate's recess gap.

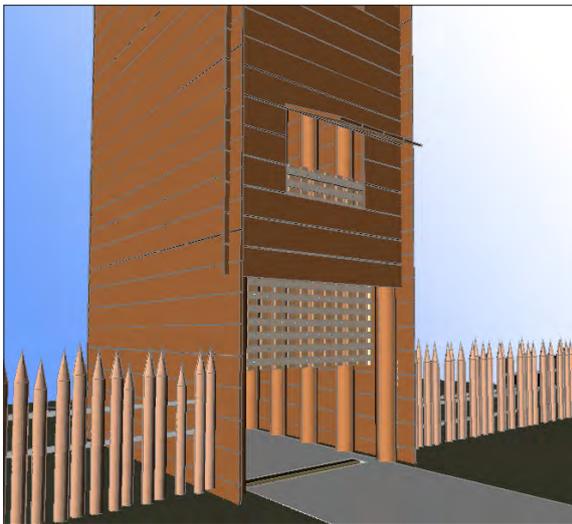
Figure 12. Restitution of the gate-tower, with the gate half lifted. AutoCAD, seen from southeast.

Of course, the proposed restitution is only one of those possible. One could add side windows, at least for the second floor. Another problem is the location of the stairs for access to the upper floors. The simplest system is with mobile ladders, installed vertically and pulled back upstairs. The problem is that, in such a case, one would not need a 5.75 m long tower, a 4 m long one being enough. As the building was done, they must have been used a retractable ladder (Figure 13). The design could vary, of course, but what we have intended to mark here is the fact that for a 3 m high floor one will need at least a length of 4 m (better 4.3 m) of the floor's plan reserved for this purpose. As we suppose a two floor tower, we have now to understand that the first floor was congested, having the system of pulleys of the gate in the front part of the sides, a mobile ladder taking 4.3 m from the rest of the tower's length (for descending at the ground floor), on one side, and a reserved place to 'land' the second floor retractable ladder, on the opposite side, and this was pretty much all the available place. This is a second major argument that the tower must have had two floors above the ground level, because only at the second floor could be enough room for sentries, a stock of arms, and edibles for at least one shift.

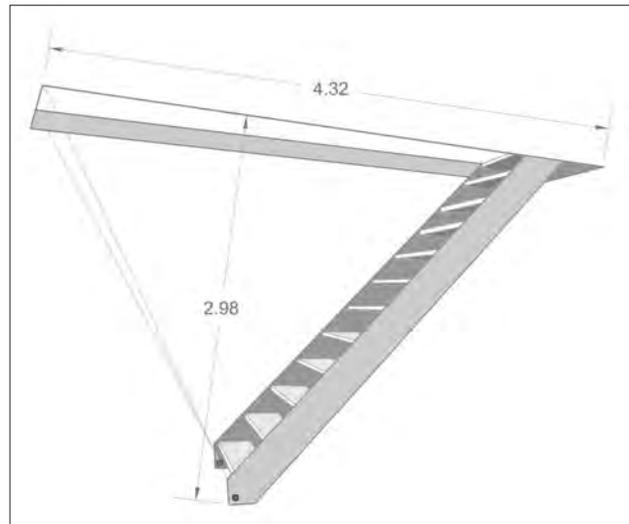
Figure 13. Theoretical model of a retractable ladder, as possibly used within the tower-gate.

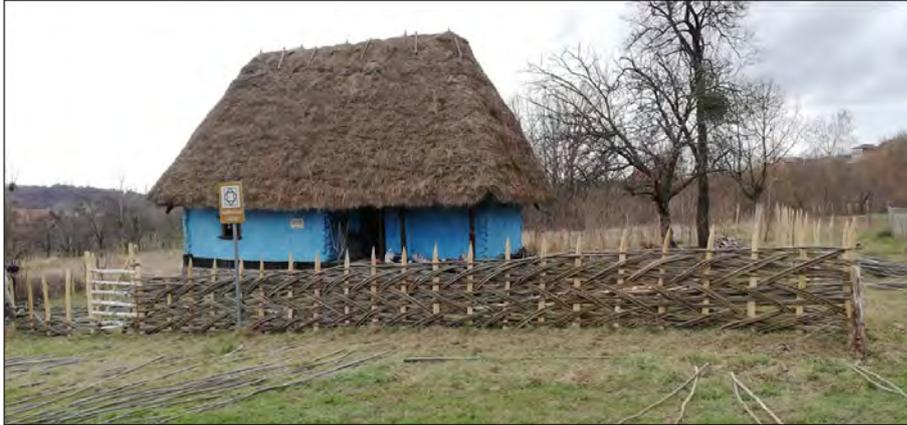
Figure 14. Fence of braided threads, on the making. Household from Călinești-Oaș (19th century type), County Museum Satu Mare (north-western Romania), ethnographical section. Photo-credit Ciprian Honca, courtesy Liviu Marta.

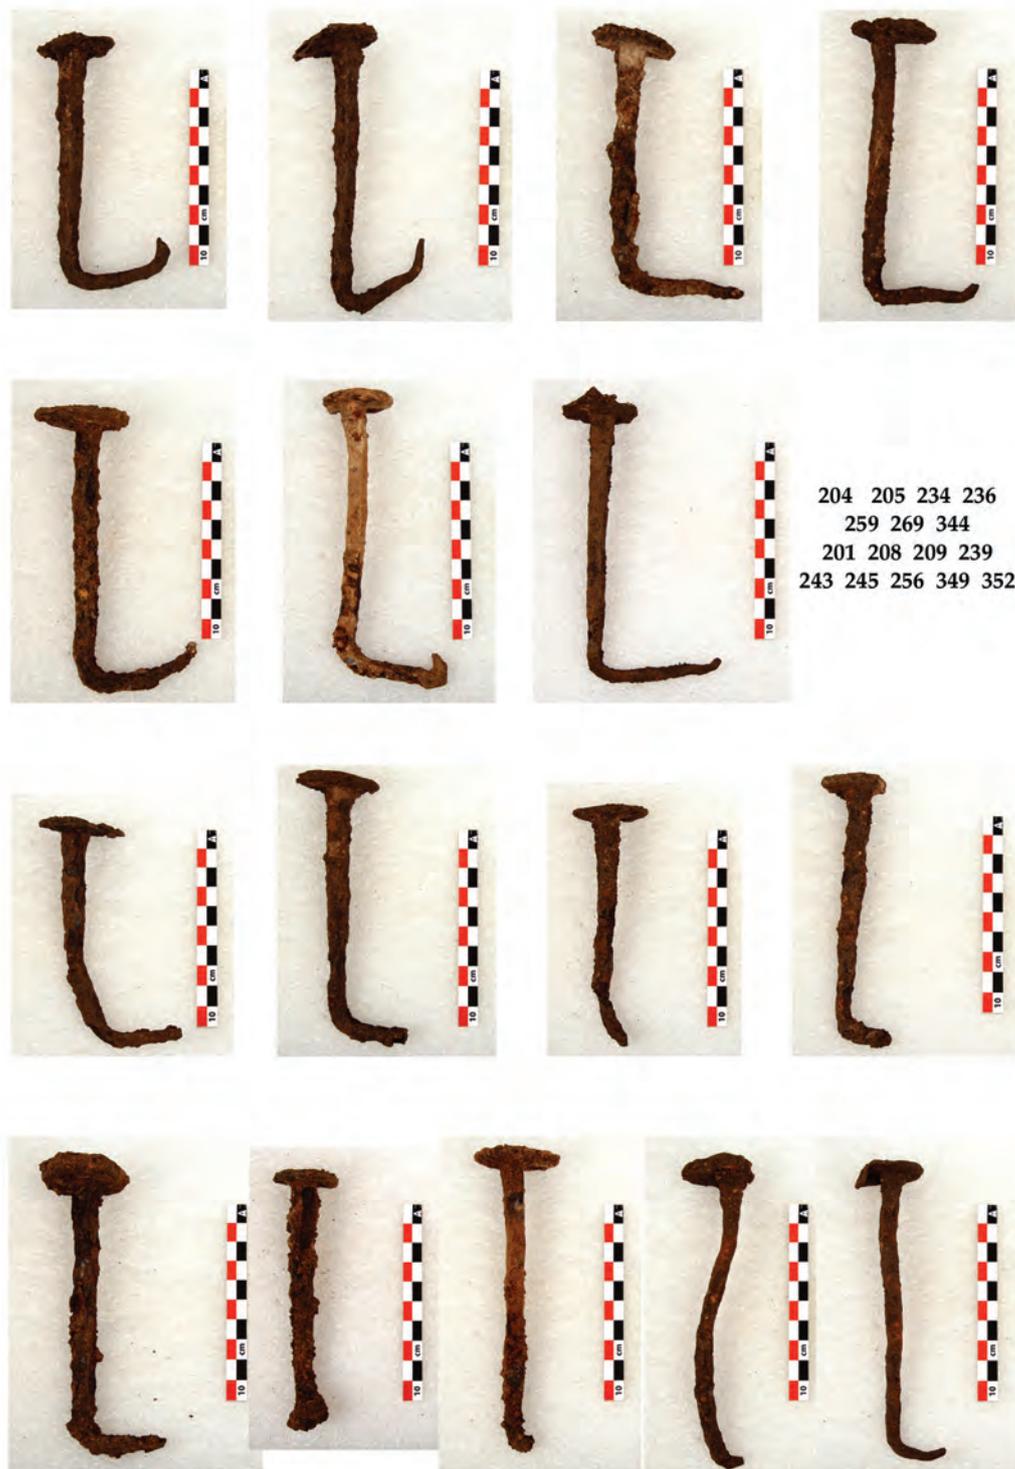
Figure 15. Large iron nails with a double bent, used in the construction of the gate. Selection, all from 2018, complete (first two rows) or fragmentary.

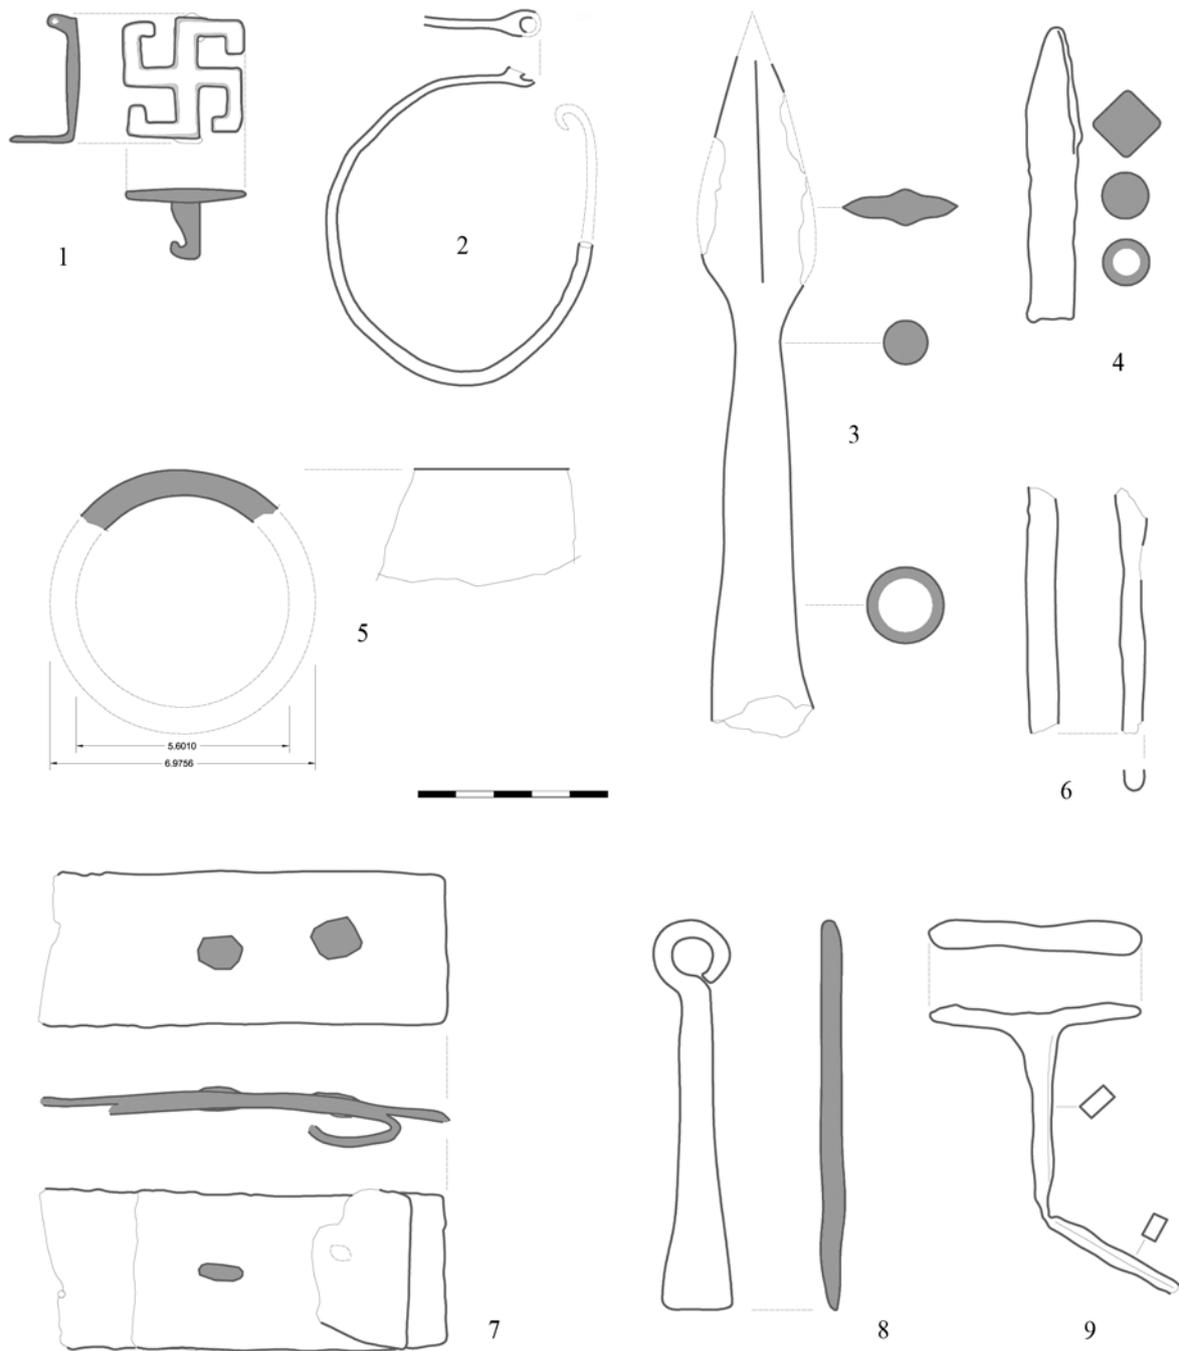
Figure 16. Metallic inventory (selection). 1, 2, 6 – bronze; the others – iron. No. 2 from the second phase all the others from the first phase.

Another decorative artefact is a thin bracelet made of bronze, with the hook absent and the ring partially preserved (Fig. 16/2). Its sizes are suggesting a female user. This is the only one item – from the short list of relevant artefacts – surely related to the second phase of the Roman archaeological site, found in the upper filling of the former defensive ditch.

The catapult bolt (Fig. 16/4) is rather short (78 mm), with a square section tip and a relatively long socket (38 mm). It was found in the defensive ditch located immediately south of the tower, and could get there in both ways: thrown by the besiegers or lost by the defenders, when the tower collapsed, as the distance from the tower to the spot of discovery is only 4.7 m. In the previous campaign (2017) we found another bolt, supposed than to be rather lost by the defenders than shot by the enemy, due to the location and position (on the porch of the barrack, standing on the ground level).⁴⁵ A second catapult bolt is strengthening the hypothesis; more, it could be a very good explanation of the unusual tower, made of 6 pillars on each side, when a simple, square plan tower, using 4 pillars at all, would accomplish apparently the same purpose. Such a hypothesis says that they needed a strong tower, able to take the kick of a catapult blow, therefore a long tower would be recommended.

In the same respect could be a fragment from an iron cylinder (maybe slightly conical, see Fig. 16/5), but there is conserved less than a quarter of its diameter and maybe half of its height. As morphology it could be a catapult washer,⁴⁶ but critical elements are missing (compare with Figure 17), as the horizontal sheet to be fixed on the

Another interesting item is a bronze sheet, relatively thin (about 1 mm), 65 mm long, bent longitudinally in U shape (Fig. 16/6), which might be a shield binding, i.e. keeping together the wooden boards. On the analogies found⁵¹ the space closed by the U shape is larger, about 8 mm, compared with Băneasa artefact, on which we can measure about 6.6 mm, but the object is deformed by the weight of the soil above. On the same analogy there are rivets at every 10-12 mm, but our artefact is shorter than that. Although there is no certainty, we think it is a binding for an oval shield (from the side part).

⁵³ Two relatively large iron rivets are holding in place (Fig. 16/7), but the way in which the two plates are working together is not clear. The only analogy of a plate with two large rivets comes from Windisch (Thomas 2003, 134, no. 117), but only one plate is present, explained as „portion of a girdle plate, retaining two large leathering washers”. Our plates could have also other smaller holes, not visible on the actual estate of conservation (rusted). One cannot outcast other purposes of the plates, but none came into our minds.

limited needs, as working on wood or leather. The last implement, Fig. 16/9, has a handle suggesting that it could be used like a drill,⁵⁷ but the tip is missing, along with the supposed helical section.

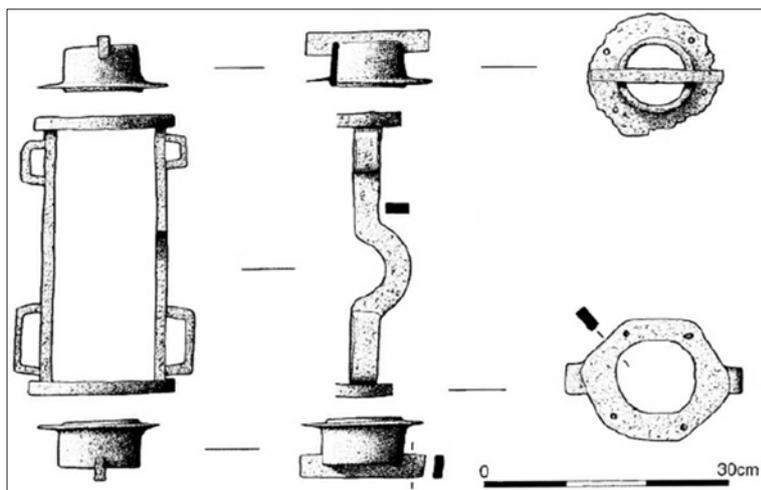
Figure 17. Analogy for the catapult washer (Fig. 15/5), after Bishop, Coulston 2006, Fig. 82.

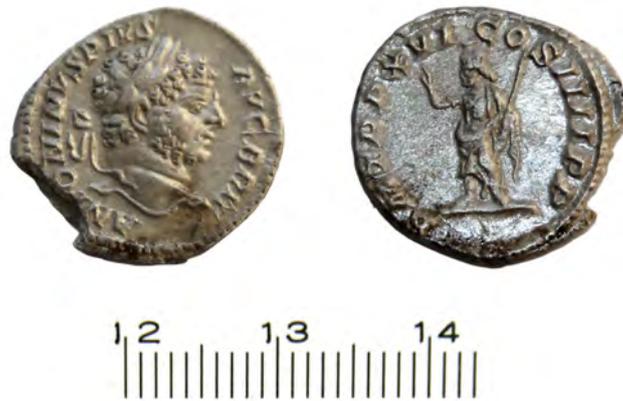
Figure 18. Denarius (Caracalla, RIC IV/1, p. 241, no. 208, Roma, year 213) found in front of the gate.

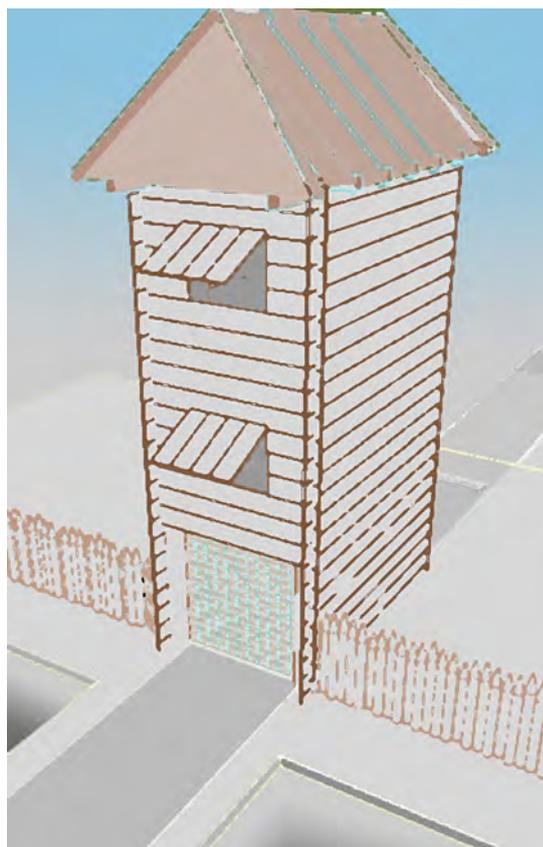
Figure 19. Restitution of the area of the eastern gate.
Sketch. View from north-east.

In 2018 and 2019 we have dug at the middle of the eastern side of the Roman fort at Băneasa. What we have found is basically a tower-gate (Figure 19), unusual from several reasons in the early third century. First, we have only one tower, not two, serving as gate.⁶¹ Secondly – it is its plan, almost twice long than wide. Thirdly – the weird
