# DIGGING THE FRONTIER, TACKLING THE EPIDEMICS. RESEARCHES ON BRAN PASS

EUGEN S. TEODOR

## ABSTRACT:

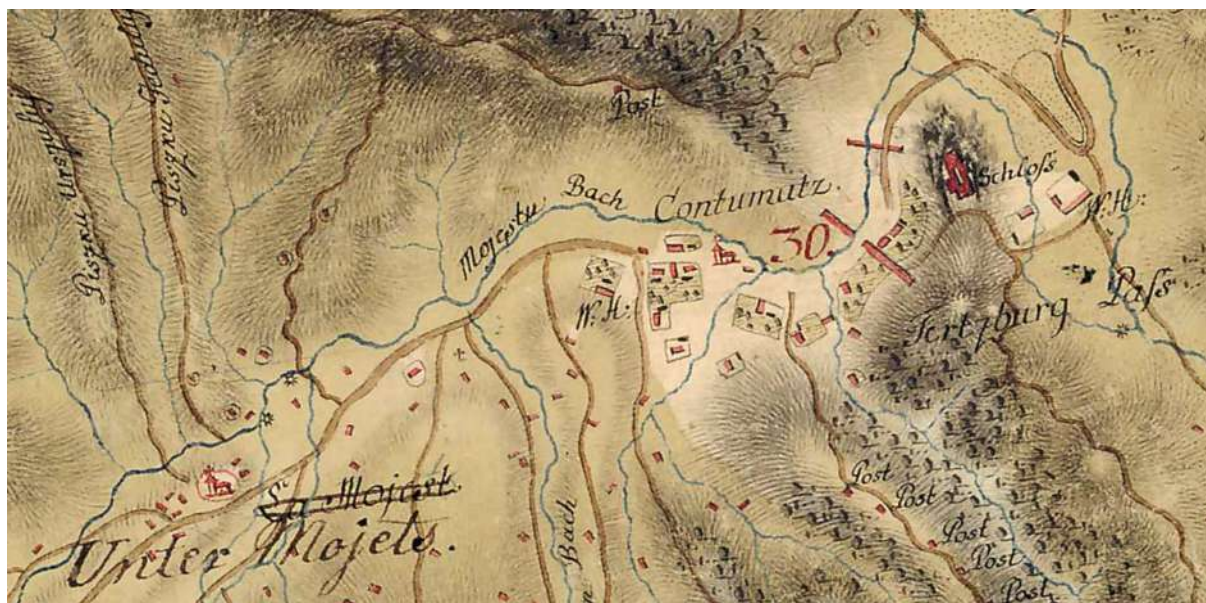
Fig. 2. First Austrian Survey (or Josephinian Land Survey), 1769-1773 (for Transylvania), depicting Bran ('Tertzburg') customs. The meaning of '30' is that a military unit of 30 cavalry is watching the place (Zylberman 2020, 32).

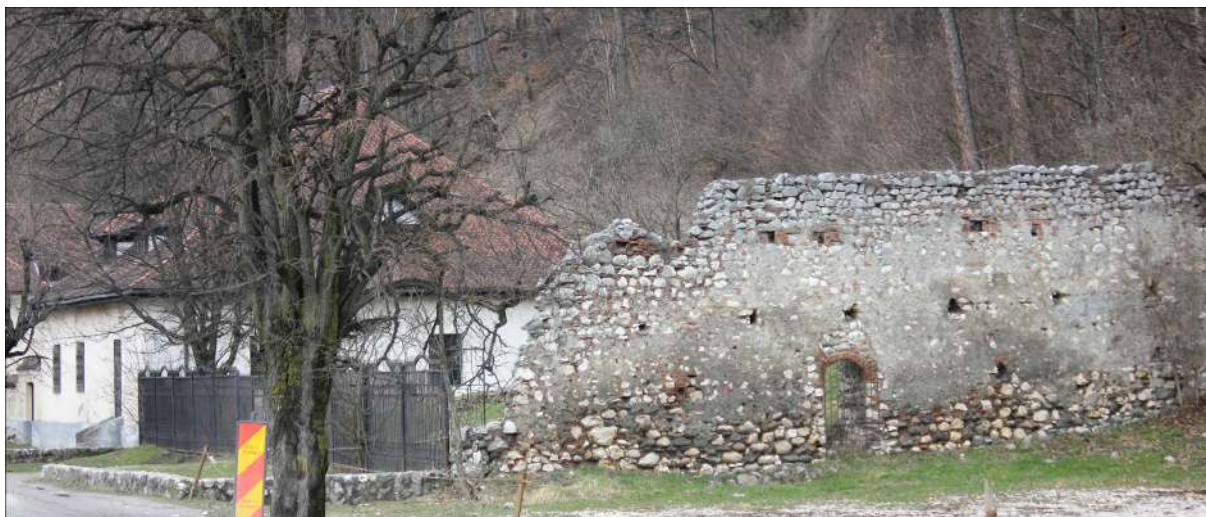
Fig. 3. Defensive wall closing the customs area from Bran and one of the historical buildings.  
View from outside, east of the river. Photo Ovidiu Popescu.

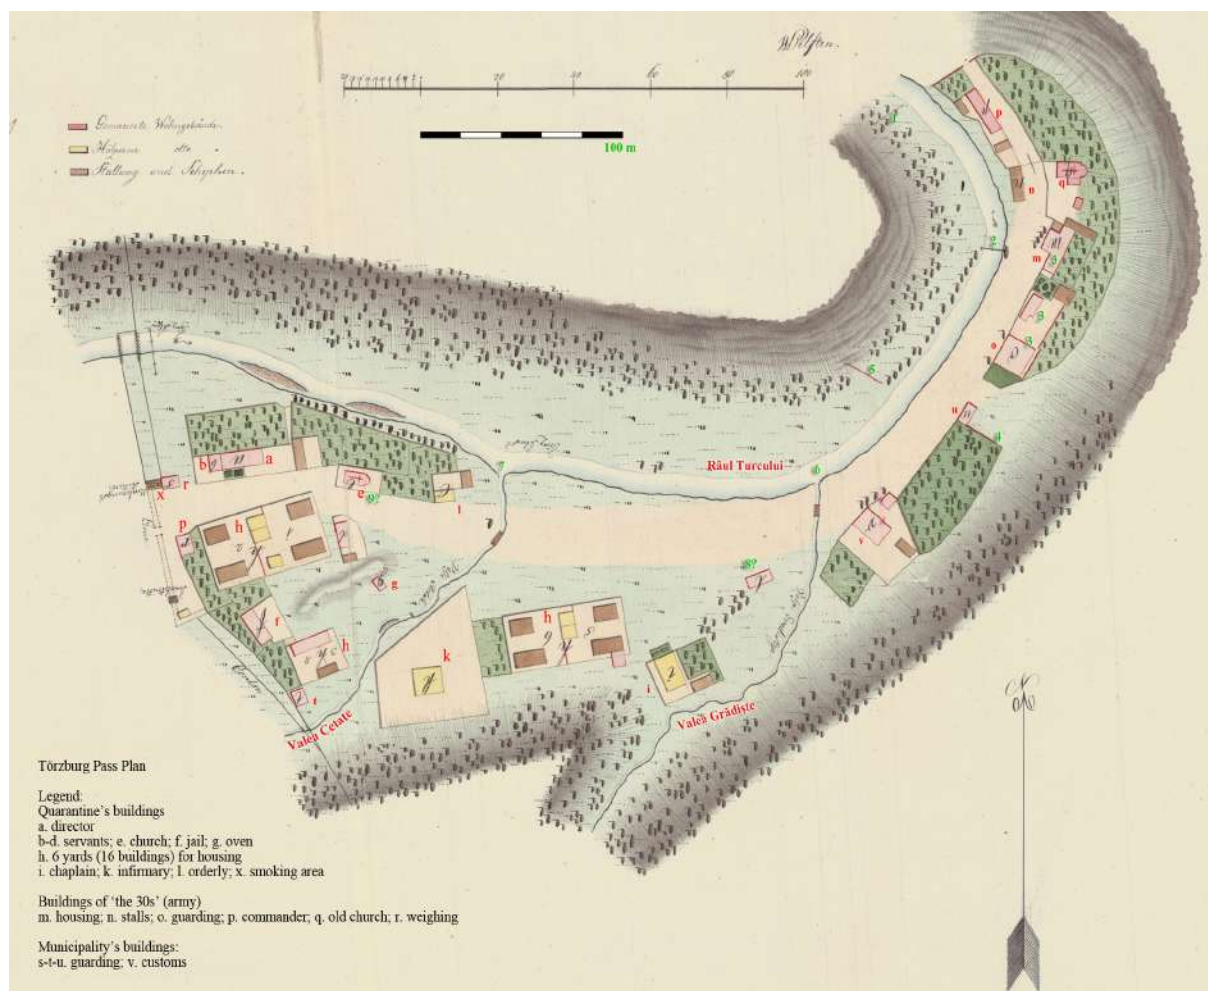
Fig. 4. Plan of the quarantine facilities (west of Grădiște Valley) and customs' offices (east of the same). Brașov County Archives (BV-FD-00001-43-397D, Contumatz Gebäude in Törzburg), original heading south, rotated towards north, dated 1819 (on the back, pen).

Fortunately, at the Braşov County Archive there is a detailed plan of the place, dating from 1819 (Fig. 4).<sup>30</sup> West of the Grădişte Valley there are some administrative buildings, such as the Director's headquarters (a), his staff (b), a bakery (g), the jail (f) or the church (noted e, a new one, built for this occasion), all made up of masonry, except for the chaplain's house. There are also three double yards (noted h), containing double houses (in two cases made of wood, the third of masonry), measuring close to 12 x 11 m. Some light structures are located in the same yards, such as stables and sheds, for the animals and goods of the quarantined. There is also a lazaretto for those visibly ill (k), in a large yard, keeping the sick people at a distance.<sup>31</sup>

The place of the old quarantine in Bran is still visible on the ground. The buildings of the customs' offices (noted 3, in green, in Fig. 4) are still there, the small bridge in front of them (noted 2, in green), the front defensive wall (noted 4 and 5 at the Fig. 4, see also Fig. 5), and the back wall closing the area (noted 1), although in ruins, are all there. There are less surviving monuments of the western area, such as the church,<sup>35</sup> but the general configuration

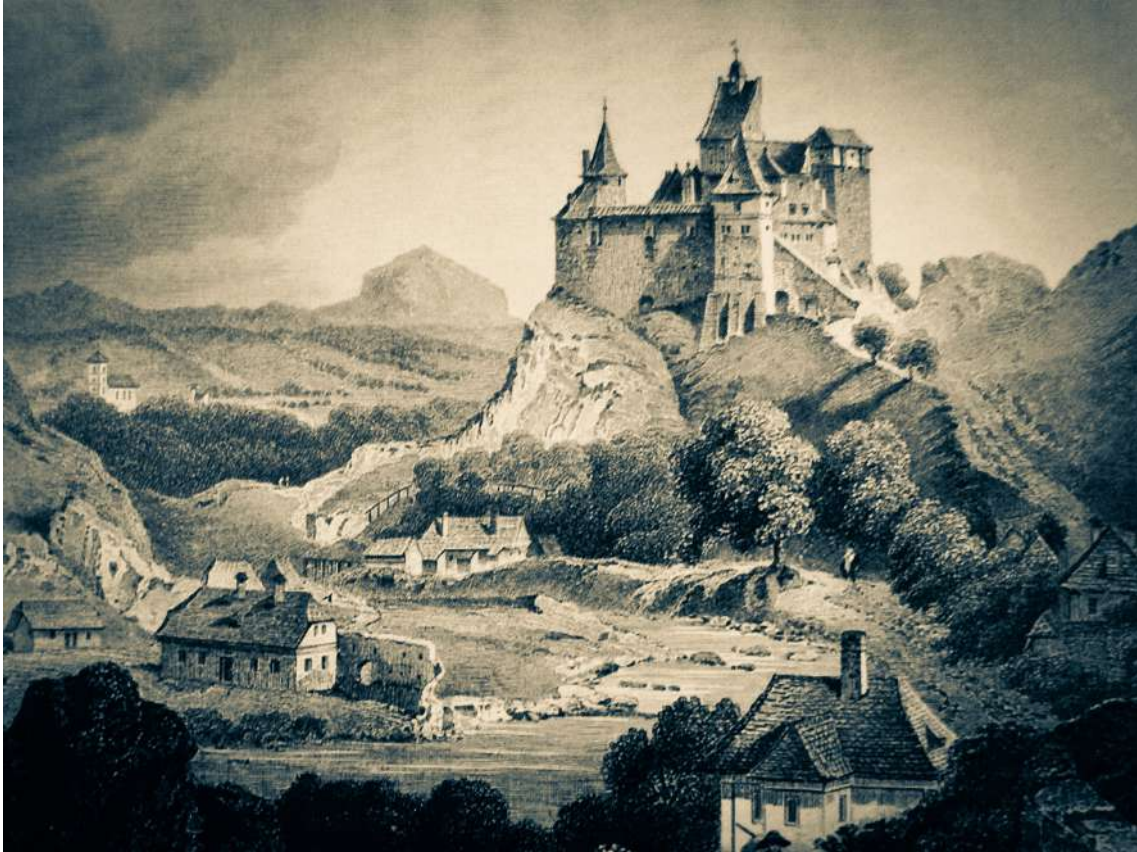
Fig. 5. Depiction of the Bran Castle and its surroundings as seen from southwest (coming from the mountains).  
Ludwig Tohbock, 1883 (public domain).

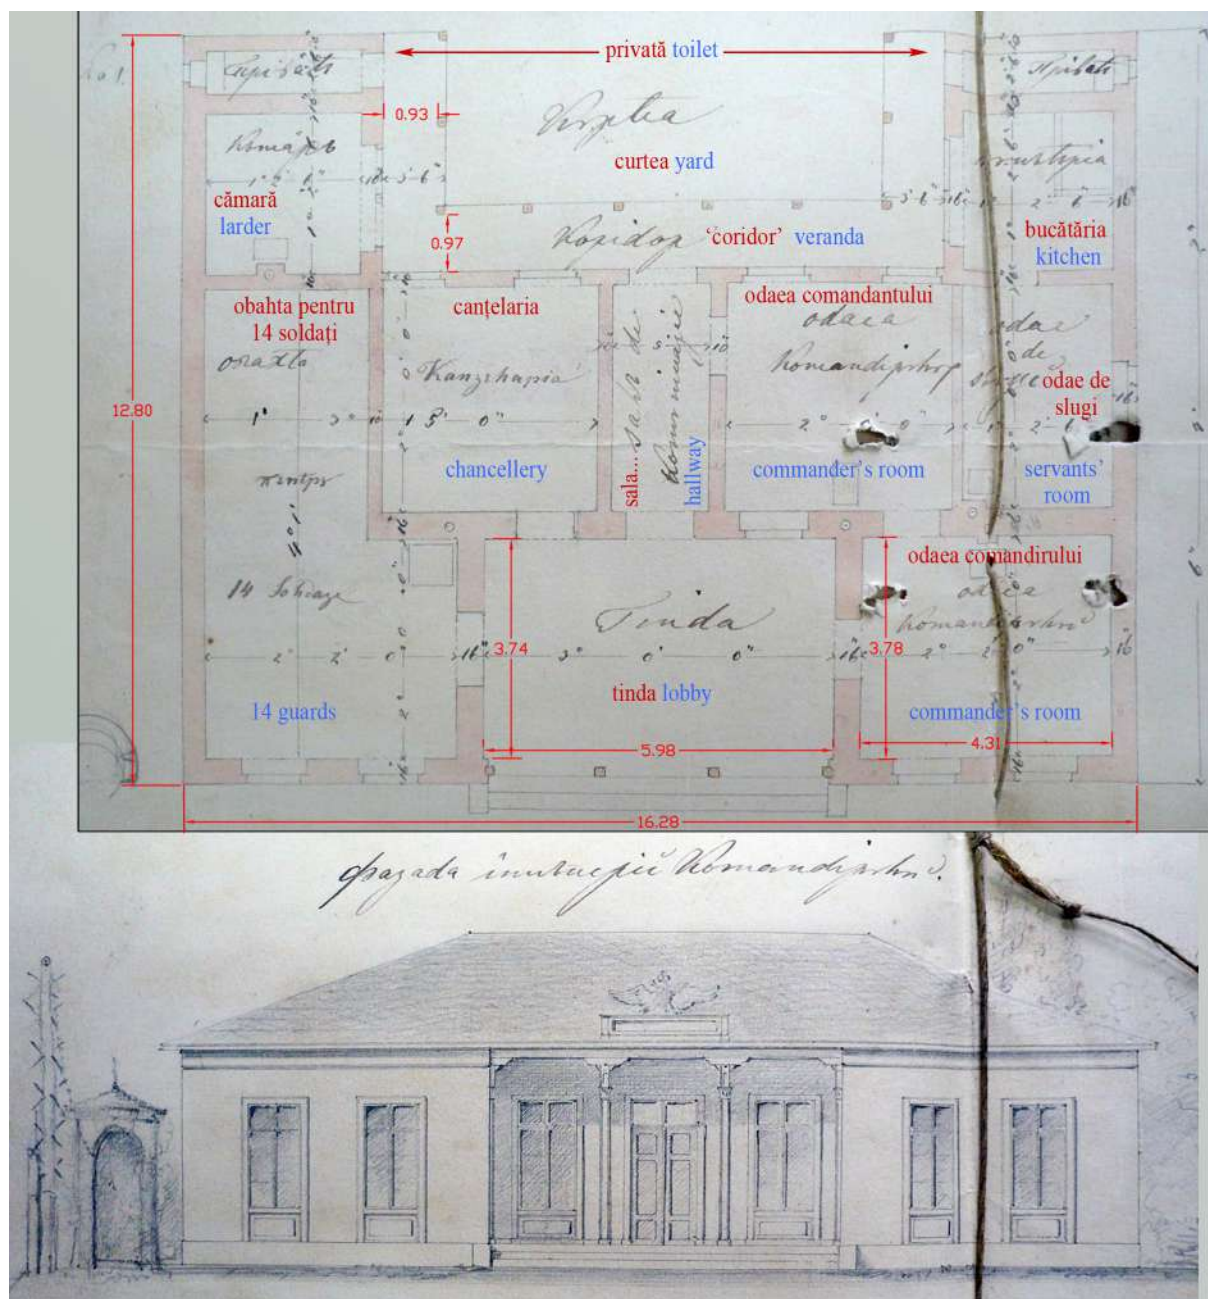
Fig. 10. Plan and faade of the building of the commander, planned for Râul Vadului, 1850. National Archives, Ministry of War, Mountain Inspectorate, file 1. Original dimensions in stânjeni-palme-degete, added measurements in meters (red).

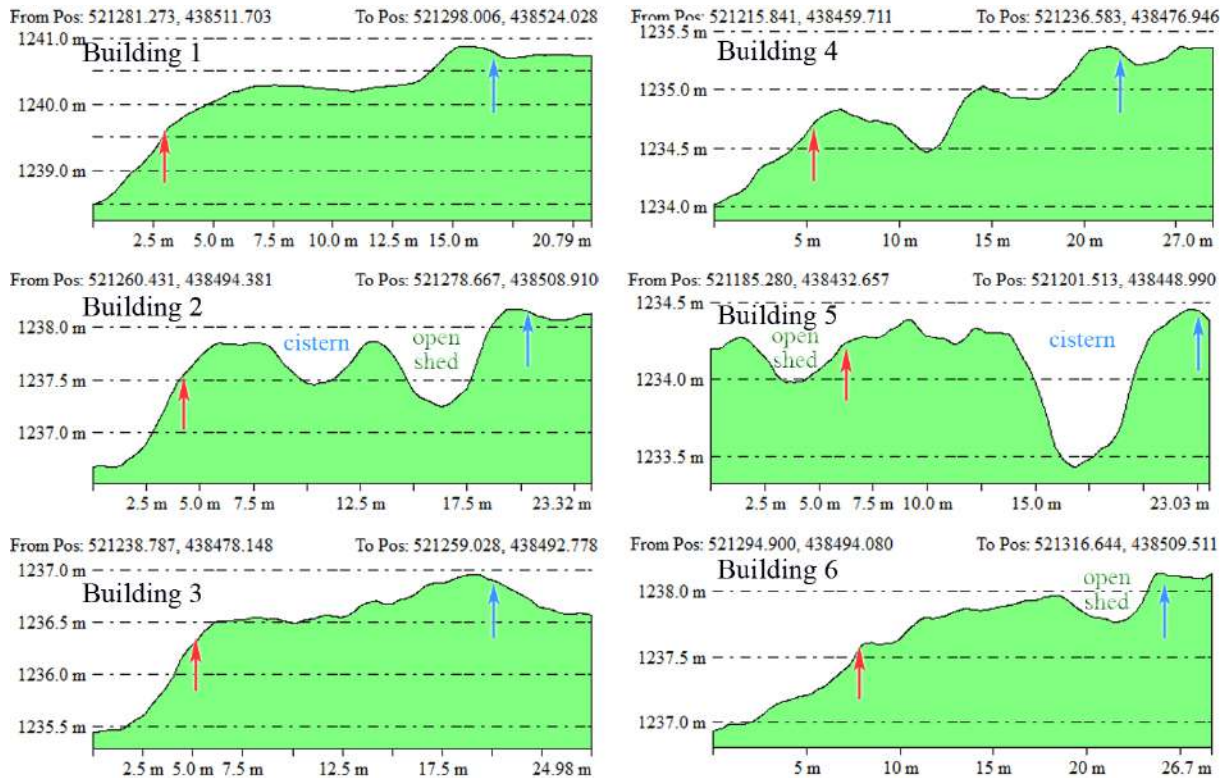
Fig. 13. Altimetric sections through the buildings B.1 to B.6 (see Fig. /Podu Găveni/), all parallel to the old road. Coordinates in Stereo 70/Dealul Piscului 1970.

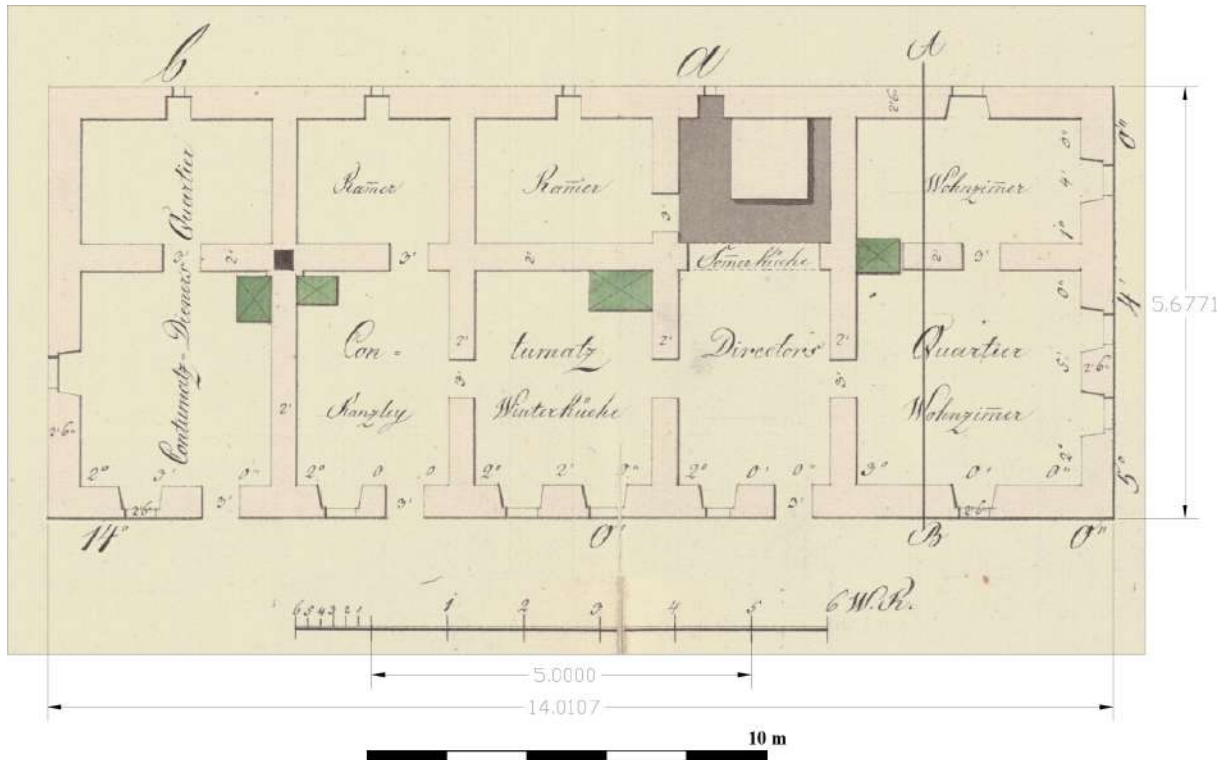
Fig. 15. Plan of the building of the director of the quarantine camp from Bran, 1819. Braşov County Archives (BV-FD-00001-43-397A), excerpt. Original scale in Klafters.

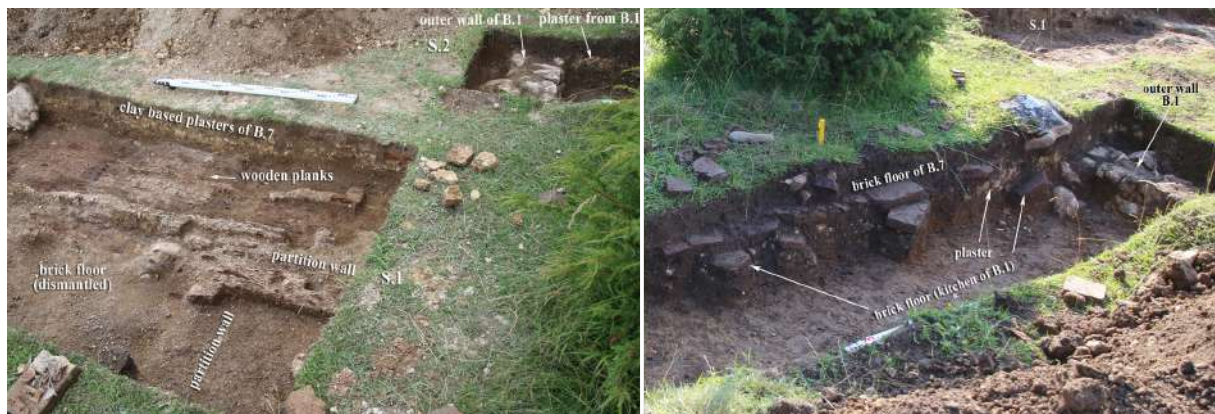
Fig. 19. Snapshots at the origins of the archaeological trenches S.1 and S.2. Photo heading southwest, at the head of the trench S.1 (left); photo heading east, to the trench S.2. July 2020.

The stratigraphic relationship between B.1 and B.7 is obvious in two places: in the eastern profile of S.2 (Fig. 19), where the plaster of B.1 is caught between the bricks of the older kitchen (depending on B.1) and the pavement of the later construction (depending on B.7), and also in the upper end of S.1, where the wooden wall of B.7 is superposing the inner face of the older foundation.

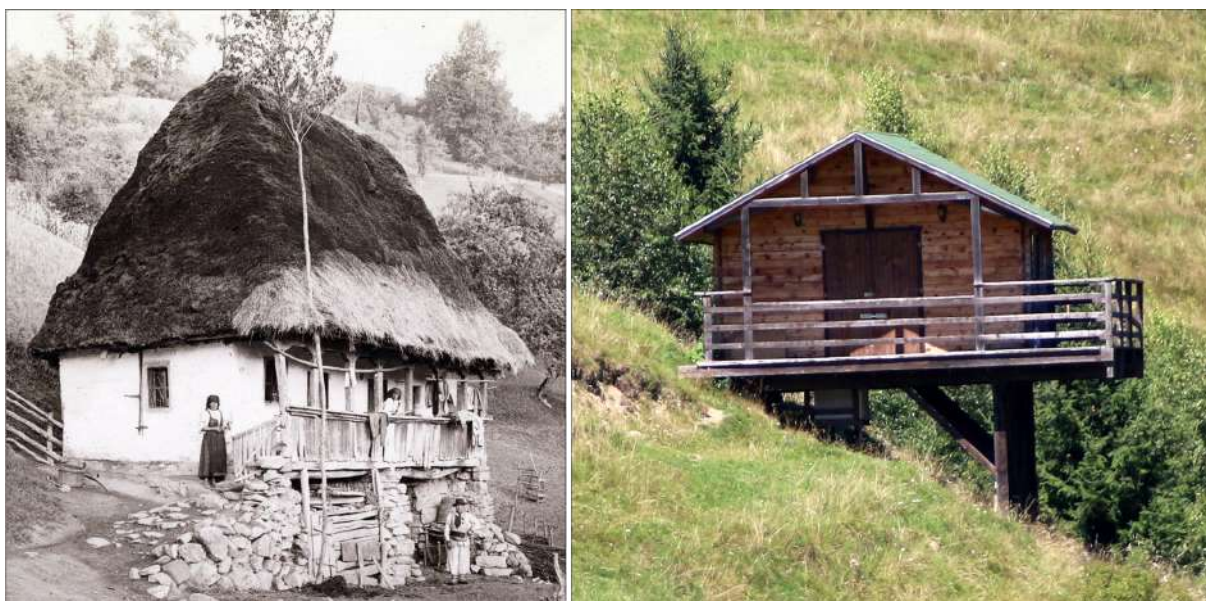
Fig. 22. Ethnographical analogies for buildings on strong slopes: house from Blăjeni (Hunedoara County), ca 1890 (Arhiva MTR, K-1580), left; chalet from Șirnea (Brașov County), 2019, own photo, right.

The archaeological data possible to be collected on such a strong slope are poor. Nevertheless, such buildings are not rare on the mountains, and ethnographic analogies could be suggestive (Fig. 22).

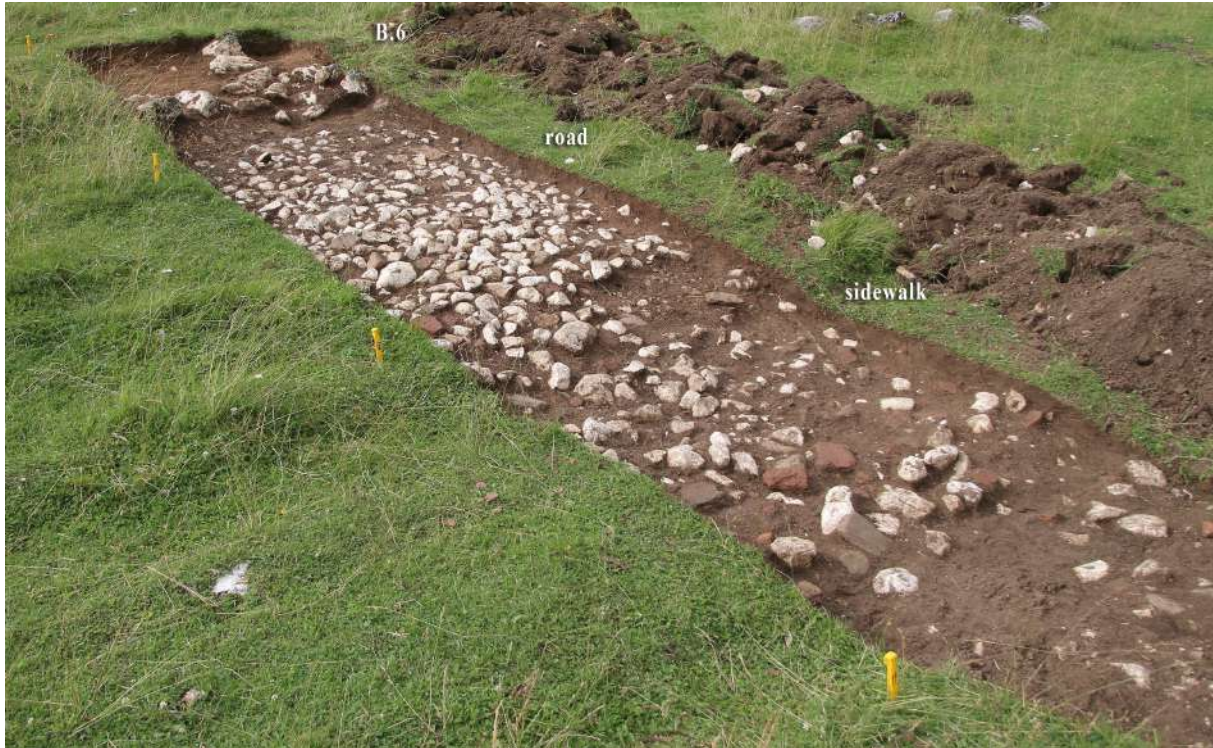
Fig. 24. The earliest road at Podu Găvenii, image on the trench S.1, view heading south.

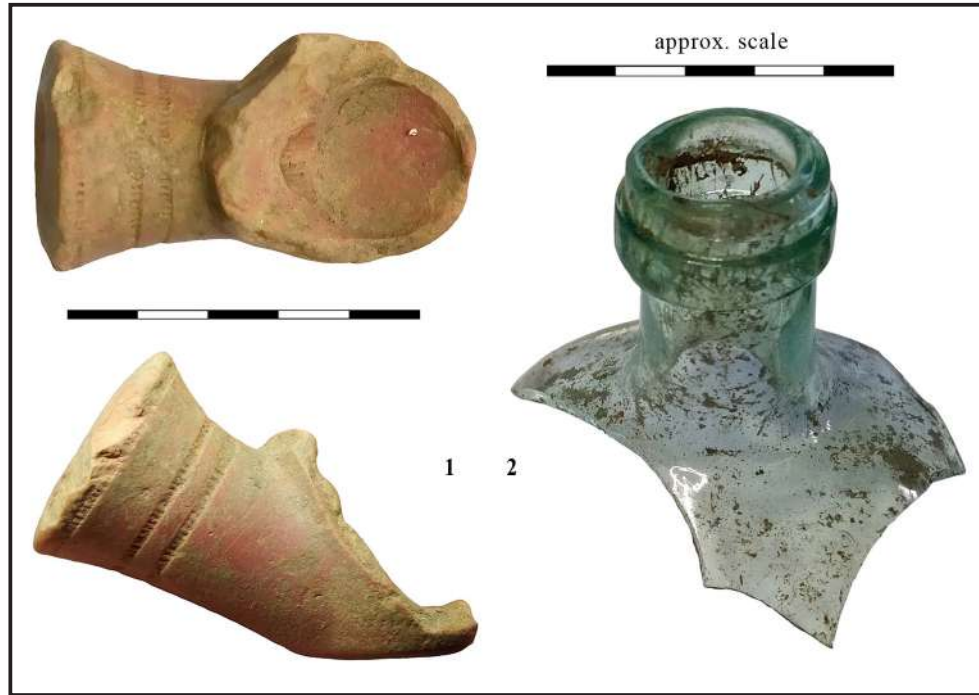
Fig. 28. Small finds: a 'Turkish' pipe of local production (1) and glass bottle (2).

In order to close the pottery section, I am adding here that two fragments of Turkish (type) smoking pipes were also found (rather local production, see Fig. 28/1). Having my own experience in digging late mediaeval sites,<sup>115</sup> I can

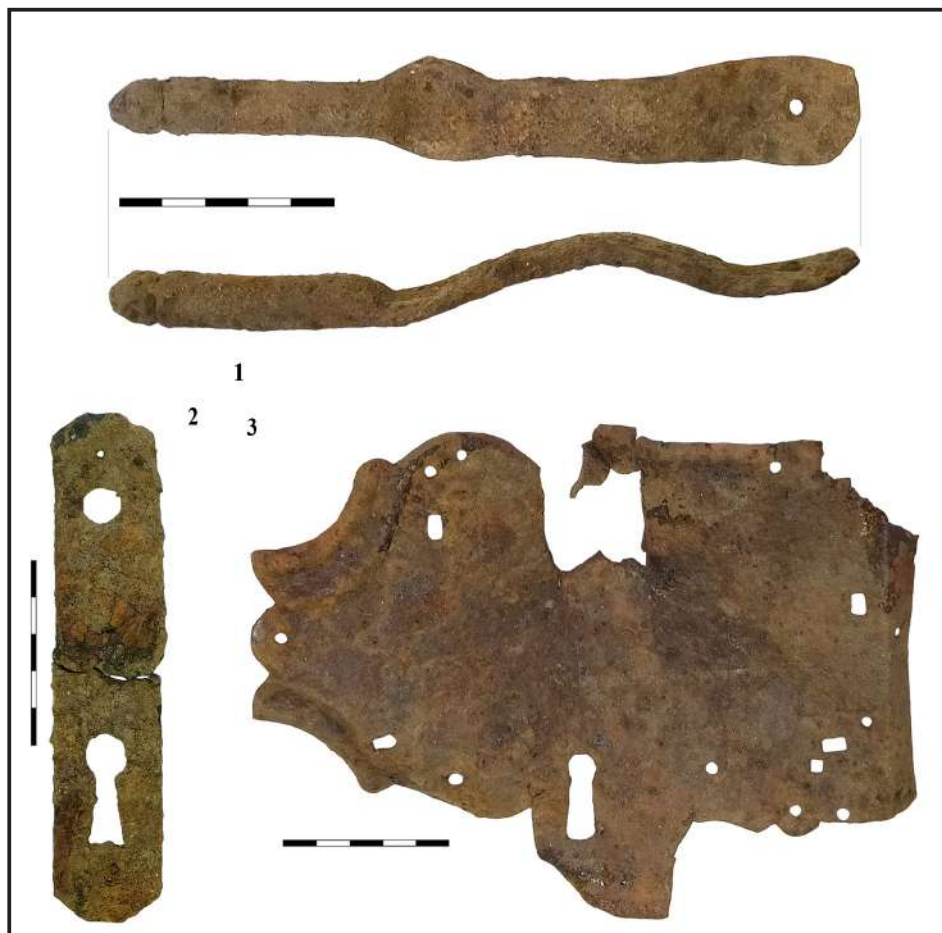
Fig. 33. Iron parts of the doors: fastener (1), the outer protective sheet for a lock ward (2), the box of a lock ward (on the inner side of the door, 3).

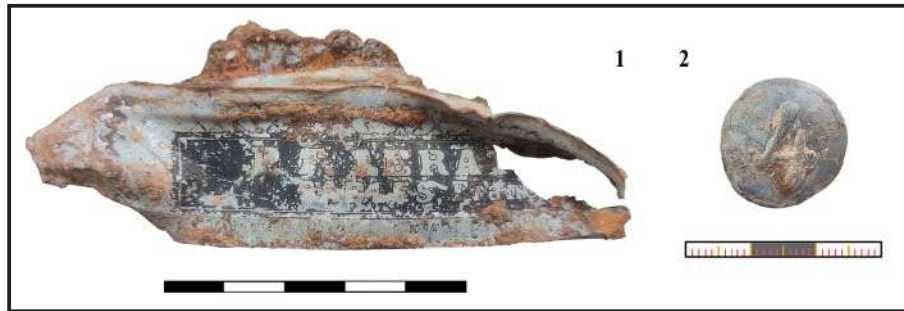
Fig. 34. Left: Sardine can, France, post 1853. Right: regimental button, 1872-77.

One of the most interesting metal artefacts is a fragment of a tin can, which can be read 'P.F. LERAT / SABLES, Franc(e)' (Fig. 34/1). This is the earliest can factory in France, for sardines, opened in 1853.<sup>129</sup> The metal sheet appeared in excavation in the trench S.4, grid 10, 50 cm below the surface, between the second and the third modern road. This is suggesting that the modern second road was made approximately in 1860-65. How exactly an Atlantic sardine can has reached Carpathians remains a mystery, but it probably should be connected with the Crimean War and the presence of the French army in the area of the Black Sea (1853-56). It is obviously military furniture, suitable for a military unit located in such a remote place.
