ANALYSIS OF LANDSCAPE TRANSFORMATIONS IN THE AREA OF ANCIENT TROESMIS DURING THE 19TH AND 20TH CENTURY

Abstract: *The latest archaeological research on the ancient site Troesmis, located between Măcin and Turcoaia (Tulcea County), raised questions about the transformations that affected the area, especially the Danube shore platform and bank (Măcin Branch). Cartographic materials and aerial photographs from different periods in the last two centuries have been analysed in order to find an answer. These were assessed and compared to the contemporary situation (documented by orthophotoplans and drone images as well as exploration on the ground). In addition, information from the archives and specialized publications concerning the geology of the area, the exploitation of local natural resources (especially stone) and land developments in the second half of the last century were also used. The conclusion is that a large part of the shore platform below the two fortifications still visible at Troesmis (and under the fortress of legio V Macedonica spotted by way of geomagnetic prospections on the plateau between them) underwent changes at the end of the 19th century and especially in t

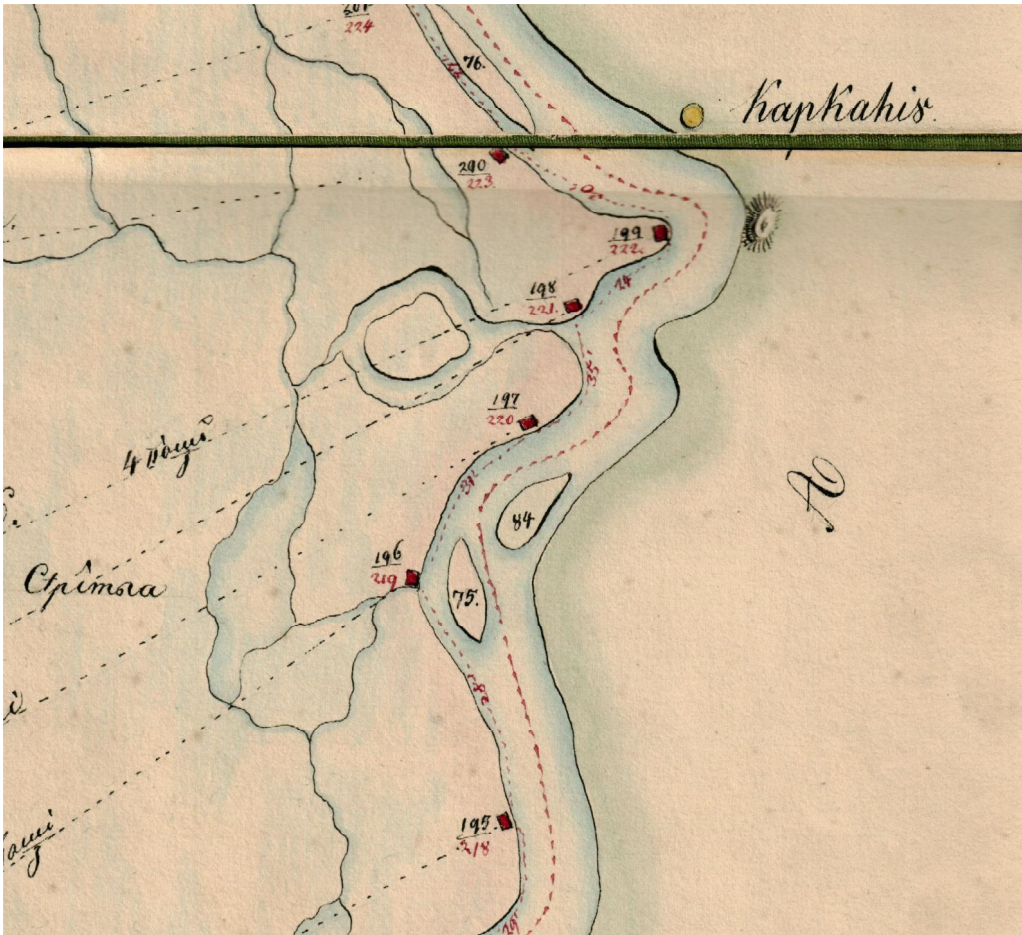
Fig. 2. Captain Begenau's Map, 1844 – detail of the area of the Troesmis site with Carcaliu village in the upper right corner and the location of the place called Strâmba on the Insula Mare a Brăilei (written in Cyrillic script).

Analysing Begenau's map (Fig. 2), the Danube's river branch Măcin can be easily observed as being very similar to the one seen today. Some differences can be identified for the river islets and secondary river branches, which were more numerous and apparently more active some 200 years ago. This is the case with Dunărea Veche Lake (Old Danube Lake) in present days, which was still connected

with the Măcin river branch back in 1844, according to Begenau's map. Although the map's accuracy is to be appreciated for that time, we must mention the low accuracy in depicting Romania's relief, as extended triangulation works were not completed at that time¹⁷. Begenau marks the old and new numbering of the border posts¹⁸ on the Danube frontier with the Ottoman Empire. The numbers and their corresponding names in the area of interest for the present paper, according to later maps¹⁹, are the following: 200/223 = Iglița; 199/222 = Mâna Iglița; 198/221 = Turcoaia. Further important is that the map illustrates all the Danube islets, with precise identification of those on the Romanian and Ottoman territories respectively. The islets are also numbered and there is a colour differentiation - rosa/red for Romanian, green for Ottoman. Islet number 76 is identified as the Iglița Islet²⁰. On the later map of Begenau (1854) the right bank of the Danube (the Ottoman side) is not as widely illustrated and there is a visible difference/correction for the location of the Iglița Islet. The numbering of the border posts changed, but the map legend identifies the places and enables the correspondence with earlier and later maps.

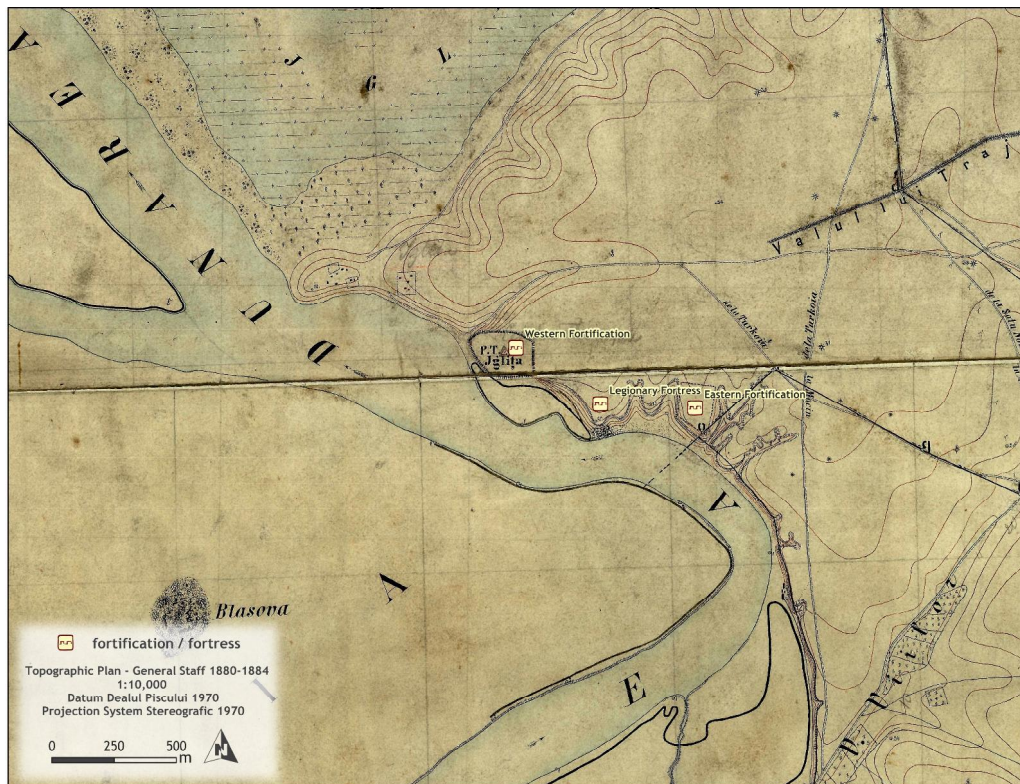
Fig. 3. Troesmis site on topographic plans in 1880-1884.

The area of the Eastern and Western Fortifications is highlighted on the topographic plans from 1880-1884, scale 1:10,000 (Annex 1, No. 3). The Iglița hamlet can still be seen on these early plans, west of Troesmis²⁵. No important transformations were made to the environment at that time, the Iglița Pond being situated north of the homonym settlement. As for the loess deposits and river bank, there are some notable differences compared with the later maps and plans (1940, 1960, 1970, 2009 - Annex 1, Nos 10, 12, 13, 17). The high scale of the plan allows the direct comparison of some of the gullies and erosional processes specific to the area. Thus, the large gullies appear on the map in the same position, whereas the small ones, close to the river bank appear to be less pronounced than they are today. The area close to nowadays temporary storage place of the ballast and south-east of Troesmis is much more fragmented today than it was in 1884. The big quarry on the east side of the Legionary Fortress did not exist in the 19th century, and probably the others were not that developed as well. The plan offers many other details on the road network, tumuli and even the so-called Trajan's Wall (i.e. the Roman aqueduct²⁶), being an important evidence of some of the artefacts and archaeological objectives that might have been lost during the last century.

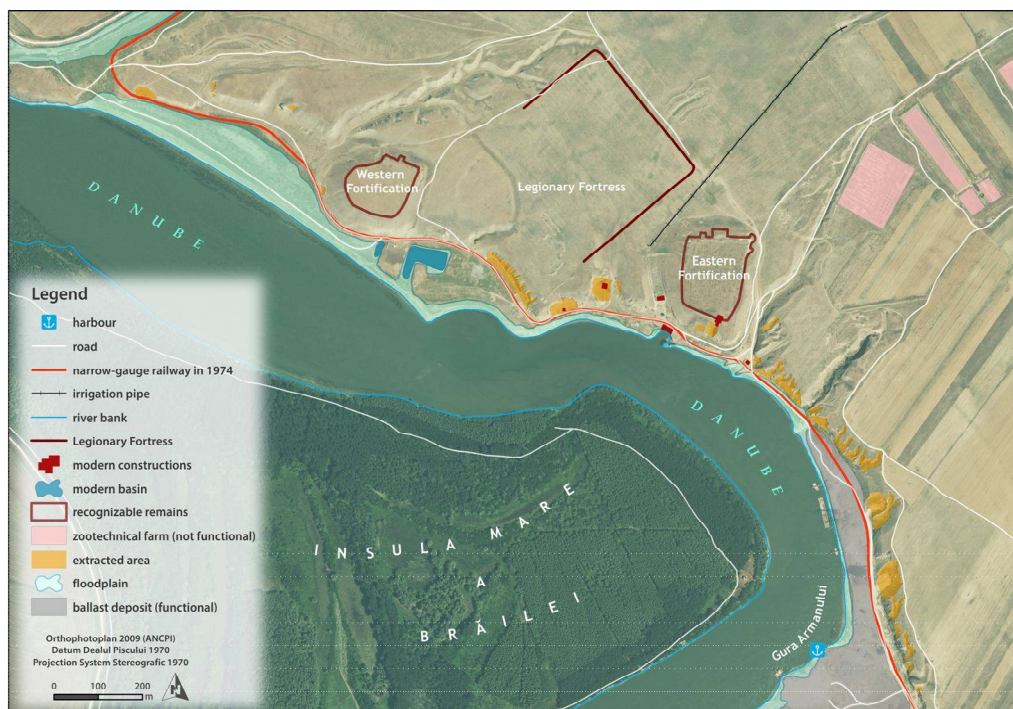
Fig. 11. Anthropogenic elements in the Troesmis site area.

Agricultural activities, grazing, as well as different constructions, some illegally placed near the ancient fortification, caused relief and landscape degradation over time. Thus, the Troesmis site area was affected by the pig farm built near the Eastern fortification, the hydrotechnical improvements, by the exploitations on the road that connects the quarries in Pietra Râioasă, those near the village Greci and those from Iacob-Deal with the river bank, the construction and maintenance of the narrow-gauge railway (20th century) and the grey limestone exploitation placed at the basis of the loess cliff, beneath the ancient fortifications (Fig. 11). The inadequate exploration and unsystematic investigation of the archaeological site in the past⁵⁴ as well as the intervention of the illegal metal detecting have damaged most of the Troesmis site area.

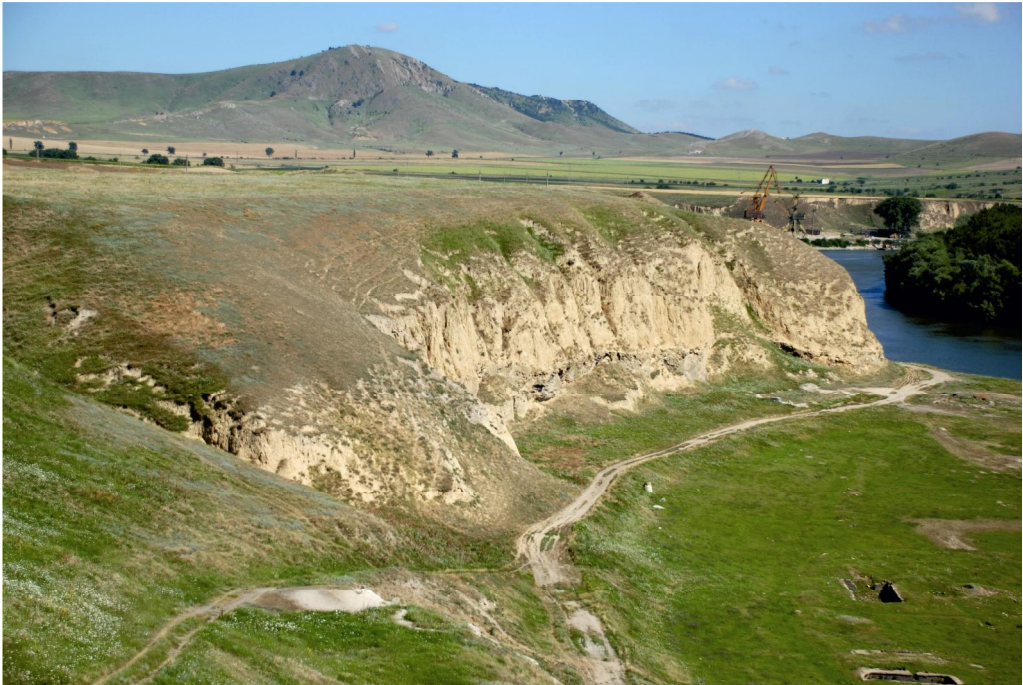
Fig. 13. Photos of the modern time grey limestone quarries that damaged the sector near the legionary fortress.

probably with occasional exploitation. Nowadays the limestone is no longer extracted from the quarry (Fig. 13 and 14).

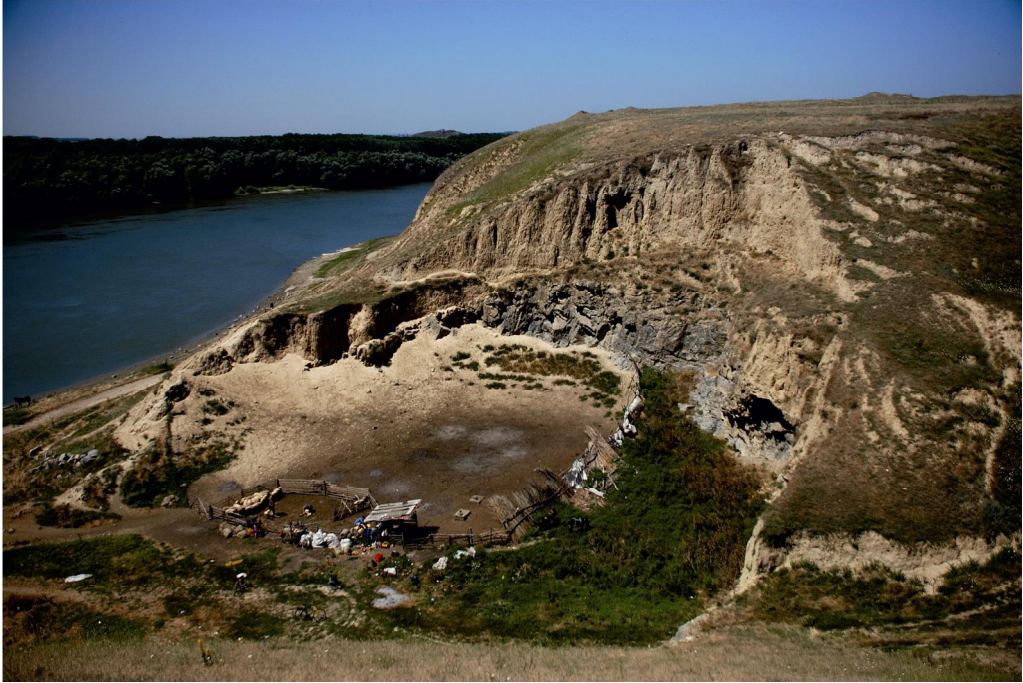
Fig. 14. Photos of the modern time grey limestone quarries that damaged the sector near the legionary fortress.

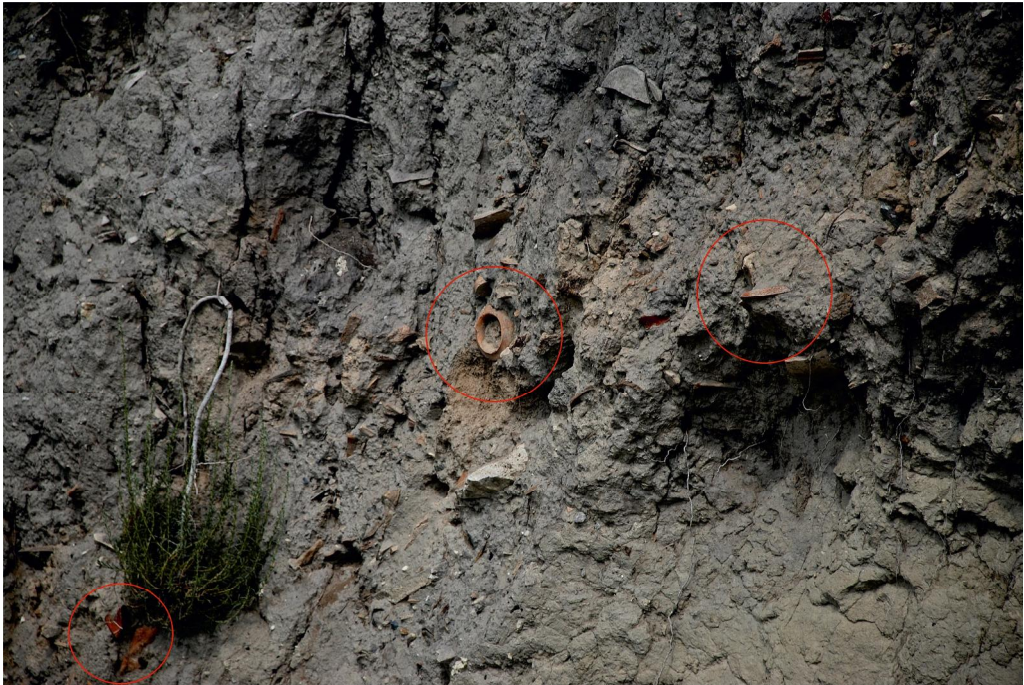
Fig. 15. Archaeological materials falling apart from the loess cliff (Legionary fortress) as a consequence of quarrying activities and their short- and medium-term consequences

The lithological characteristics are also important for the Troesmis area. The fortifications lie on a loessoid deposit that is 20 to 30 meters thick (above the grey limestone deposits)⁶⁷. The loess can resist for long if it is not sectioned. Once sectioned, it has the tendency to separate in plates/pieces (breaking vertically) and to erode due to surface erosion and water from precipitations⁶⁸. At the moment, the area of the legionary fortress is endangered by the active erosion triggered by the limestone excavations (Fig. 15).
