# THE ARCHAEOLOGICAL SITE OF ORAȘUL DE FLOCI ROMANIA

**Site type:** Medieval archaeological site “Orașul de Floci”

**Main dates:** Giurgeni commune. Archaeological site, extinct medieval town, 15<sup>th</sup>-18<sup>th</sup> centuries.

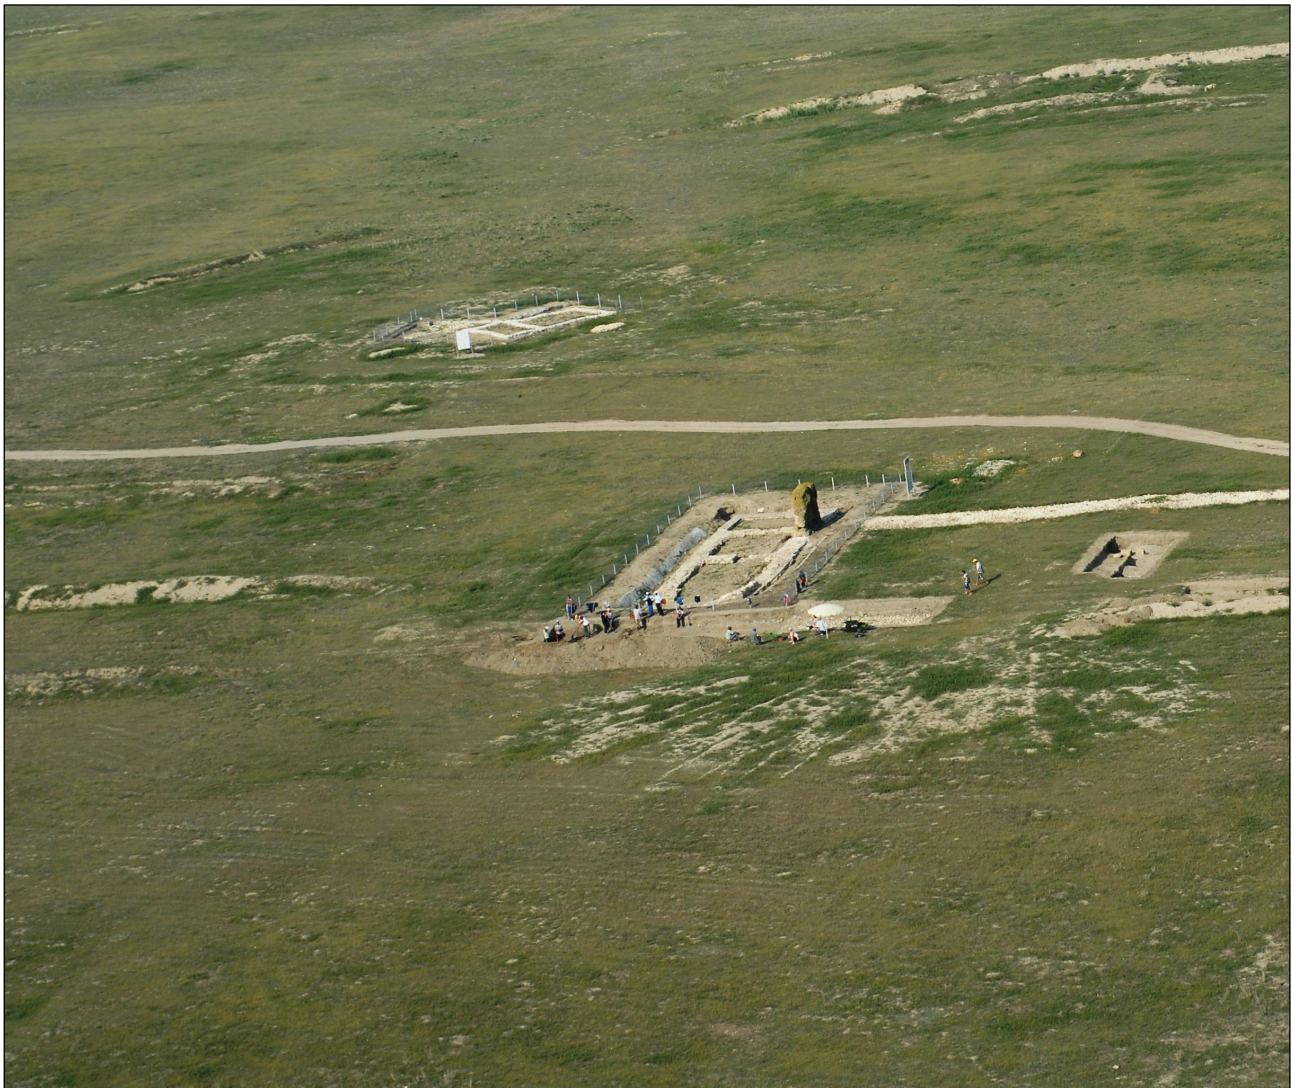
Fig. 4. Church no .1. Aerial view

7.4.1. *Church No. 1* has stone foundations and the elevation is made of bricks, with large splaying of mortar. Between them are traces of wooden bars, covered in tiling. (fig. 4)

The church is rectangular, with one aisle only, and consisting of altar, nave and narthex. The altar apse is of a semi-oval shape, while the narthex was rectangular. The first stage was built at the end of the 15<sup>th</sup> c. and beginning of the 16<sup>th</sup>. During the second stage, the church has been totally rebuilt in brick, on the former stone foundation, adding afterwards a porch which would extend the building by 4 m. On the south side of the narthex there were inlaid bricks set on the width. The church did not have a spire, nor a belfry, since there was no supporting element for such additions. The only element preserved out of the elevation of that church is the narthex wall, more than 3 m high and approx. 2.5 m wide, which is not consolidated, renovated and has never been restored. The foundations of the building are covered in soil.

1. Entrenchment and restoration of churches Nos. 1 and 2.
2. Emergency conservation and restoration of the edifice with buttresses, as well as of the stone-foundation dwelling at the foundation level.
3. Demarcation and enclosure of the archaeological site, as well as insurance of protection services for the site

1. Uncovering of the foundations of churches no. 1 and 2, their restoration at the foundation level, as well as addition of several layers of the elevation.
2. Uncovering and restoration of the buttressed constructions and of the stone-foundation dwelling.

c. Priority of intervention. Repair of the wall at church No. 1

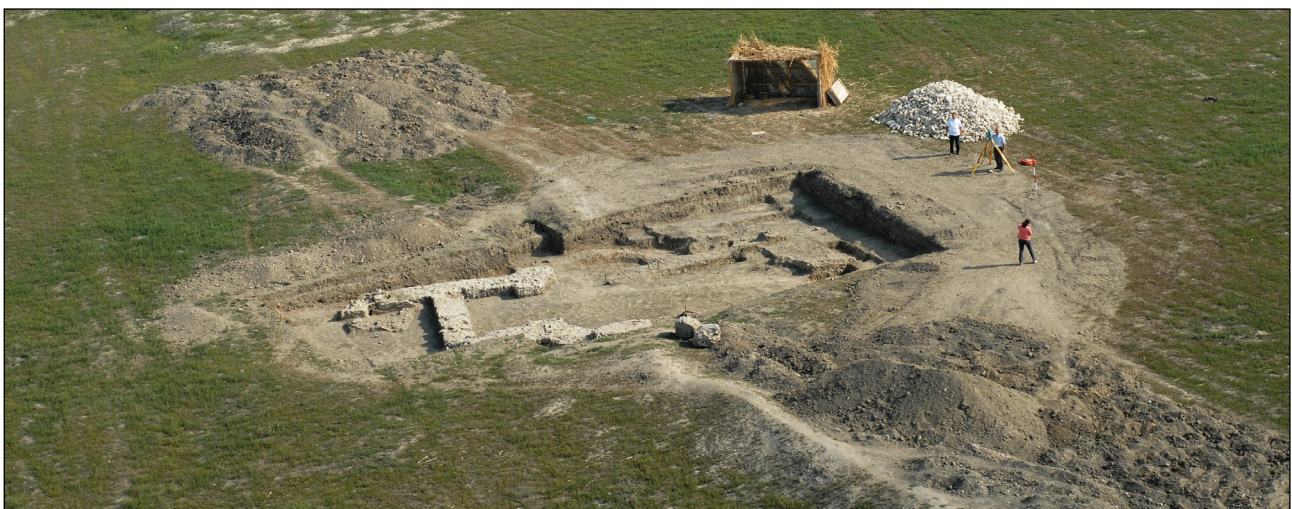
Fig. 5. Church no.2. Aerial view

The second monument was discovered approx. 300 m north-west from the first church, on the left bank of the old bed of Ialomița River. The building is built in a triconch plan, 18 x 11 m in size. The nave is in a rectangular shape and separated from the narthex by a thick wall, of 0.70 m. Foundations are partially preserved and covered in soil. (fig. 5)

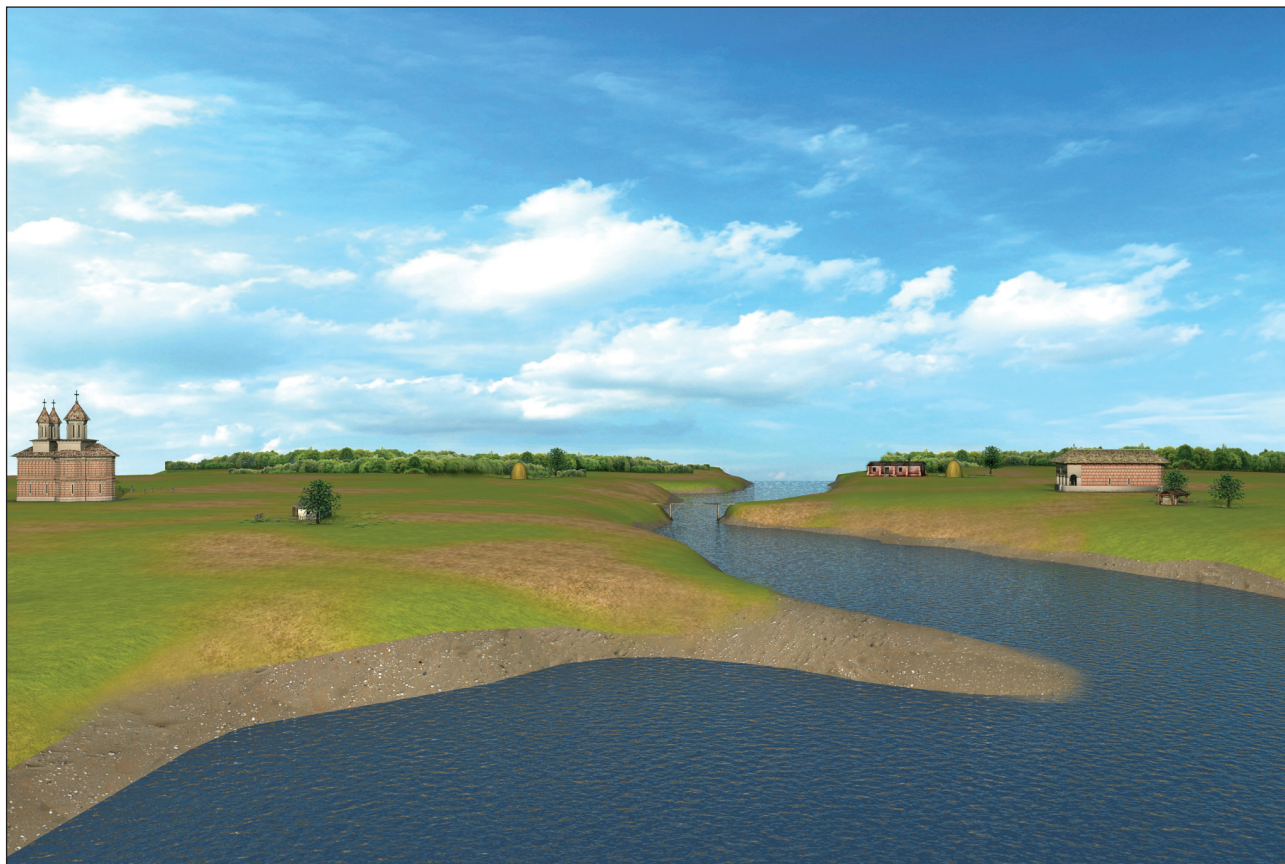
Fig. 7. 3D reconstruction. Medieval town Oraşul de Floci

In November 2009, starting from the Programme initiated by the Council of Europe, the museum was finished and officially opened to the public. The centre is based on the image of a medieval town, of the other edifices discovered during the investigations, the major attraction of the museum being the 3D reconstructions of the most important religious and civil edifices discovered at Orașul de Floci. (fig 7, 8) Also, besides the site museum, the investment plan approved by the local council includes operational spaces for accommodation of archaeologists, as well as for processing and storage of archaeological artefacts. It is important
