The beginning

Laser tool and function

Author:

Federal Office for Care and Protection of Monuments, Austria, Department for Conservation (Bundesdenkmalamt)

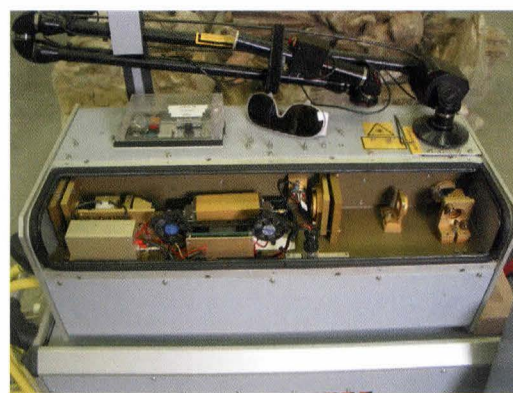
Fig. 2. Example: The inside of the Palladio Laser from Quanta Systems. The small box in the middle includes the artificial YAG crystal, which produces the monochromatic laser light (1064 and 532 nm). The transmission of the laser beam is caused by mirrors. This tool is qualified to the work on the scaffolding.

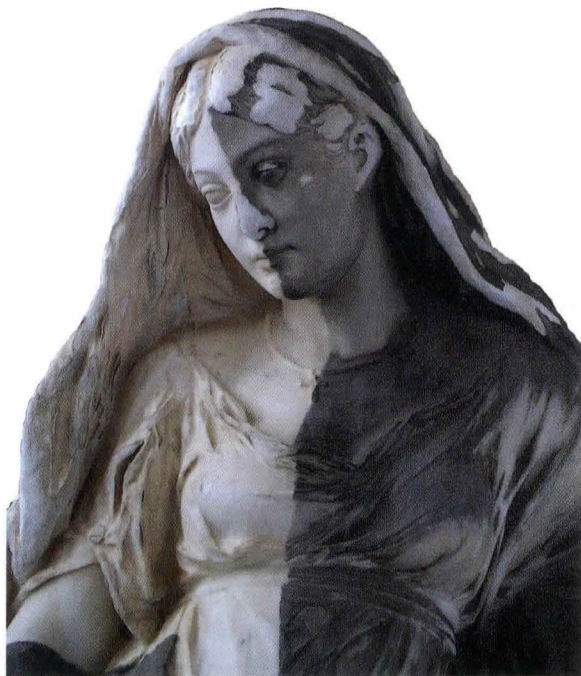
Fig. 4. half cleaned marble sculpture

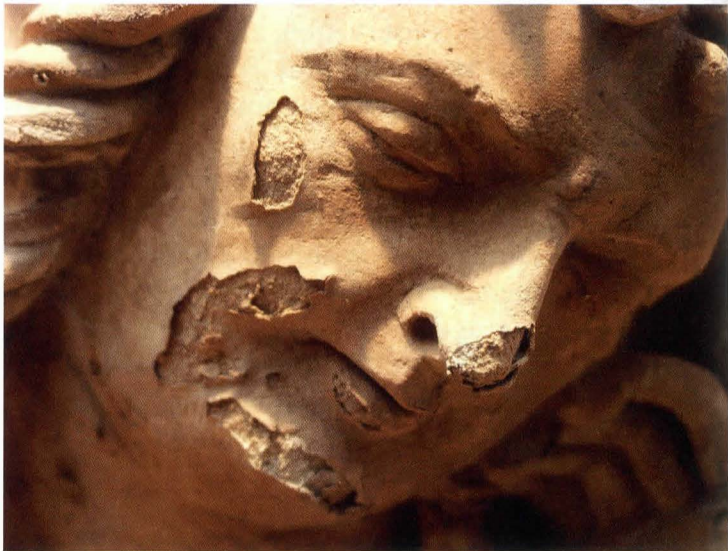
Fig. 5. Sensitive cleaning of scales on a sandstone surface

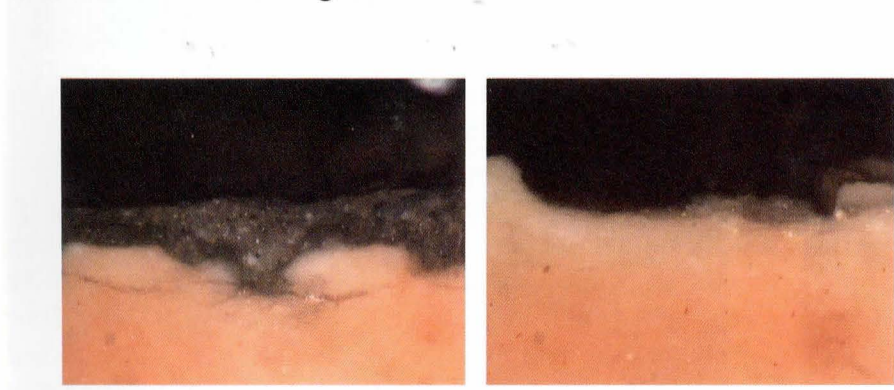
Fig. 6. Photo from a cross section of a red limestone under the light microscope before and after laser cleaning

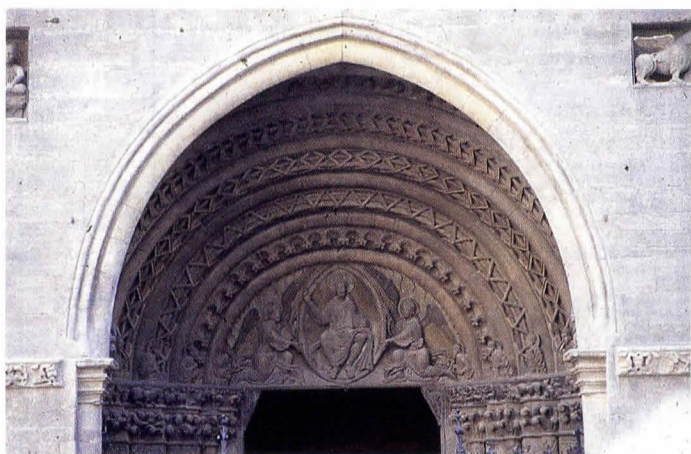
Fig. 8. St. Stephens cathedral, west portal after laser cleaning and conservation

facades were cleaned by laser technique (e.g. Romanesque and Gothic parts from St. Stephens Cathedral (**Fig. 8 and 9**), marble sculptures from the parliament and public gardens, Gothic outdoor sculptures and facades from many other churches and buildings). Four different types of modified Nd:YAG-lasers were used.

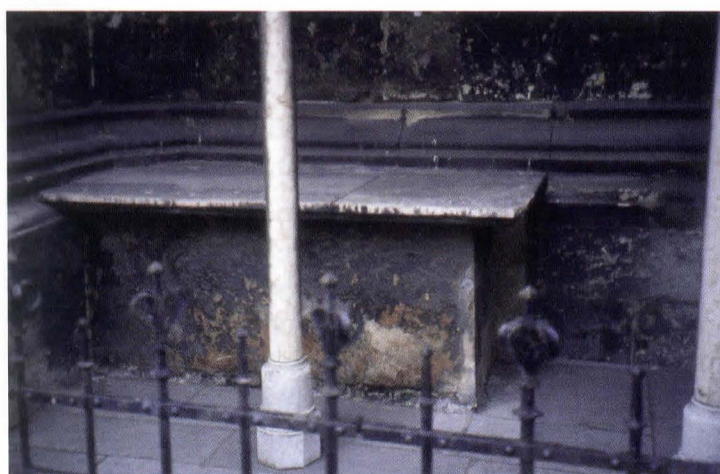
Fig. 10. The tomb before laser treatment

The tomb of an Austrian Minnesingers called Neidhart Fuchs is one of 140 other grave monuments outside of St. Stephens cathedral. It was made around 1360 and consists of a rectangular stone tomb, a formal reduced lying sculpture and a relief torso. The sculpture and the relief torso are made out of local calcareous sandstone. Originally these parts of the tomb had a totally polychrome surface. The coloration was very intense and the oil-painting was painted directly on the stone, without first ground. The used pigments are: cooper green for the hat, minium and lead white for the colour of the skin, azurite for the habit and the bolster with an inner-painting in lead-tin-yellow, iron-oxide-red for the hair, cinnabar for the outer-coat, ochre as ground for the gilding of the belt and lead-tin – yellow for the background of the coat of arms. But only traces of these colours can be found on the original surface. Most surface areas of the sculpture are reduced by weathering, black-crust-formations and mechanical damage. The stone shows a lot of cracks, a loss of binder under the black crust and a high amount of chlorides and nitrates. The cleaning, conservation and restoration is based on the results, which was applied at the west portal of St. Stephens Cathedral.

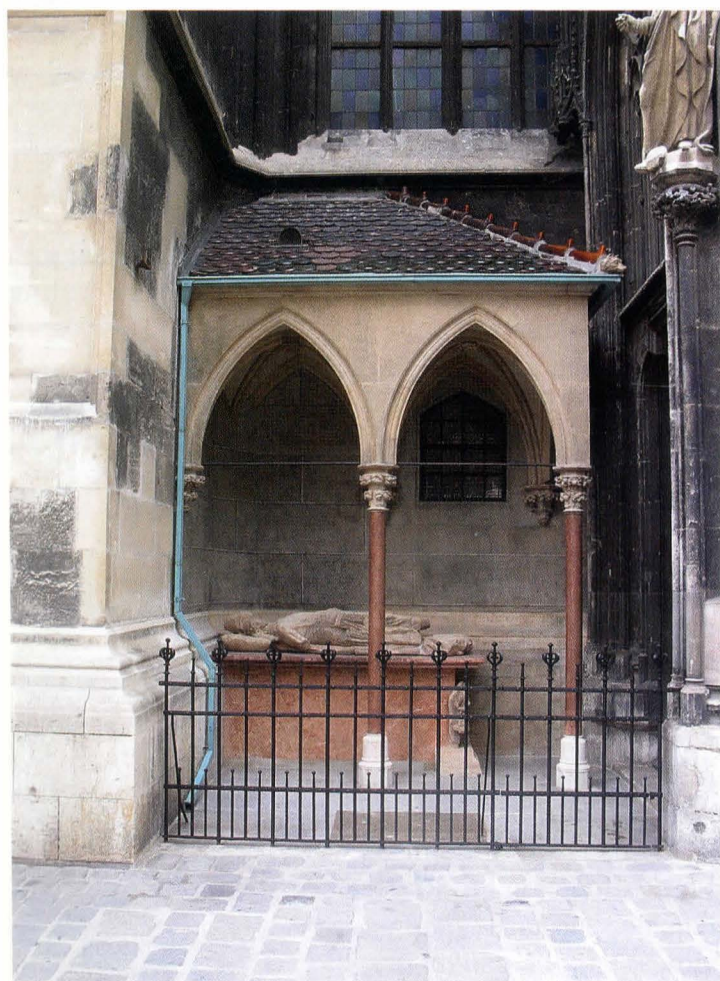
Fig. 12. The tomb after laser cleaning and conservation
