José Gonçalves

Resume

Summary

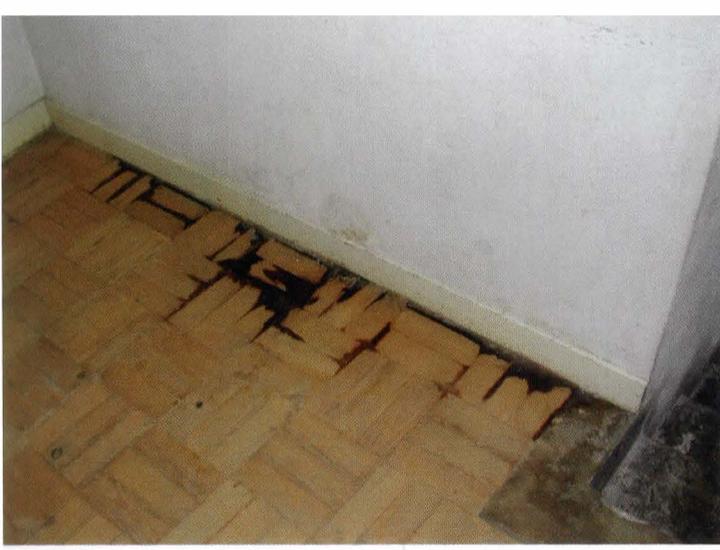
Fig. 1. Humidity in floor

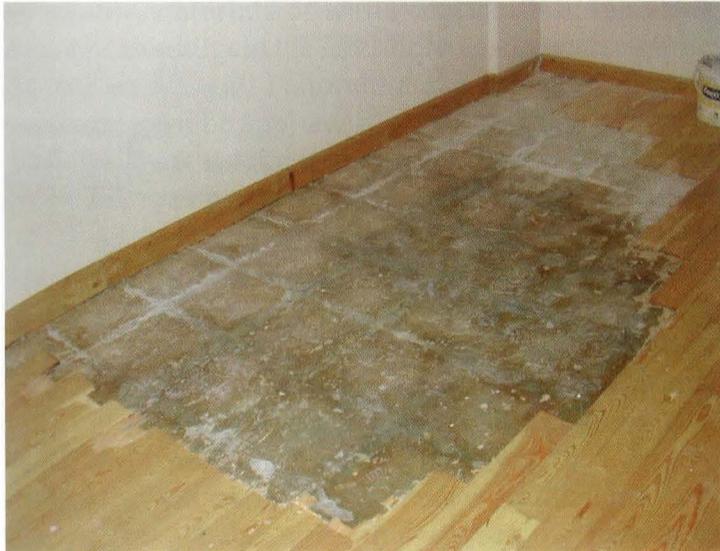
Fig. 2. Damage floor due to humidity

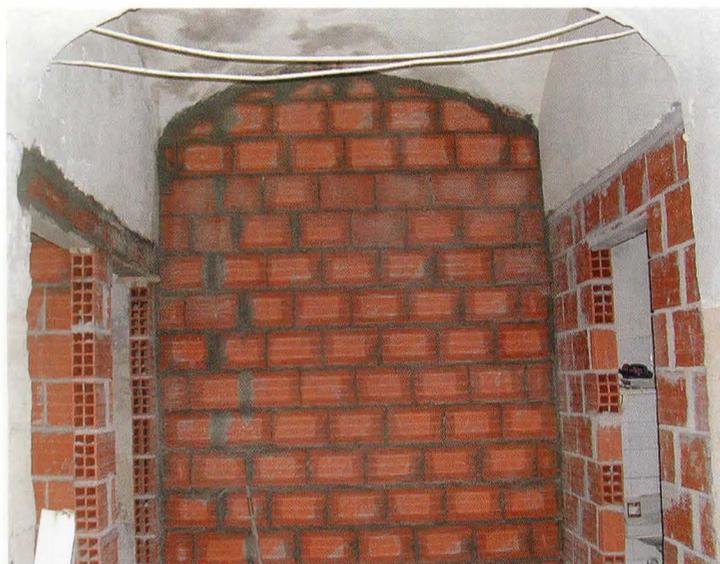
Fig. 3. Construction humidity

The manifestation of humidity due to the construction is a problem that is apparently overcome by the passage of time and its consequences on the construction behaviour and response. This is not ultimately true because it is always possible that the building has been repaired with a modern material using ancient techniques or has suffered from an important alteration in its constitution or organization. That is the example of new floor rehabilitation in which the wood planks had not conveniently dried before application and start to adjust due to water loss (Fig. 1, 2 – Teatro Nacional de São Carlos, Lisbon), or even some mortar application in old surfaces with water transmission inside the walls and consequent moisture migration to their exterior layers. (Fig. 3 – Teatro Nacional de São Carlos, Lisbon).

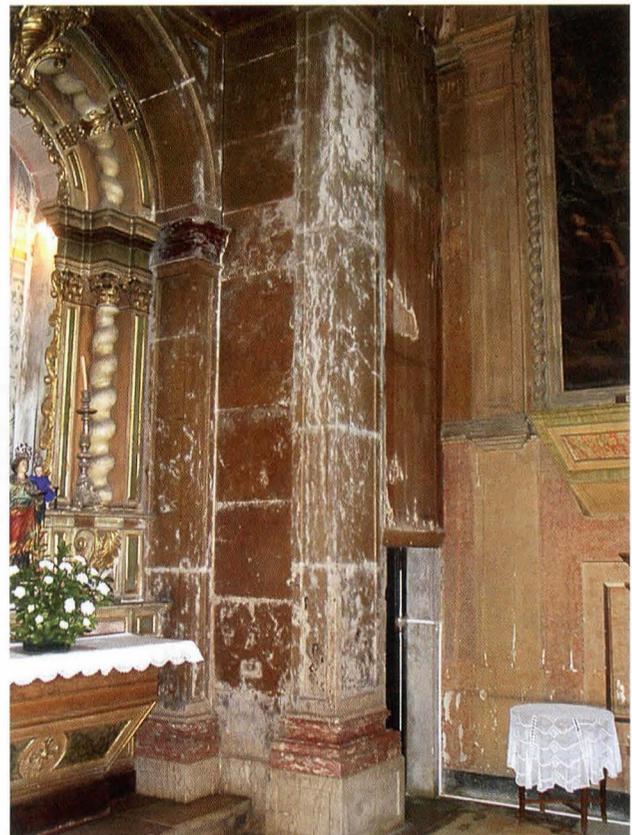
Fig. 4. Ground Humidity

The humidity from the ground beneath the building is always the consequence of hydraulic changes in the foundation that causes the migration of water trough the walls and foundation materials until the water reach the higher levels of the walls inside the building or the floor elements at ground level (Fig. 4, 5 – Igreja de São Miguel, Lisbon).

A usually alteration in the moisture content of the ground is when the conditions around the building change due to the application of impermeable materials like bituminous surfaces or hydraulic tiles in the area around the exterior walls in a urban intervention. That alteration prevents the water from the rain to infiltrate to the ground in the same

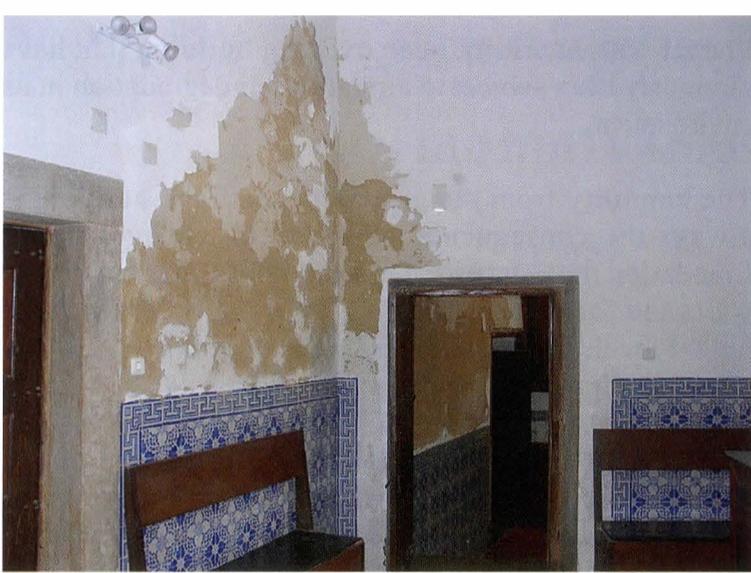
Fig. 5. Damages due to ground humidity

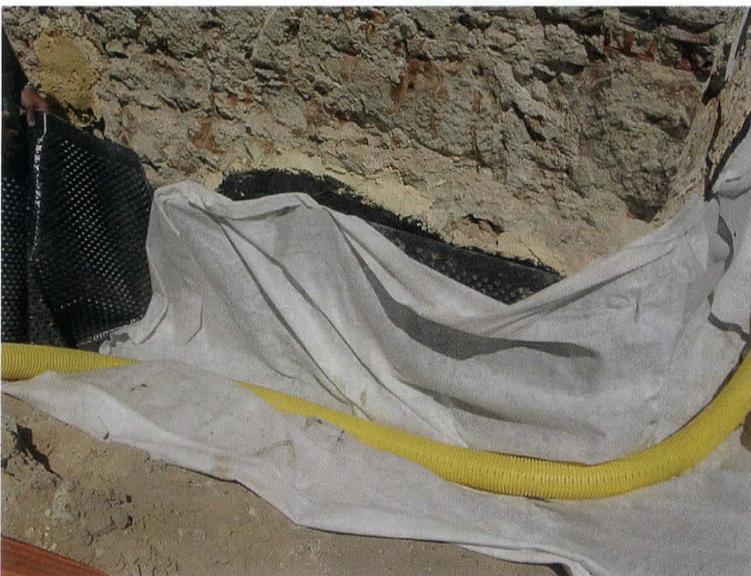
Fig. 6. Geo textil on draining solution

The solution, in this case, is an easy one. All we have to do is dig a water barrier around the exterior walls of the building and, with the application of water proof solutions like polyethylene membranes or geo textile materials to block the access of water in its way to reach the outer layers of the walls. This solution must be completed with an efficient method of conducting the water to an existing draining system, with convenient drilled tubes placed in the lower level of the water barrier and the use of small rock sand to facilitate the water migration to the draining tubes (Fig. 6, 7, 8; Drawings 1, 2 – Capela de São Sebastião, Moita).

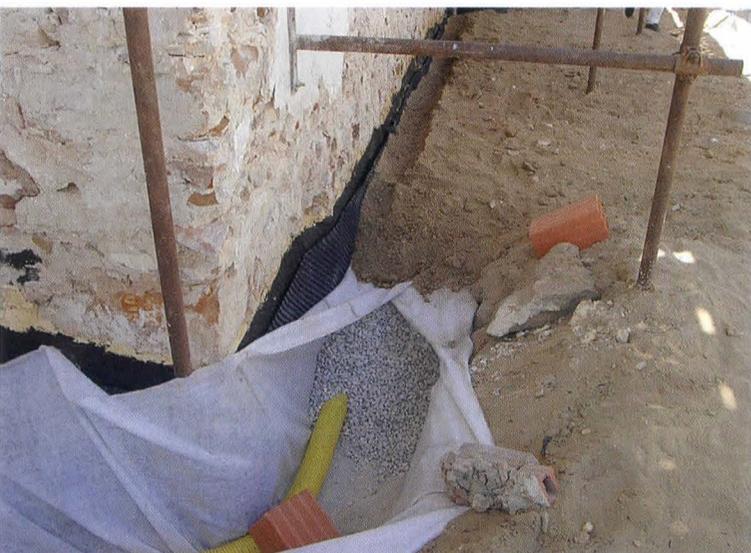
Fig. 7. Draining solution materials

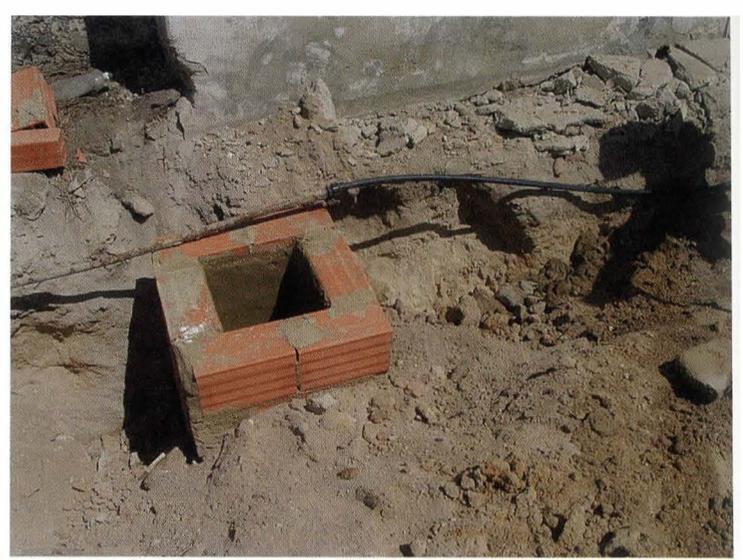
Fig. 8 . Sewer Box of draining solution

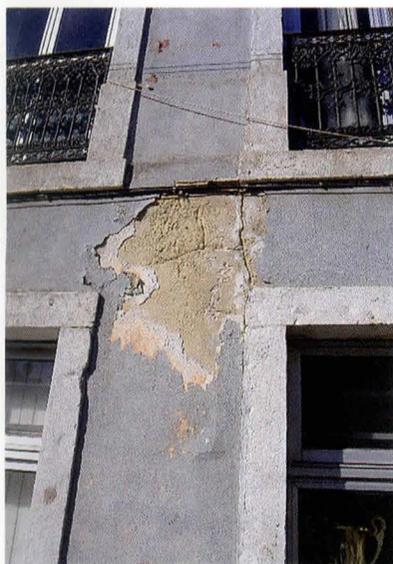
Fig. 9. Loss of paint due to incompatibility of materials

The water migration inside a wall is not only a cause for major alarm and concern due to the consequences for the existing materials but also because of the long time effect of salts dissolution and future crystallization in the outer layers of the walls that causes the premature degradation of the element (**Fig. 9** – Edifício do Café Barreiro, Barreiro).

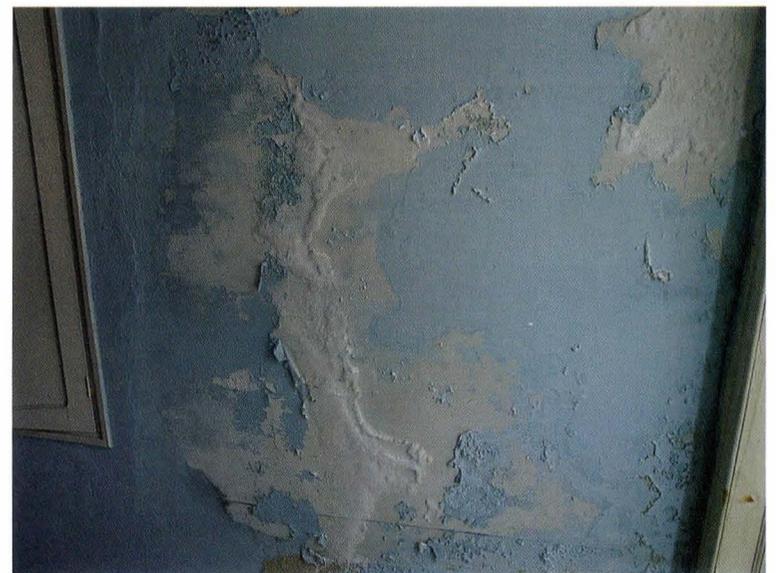
Fig.10. Salt migration for exterior

Special care must be taken also with the use of modern water repellent painting systems that, as well as preventing the water passage to the inner layers of the walls, prevent the migration of the water vapour to the exterior, and, consequently, become non-adherent to the wall and fall after some time (**Fig. 10** – Edifício do Café Barreiro, Barreiro). In this case, lime based inks are preferably a better option for ancient walls because they allow a certain hydraulic equilibrium in both sides of the element, exposed to climatic conditions.

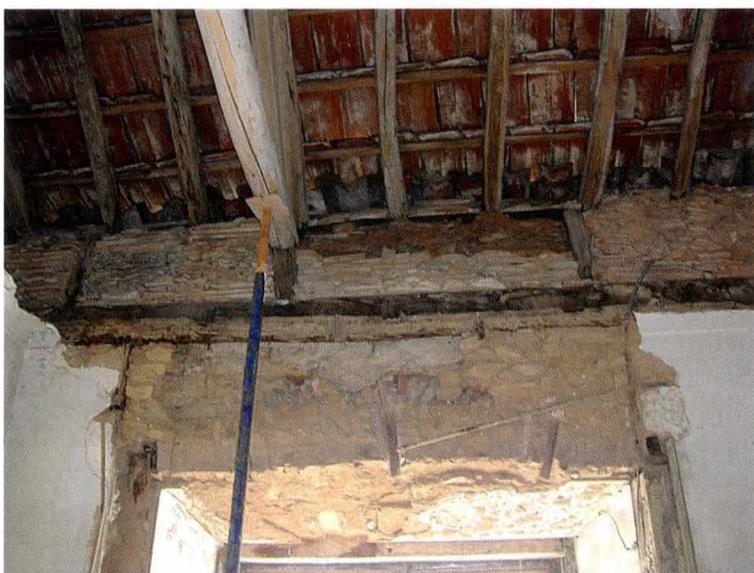
Fig. 11. Damage on structure due to infiltration

It is therefore of great significance the rehabilitation of all the horizontal elements that support the draining systems, like trusses, ceiling beams or structural frames, because their deformation or collapse leads to water problems in the building and the future loss of the remaining elements (**Fig. 11** – Convento de São Francisco, Tomar).

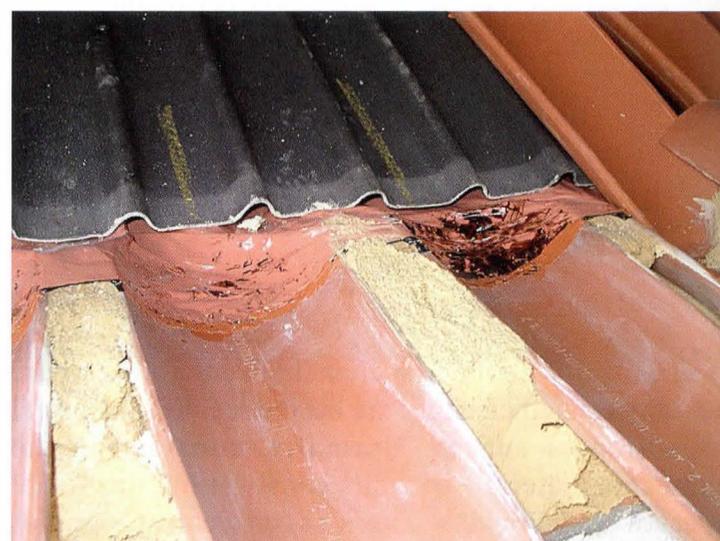
Fig. 13. Rain water protective element

involves the interposition of a water barrier material underneath the cover elements with no alteration of the final aspect of the building. These solutions are relatively easy to adjust to existing structures and modern water proof materials are generally of great quality in humidity prevention if all the actions concerning its maintenance are taken along the way (Fig. 12, 13 – Convento de São

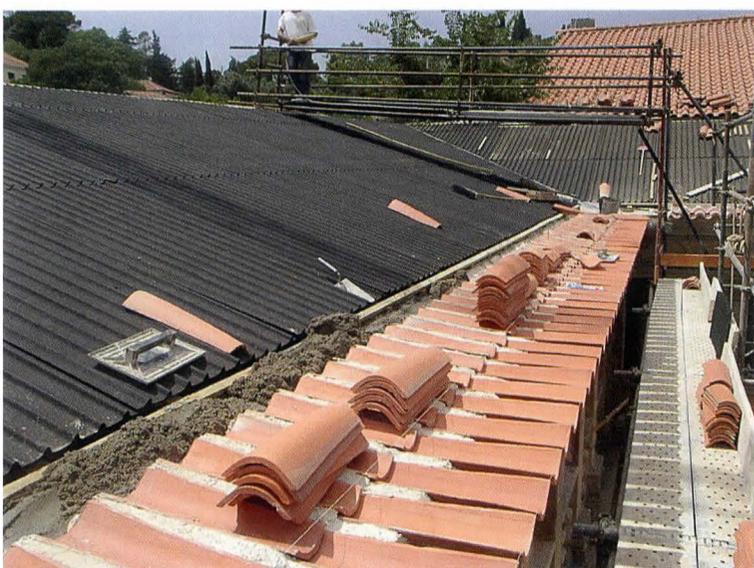
Fig. 12. Rain water protective elements

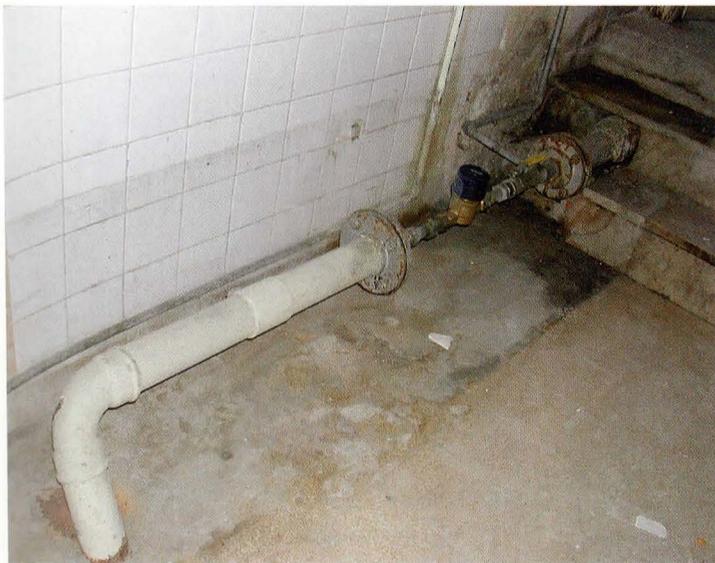
Fig. 14. Water supply pipes with leaks

Another completely different problem is some existing systems that have suffered from bad interventions in previous alteration processes or pretence reparations with non adequate materials as mixing modern techniques with ancient concepts (Fig. 14 – Teatro Nacional de São Carlos, Lisbon).

That is the case of modern materials like plastic tubes in hot water supply systems that need a considerable dilatation space when applied in existing walls which have not been devised to receive those elements. In this case, a special technical duct should be considered and all the systems easily placed there for conservation and maintenance purposes.

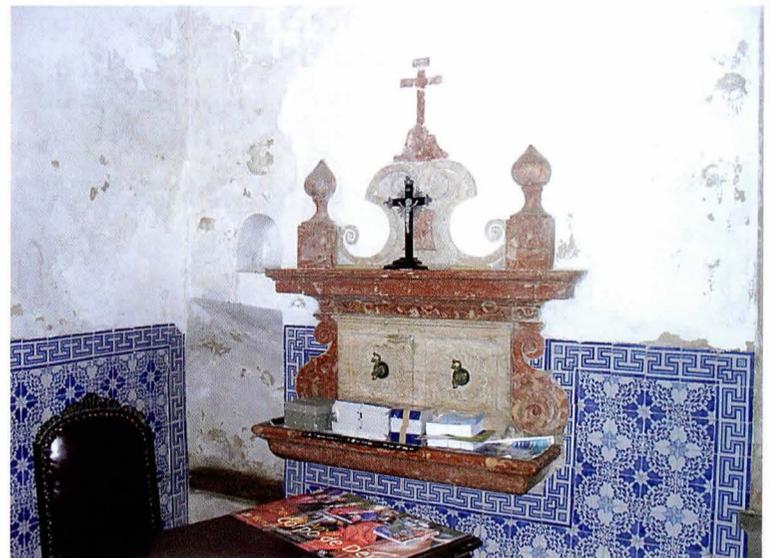
Fig. 15. Effect of condensation water

Condensation derives of the fact that air, in contact with cold environments turn into water, damaging the support material that was supposed to stay dry. This is apparently easy to solve applying insulation materials on the walls or by heating the interior of the zones where this occurrence is significant. The problem derives of the fact that with any changes in the moisture degree of the place, for example in kitchens, bathrooms or rooms with great number of people, the dryness capacity of the interior air is easily achieved and all the remaining moisture turn into water, with the known consequences for the material surfaces (Fig. 15 – Igreja de São Miguel, Lisbon).

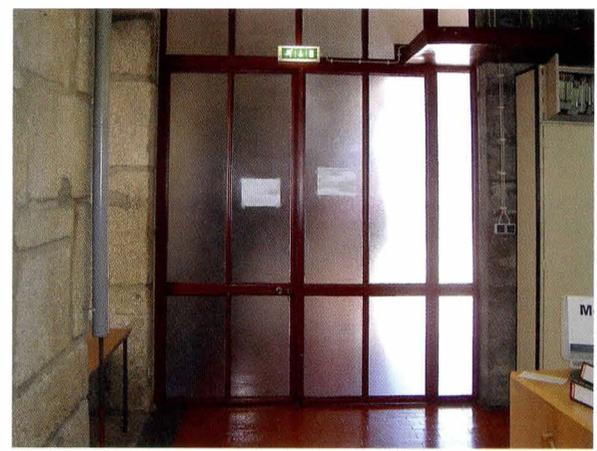
Fig. 16. Iron frame doors allowing some air penetration

infiltration and adjusting ventilation conditions to climatic environment with air permeable doors and window frames, using traditional materials like iron or wood (**Fig. 16** – Universidade da Beira Interior, Covilhã). In this case, application of modern materials such as aluminium and PVC should be considered only in a limited scale.
