Oliviu Boldura

THE PAINTING OF BĂLINEȘTI CHURCH

CERECS ART srl, Bucharest

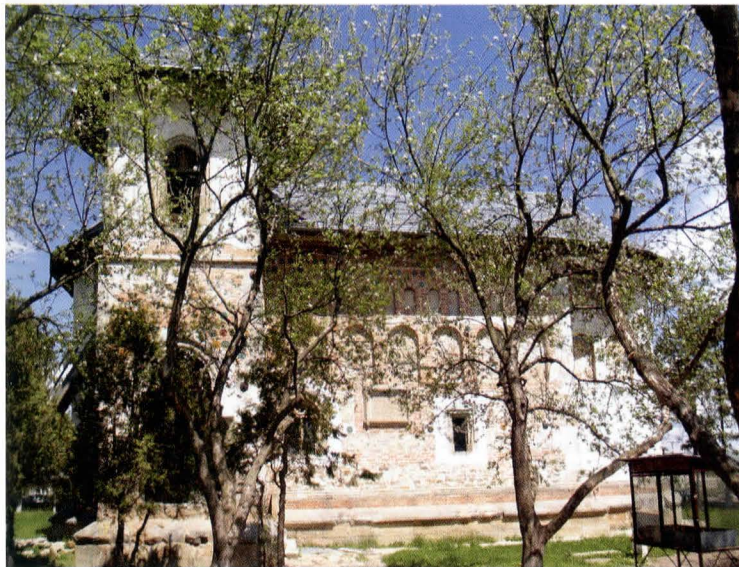
Fig.1. St. Nicholas church, Balinesti

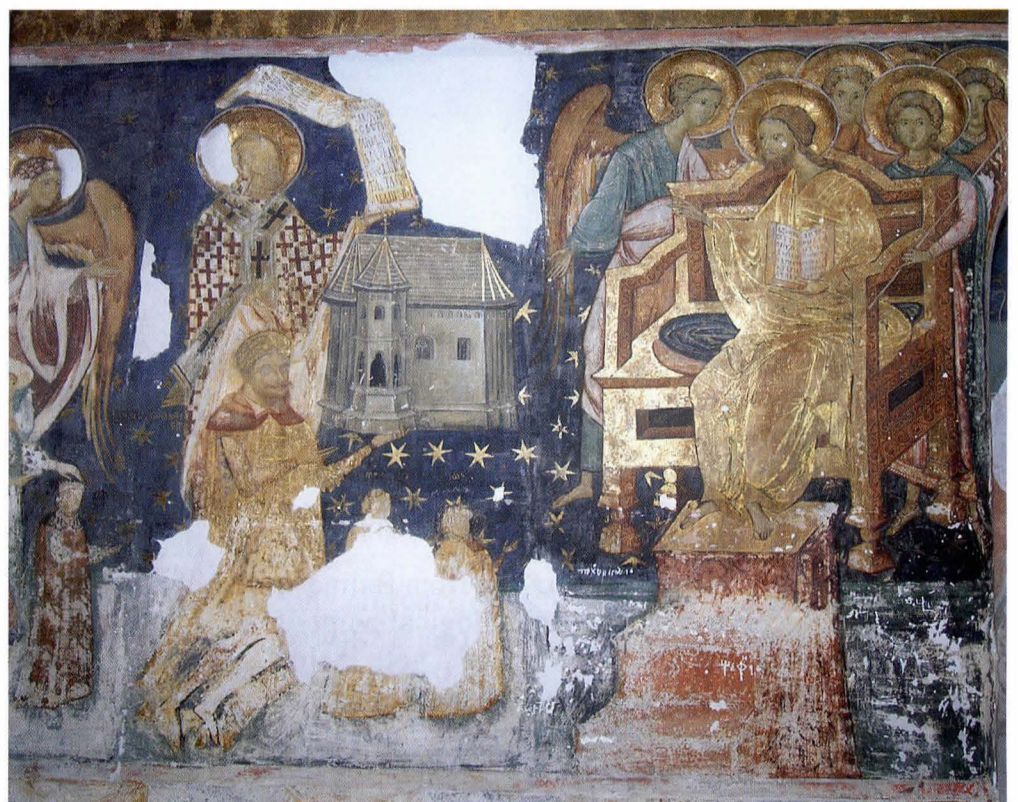
Fig.2. St. Nicholas church, Balinesti. Nave. Votive painting, after restoration

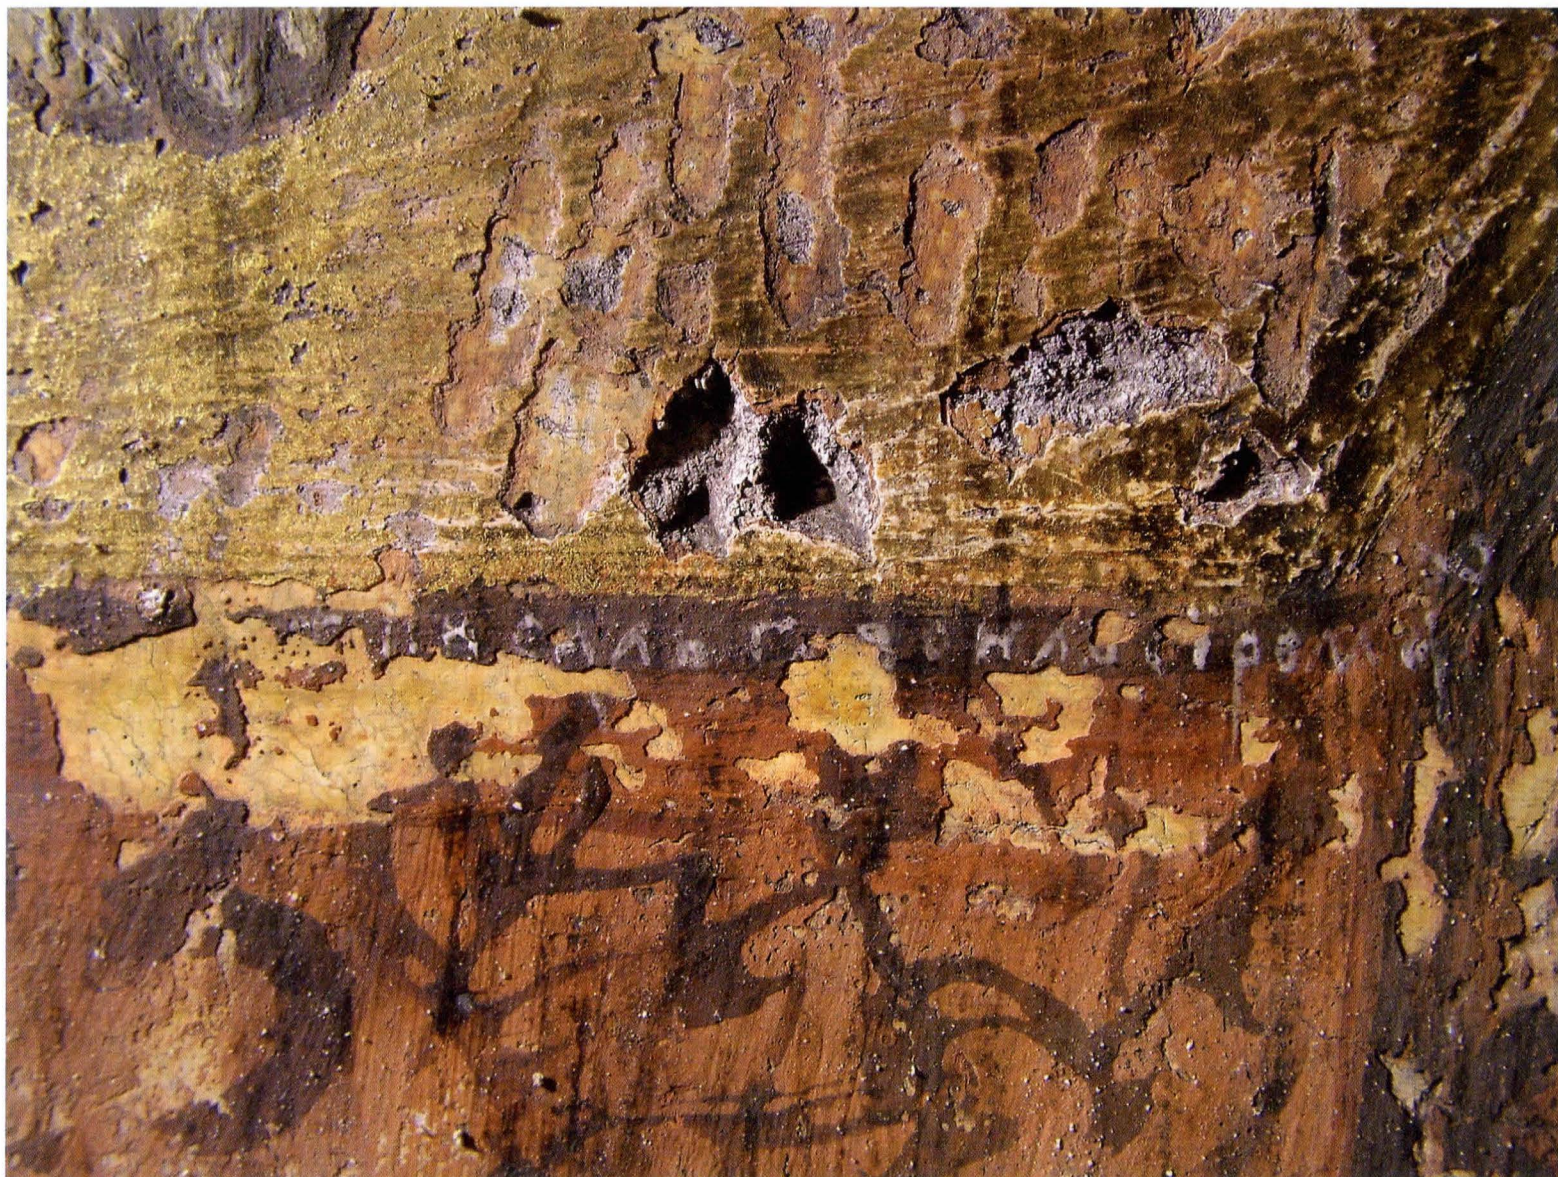
Fig. 3. The inscription of the painter

An important moment in the research of this church is constituted by the discovery accomplished in 1964 by Sorin Ulea related to the inscription that mentions the name of the painter. The researcher discovered this inscription on the votive painting at the base of the throne on which Jesus Christ sits, which tells us: “*Gavril the hieromonk wrote/painted*” (**Fig.3**). This painted text has a major importance as it offers us the name of the first known painter who signed on a wall ensemble from Moldavia.

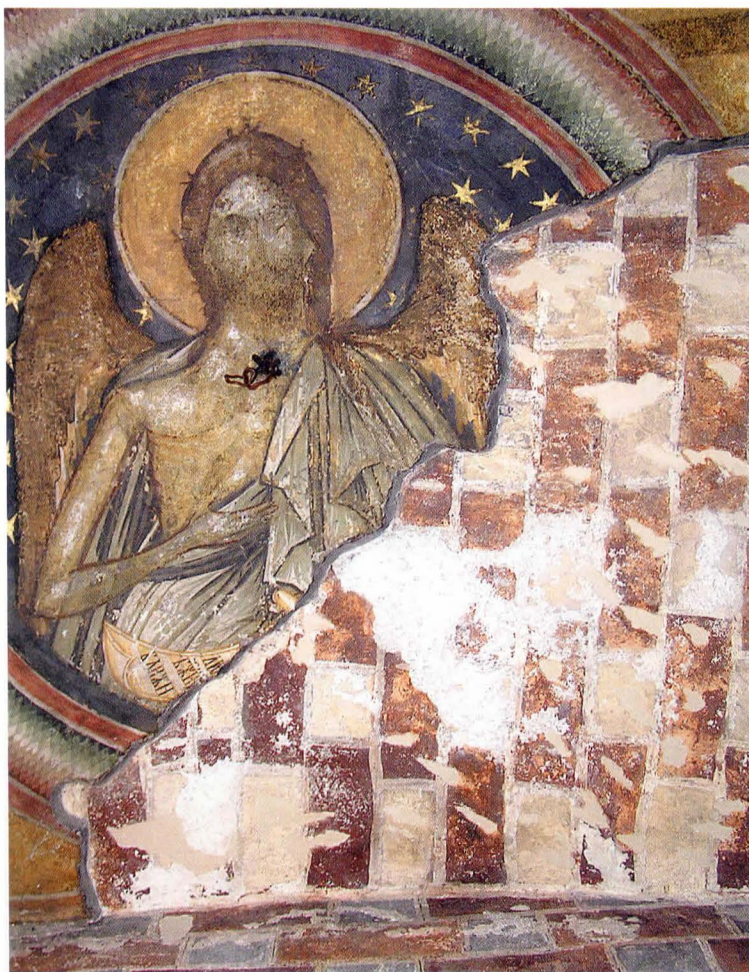
church. After the loss of the figurative wall painting on the lower areas and on the vaults, we can identify the first painted decoration mainly with geometrical elements, made up of horizontal rows of brick layers (**Fig.4**). This type of decorative painting is met on the whole surface inside the church as well as on the vault of the porch.

- **the second wall decoration, is a painting accomplished „a fresco”** applied over the first decoration. This painting layer covers great part of the church, but there are also some empty spaces, especially on the vaults because of the infiltration moisture.

Fig. 4. The two painted layers of the church

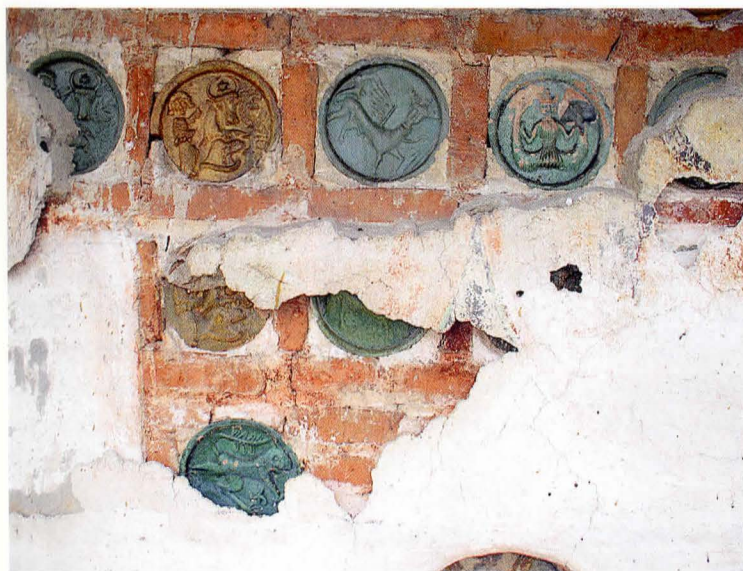
The external painting covered the entire church and was applied directly on the wall, covering the first decoration with ceramic plates of the higher areas (Fig. 5, 6). There are still maintained fragments of it on the altar layer, on the steeple and partially on the Western side where the colour layer is eroded by the mechanical action of the winds.

Fig. 5. Exterior wall of the chancel. Superposition of the murals over the enameled disks

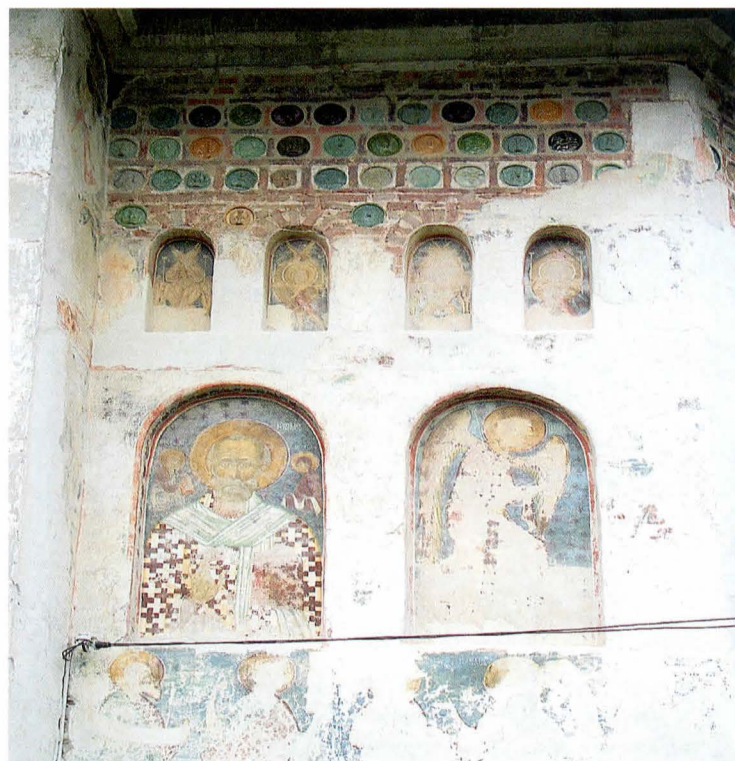
Fig. 6. Chancel apse. Outside

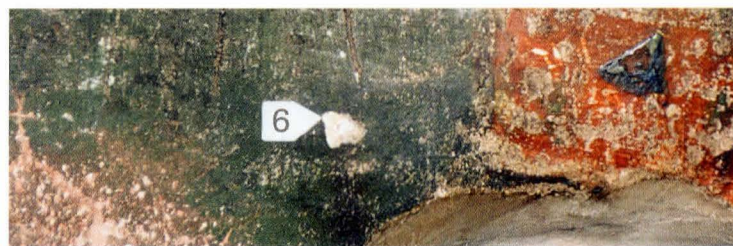
Through lab **physical – chemical analyses** they aimed at knowing original materials (pigments, mortar), their chemical composition and dosage of the mortar as well as the identification of the cases of abnormal alteration of the colour layer, especially of the pigments and their delimitation by the notion of “shade”. The pigments identified on the wall painting are those used in that age: azurite blue (used for backgrounds and applied on a black layer of wood coal), ground green (Fig. 7, 8), red ochre, yellow ochre, white chalk and red cinnabar. The chromatic alterations are mainly determined by the

Fig. 7. Pigments identification by lab analysis

Fig. 8. Pigments identification by lab analysis

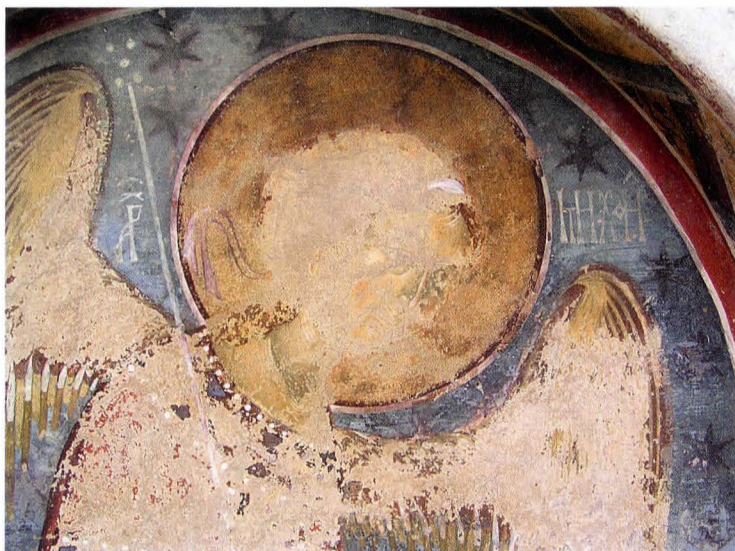
long presence of different types of moisture (capillarity or infiltration) that develops as shadowed extended surfaces. A particular case of alteration is determined by the reaction of burette that takes place under the conditions of an organic binding, in a basic environment and in the presence of copper ions. After this reaction a

Fig. 9. Pigments alteration due to "the burette reaction"

violet alteration takes place in the contact areas of white calcium carbonate that contains protean binding near the azurite pigment based on copper or gold decorations in copper alloying (Fig. 9).

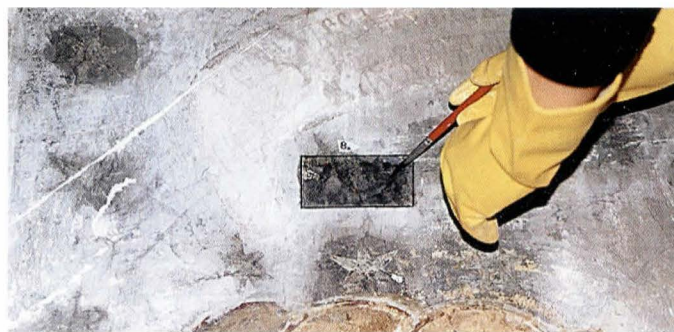
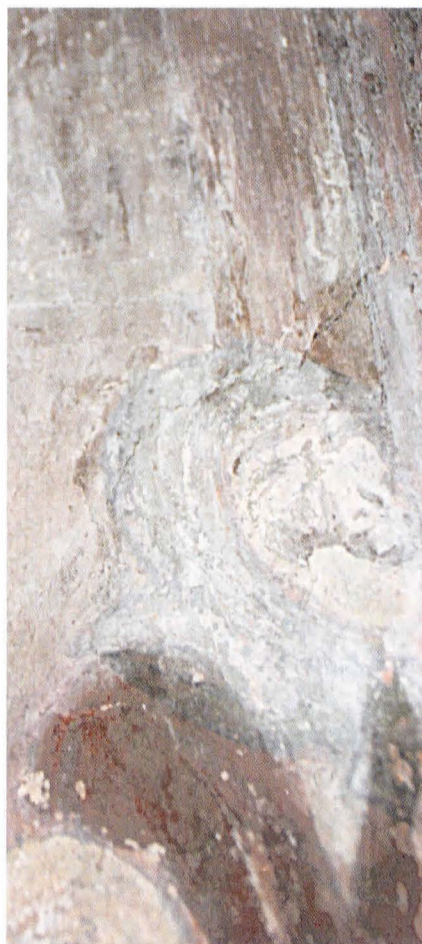
Out of the research of different types of accumulations on the wall painting surface various phenomena of biodegradation were noticed bare eyed and evidenced, inside by the heavy pungent smell and confirmed by the lab exam. The most affected areas are those where moisture of capillarity and infiltration acts. The microbiological forms developed easily in the presence of water, lack of light and optimal ventilation. Thus, inside were identified various types of bacteria such as *Aspergillus*, *Penicillium*, *Alteraria*, *Actinomycete* and other and outside developed colonies of lichens from various species such as: *Lecanora*, *Xanphoria*, *Parmelia*, *Physcia* and *Rhizocarpon*. As a consequence, the whole church was contaminated by an intense microbiologic

Fig. 10. Elimination of the biological attack. Tests

Fig. 11. Identification of the biological attack

Fig. 12. Tests for the elimination of the biological attack

attack, illustrated in the present work (Fig. 10, 11, 12).

On the surfaces marked by the microbiological formations we applied biocide treatments with Sintosept QR 15 (an ammonium quaternary salt) in a few stages on the whole surface. This treatment was applied after the cleaning and consolidation of the colour layer operations. Outside, after the biocide, the lichens were removed individually in order to regain the traces of the technological elements that were maintained on the original support layer marked by erosions.

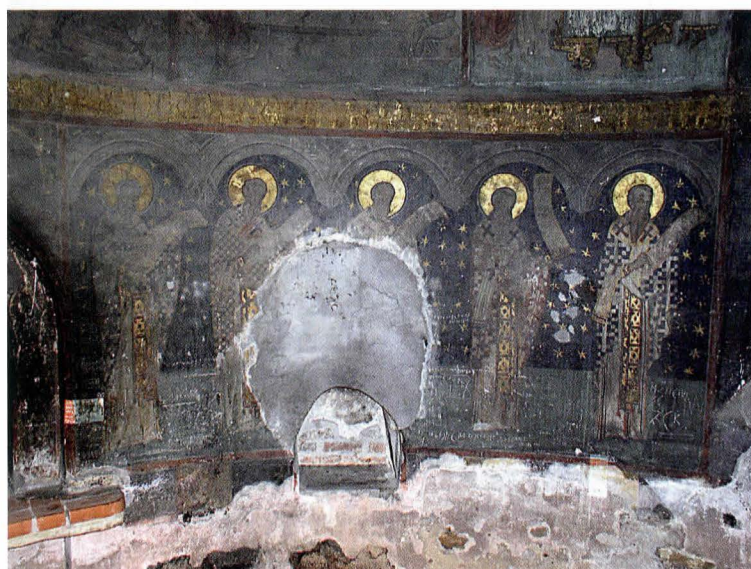
Moisture measurements undertaken inside the church indicates a high level of humidity reaching values superior to 8,6 in altar, nave and pronaos, up to a height of 2,00 m, diminishing in height (Fig. 13). As a consequence of capillarity moisture, on the lower part can be noticed a loss of the support layer cohesion due to the mechanical action of the salt crystallisation process. In the higher part, on the domes, vaults and archways, big areas affected by moisture of infiltration and a loss of the support layer adherence can be noticed.

Fig. 13. Chancel. Inside. Degradation and loss of the painting due to capillarity moisture

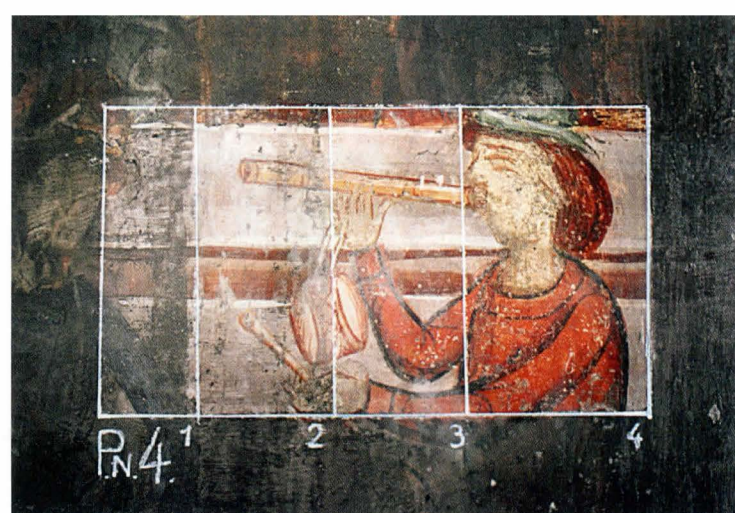
Fig. 14. Cleaning test

After the control and absorption tests done on the sample areas, we passed to the execution of different cleaning tests of adherent, and non-adherent deposits (of various nature – smoke, dust, wax, tars, etc), and the fixation of the degraded colour layer (Fig. 14). The tests continued on the areas with salt efflorescence as well as on the biological agents. In order to have control over the operations measurements of relative humidity and environmental temperature were done during the tests. These parameters registered in September 2003 varied inside between 19° C and 24° C, and the air relative humidity between 57,7% and 88,6%. The preservation state on each sample, the methodological details and the observations are accompanied by a photo illustration gathered under the form of records, which are part of this work.

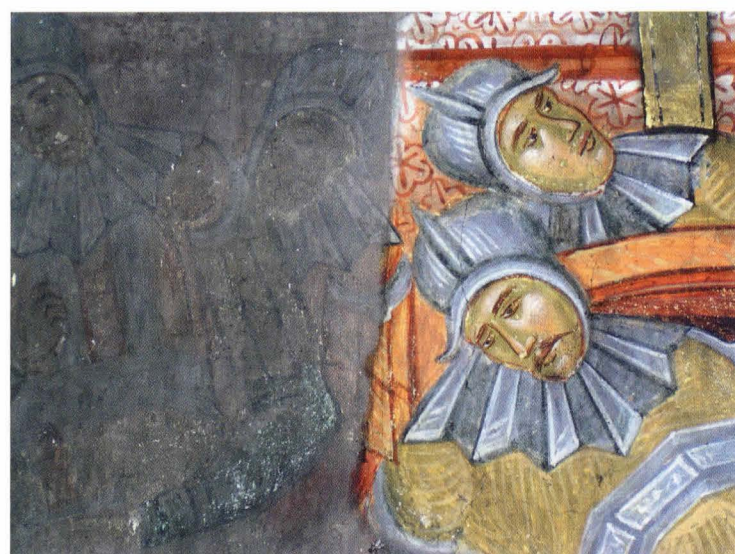
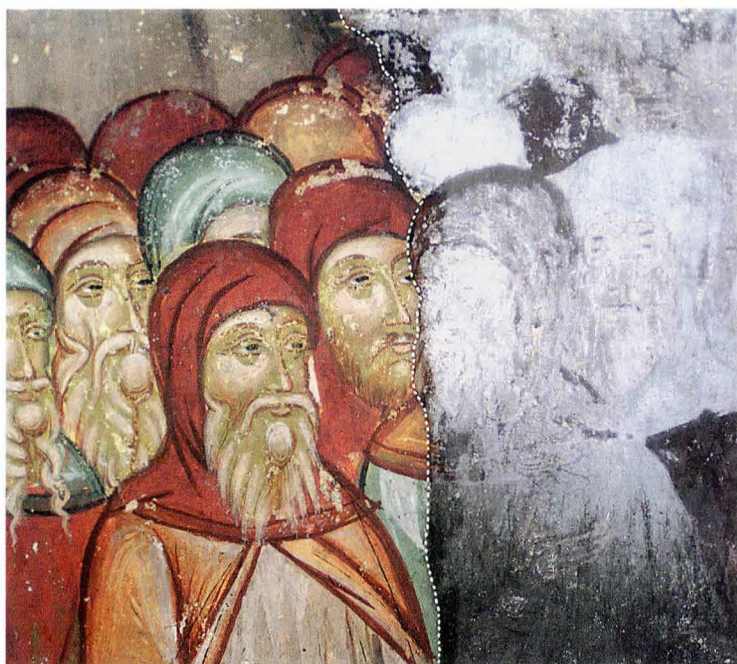
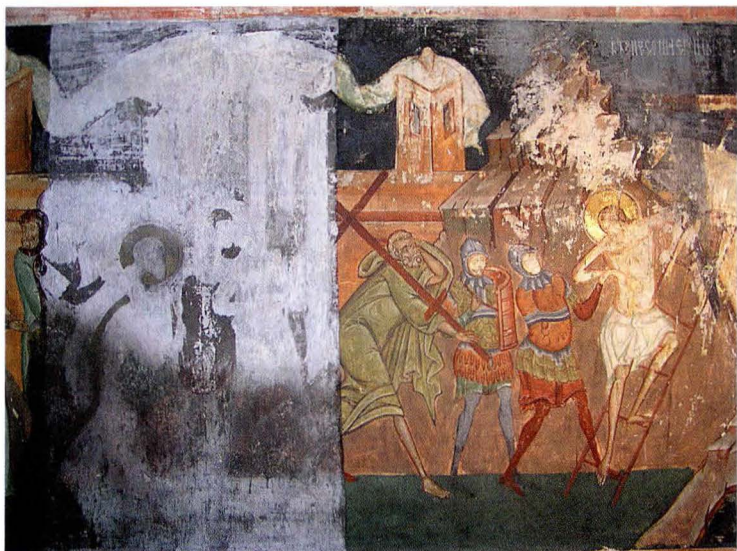
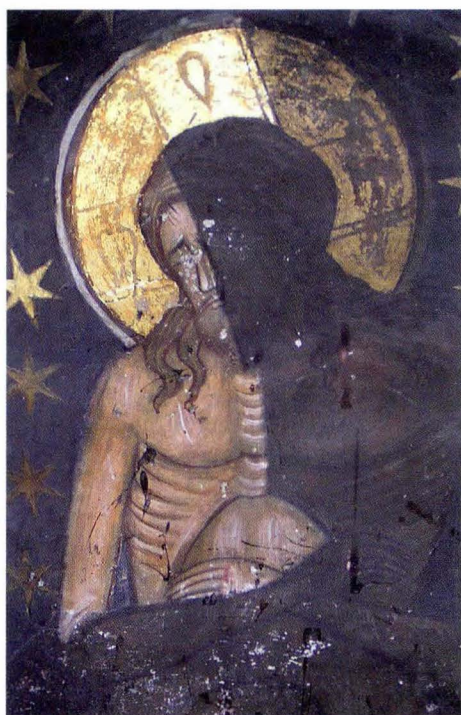
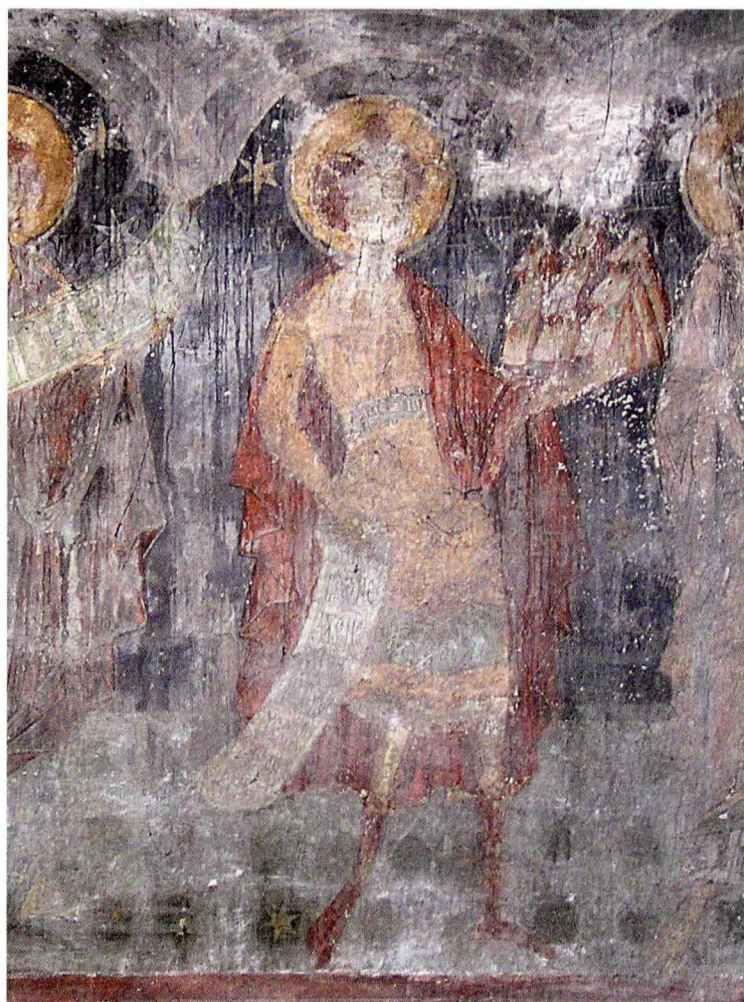
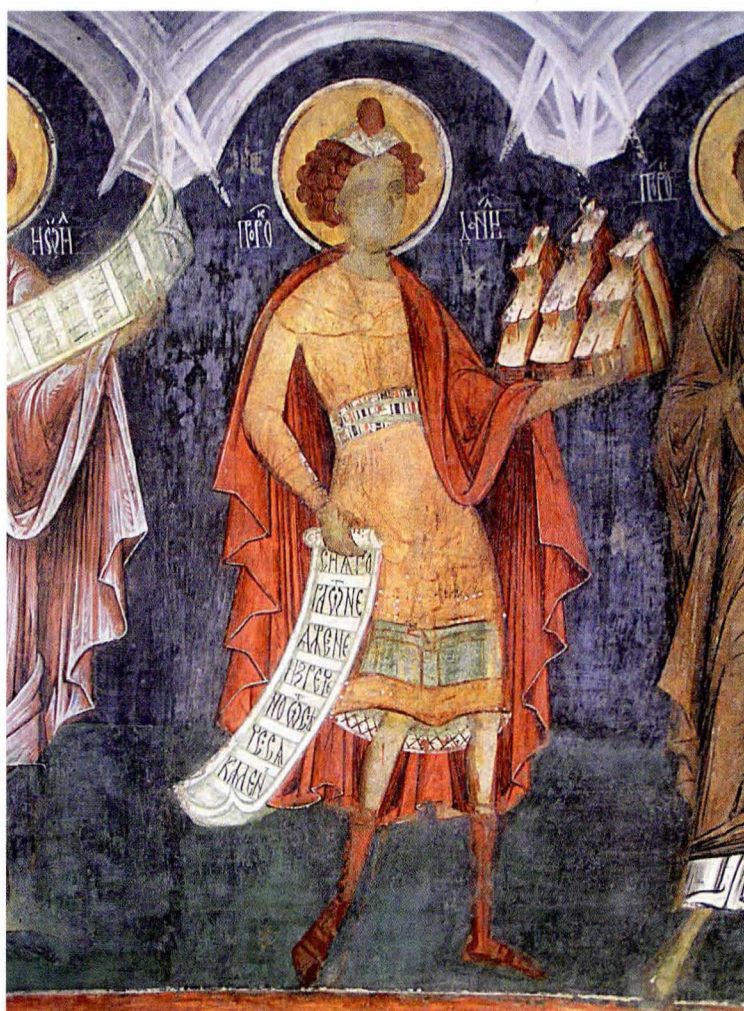
Fig. 15. Comparative zones during the cleaning

Fig. 16. Comparative zones during the cleaning

Fig. 19. Chancel. Inside. Before the intervention

Fig. 17. Comparative zones during the cleaning

Fig. 18. Comparative zones during the cleaning

Fig. 20. Chancel. Inside. The same after the intervention

The internal painting hardly legible because of the accumulations that covered it (dust, smoke, salts, biological formations, wax, etc) was cleaned in more stages. We approached separately the areas sensitive to various cleaning substances, like the backgrounds on which we found traces of azurite and gilded surfaces. These surfaces, very generous in the altar, were

cleaned with an alcohol substance. For the figurative or decorative elements we used wet ways of cleaning, with ammonium carbonate solutions (from 5% to 10%), or dry ways locally applied. The selective and differentiate approach permitted a unitary cleaning, reported to the preservation stage of every pigment. The esthetical recuperation is remarkable (Fig.15, 16, 17, 18, 19, 20).

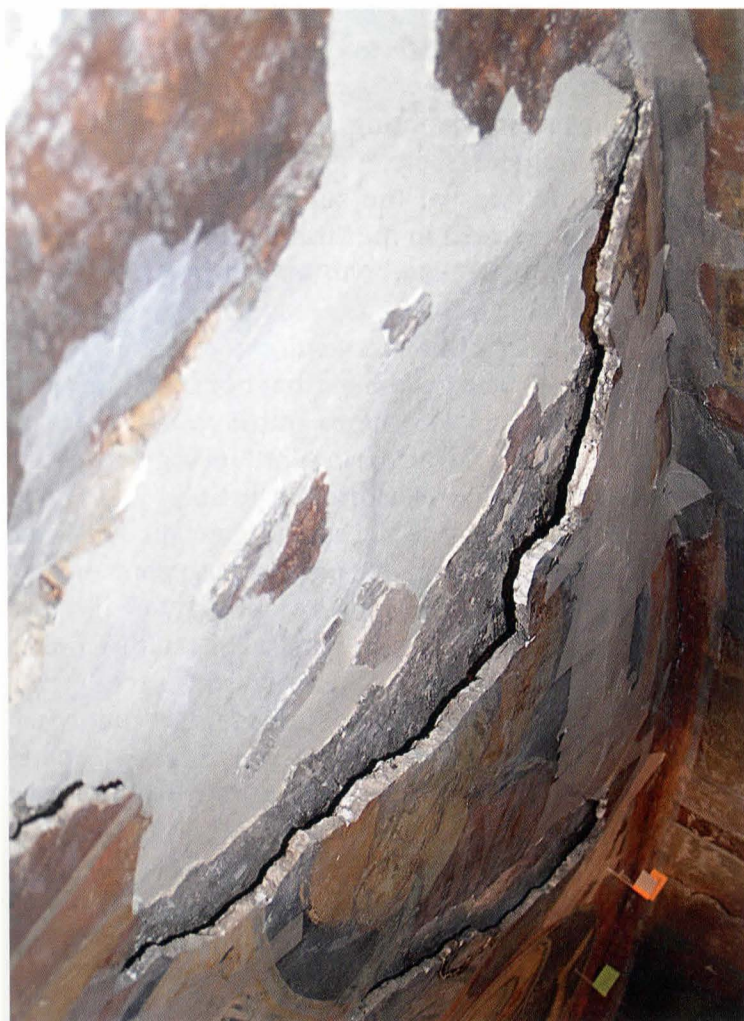
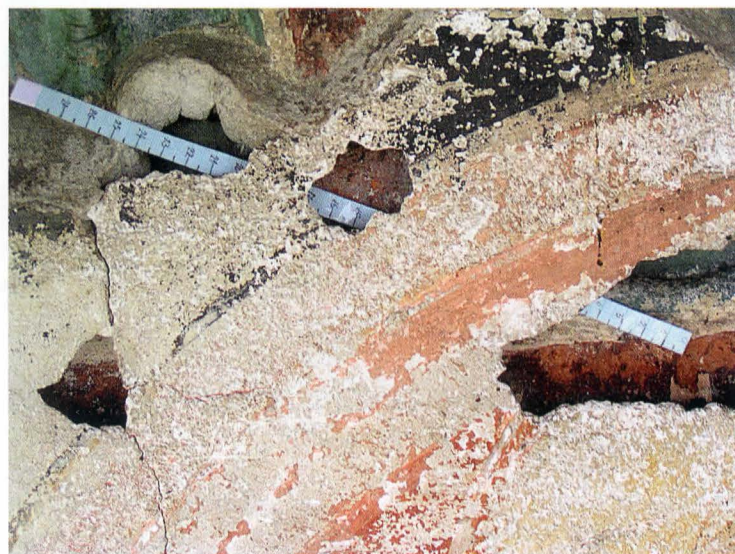
Fig. 21. Detachment of the painting layer

from Bălineşti is marked by great detachments between the two preparation layers and the wall structure (Fig. 21, 22). In fact, the painting of the vaults and the dome

Fig. 22. Detachment of the painting layer

of the altar was completely removed remaining suspended through self-support. For the remaking of the adhesion on such extended areas we decided the insurance with support props and local consolidation with anchorage points organised in a sustain network (Fig. 23, 24). The network of anchoring points began in the lower areas at a greater distance in the beginning (1

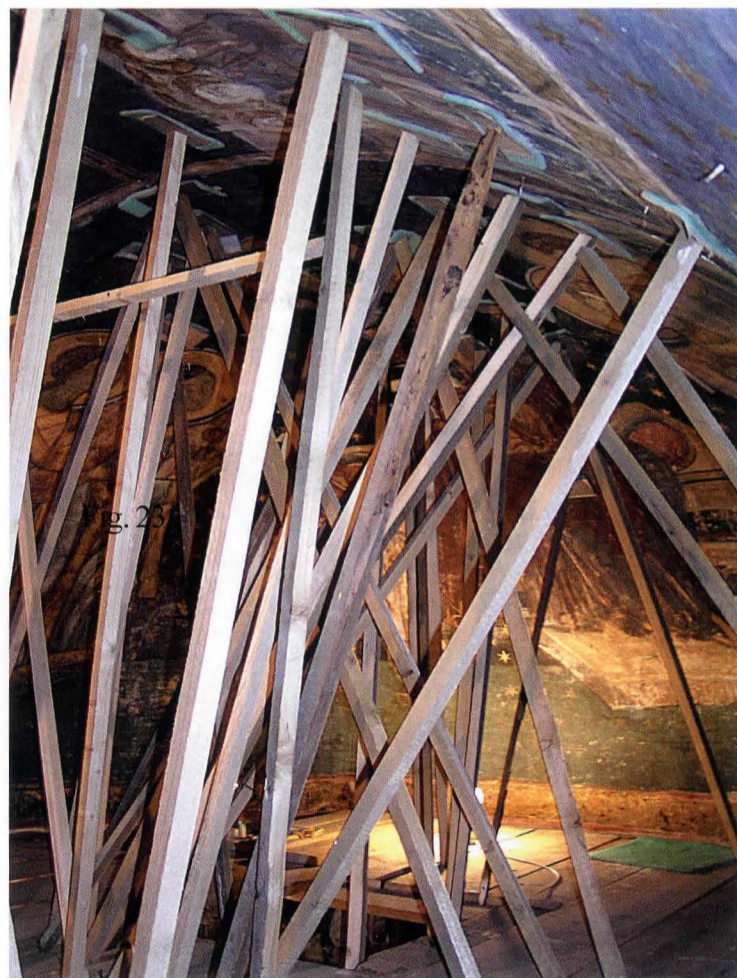
Fig. 23. Consolidation of the painting layer

Fig. 24. Consolidation of the painting layer

m) and more and more numerous as the consolidation advanced. The injection under pressure with PLM-AL

for vaults and PLM-A for vertical surfaces was made at an interval of 48 hours, period necessary for the strengthening of the consolidation introduced in the previous areas.

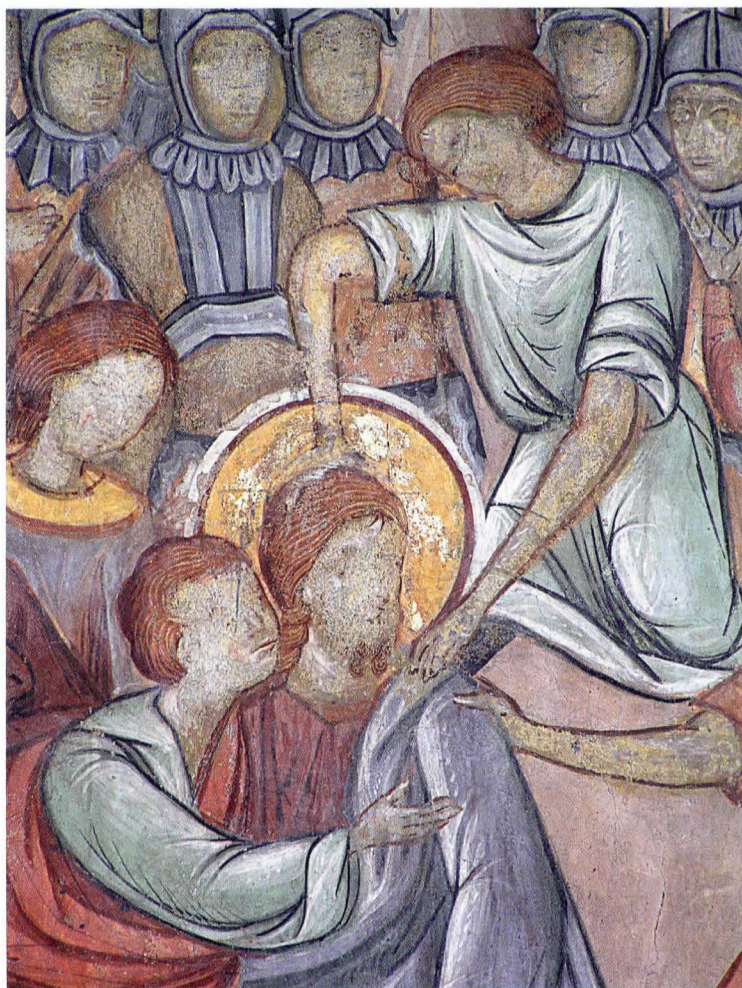
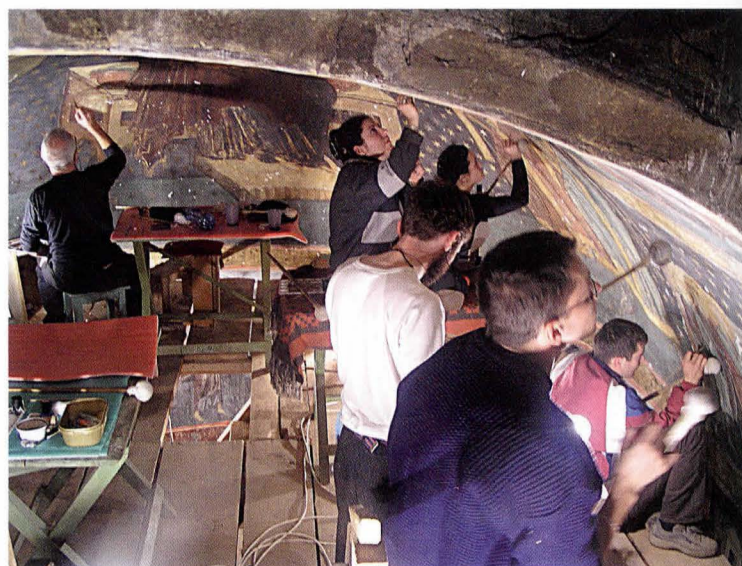
Fig. 25. Chromatic integration

Fig. 26. During the restoration process

The aesthetic presentation problems, as the final stage of restoration, showed us great incomplete surfaces as a result of the colour layer degradation. The white areas of various forms and sizes were differently approached, according to their problems. Thus, the colour erosions were chromatically integrated in the *velatura* technique by using neutral wash-tints of paint-wash (Fig. 25, 26).

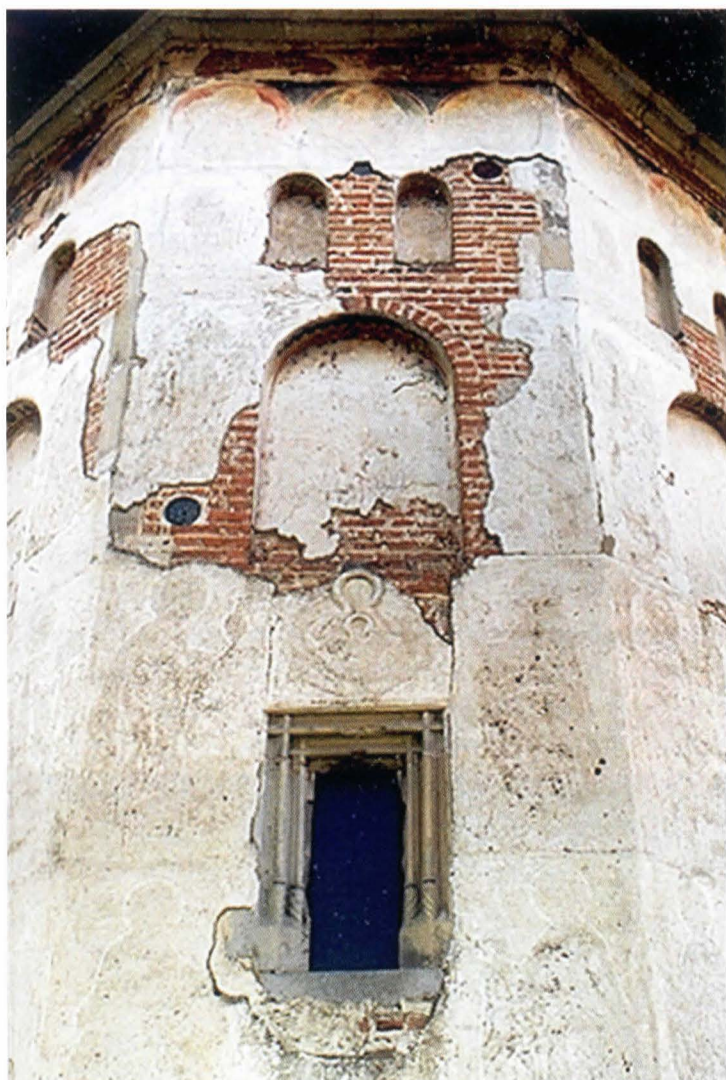
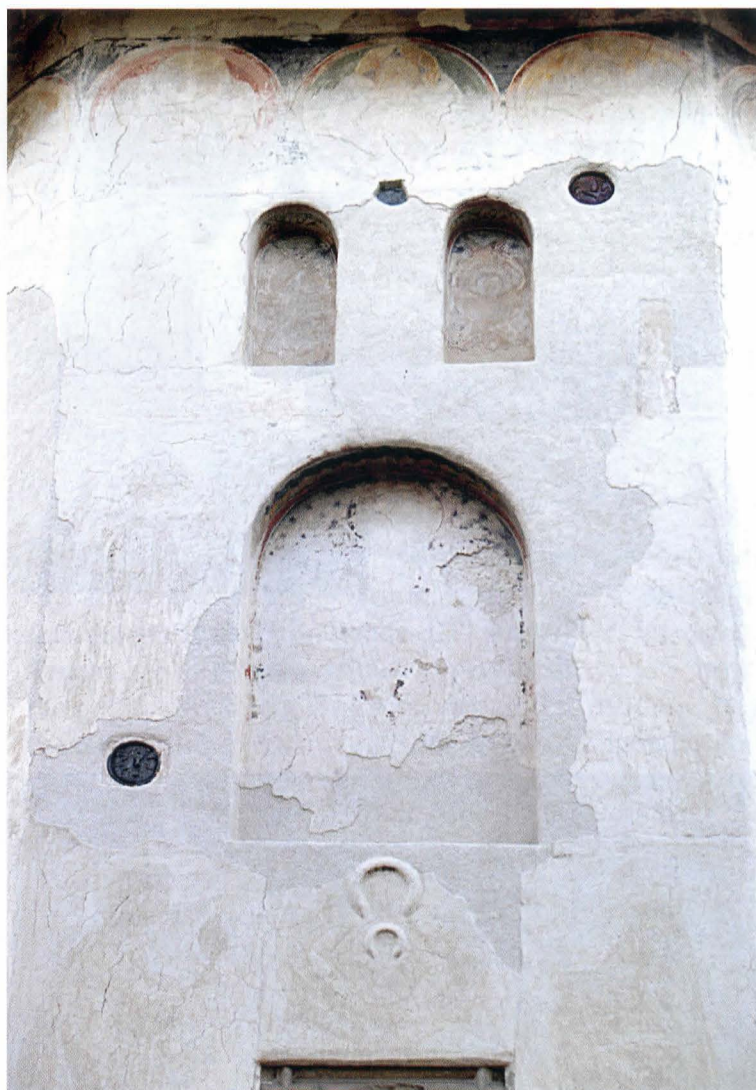
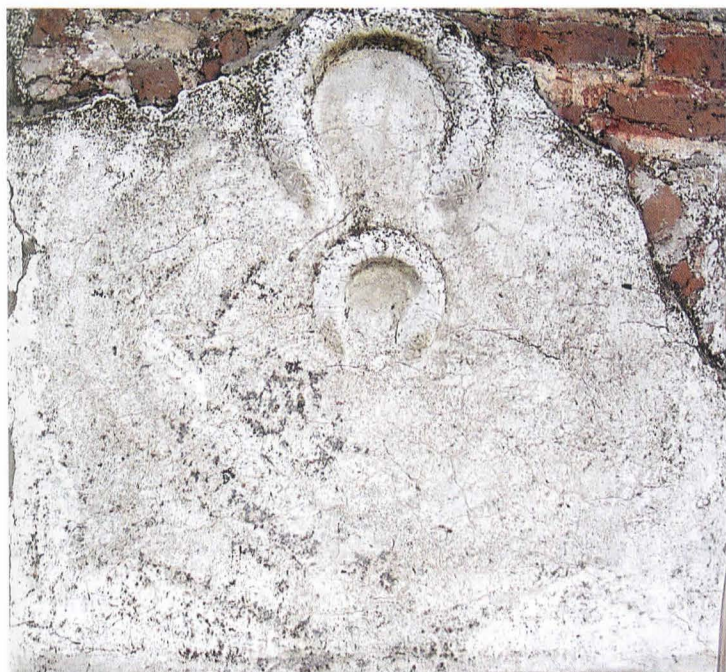
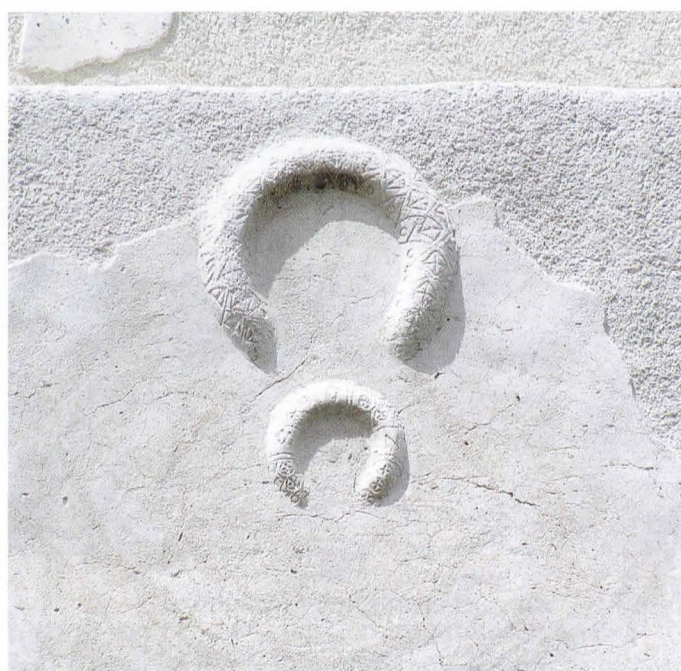
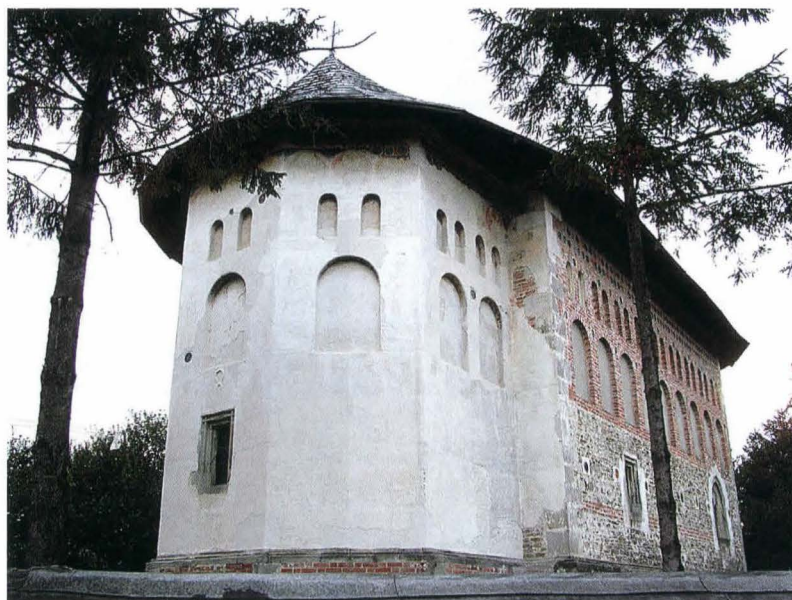
Fig. 27. Chancel apse. Before restoration

Fig. 28. Chancel apse. The same area, after restoration

Fig. 29. Chancel apse. Outside. Zone of the Virgin, before restoration

Fig. 30. Chancel apse. The same zone, after restoration

Fig. 31. St Nicholas church, seen from eastern part, after the restoration of the chancel

The integrable gaps of the support layer, previously puttied, are integrated in the “*tratteggio*” technique obtained through the decomposition and juxtaposition of some colourful vertical lines especially in primary shades. Outside, the difficulty of intervention consisted in removing the tough mortar of cement that bordered the paintings, as this material was deeply introduced between the layer of intonaco and wall surface provoking unevenness and displacements from the original position. At these we add the resolution of the big incomplete surfaces from the preservation and aesthetic presentation point of view. Thus, after taking many samples of mortar with different compositions and structures, we used mortar according to the dominant chromatic of the next area working with different types of white. These surfaces were puttied under the level of the original layer and their surface was processed with texture different from the original, trying to put it into value (Fig. 27, 28, 29, 30, 31).

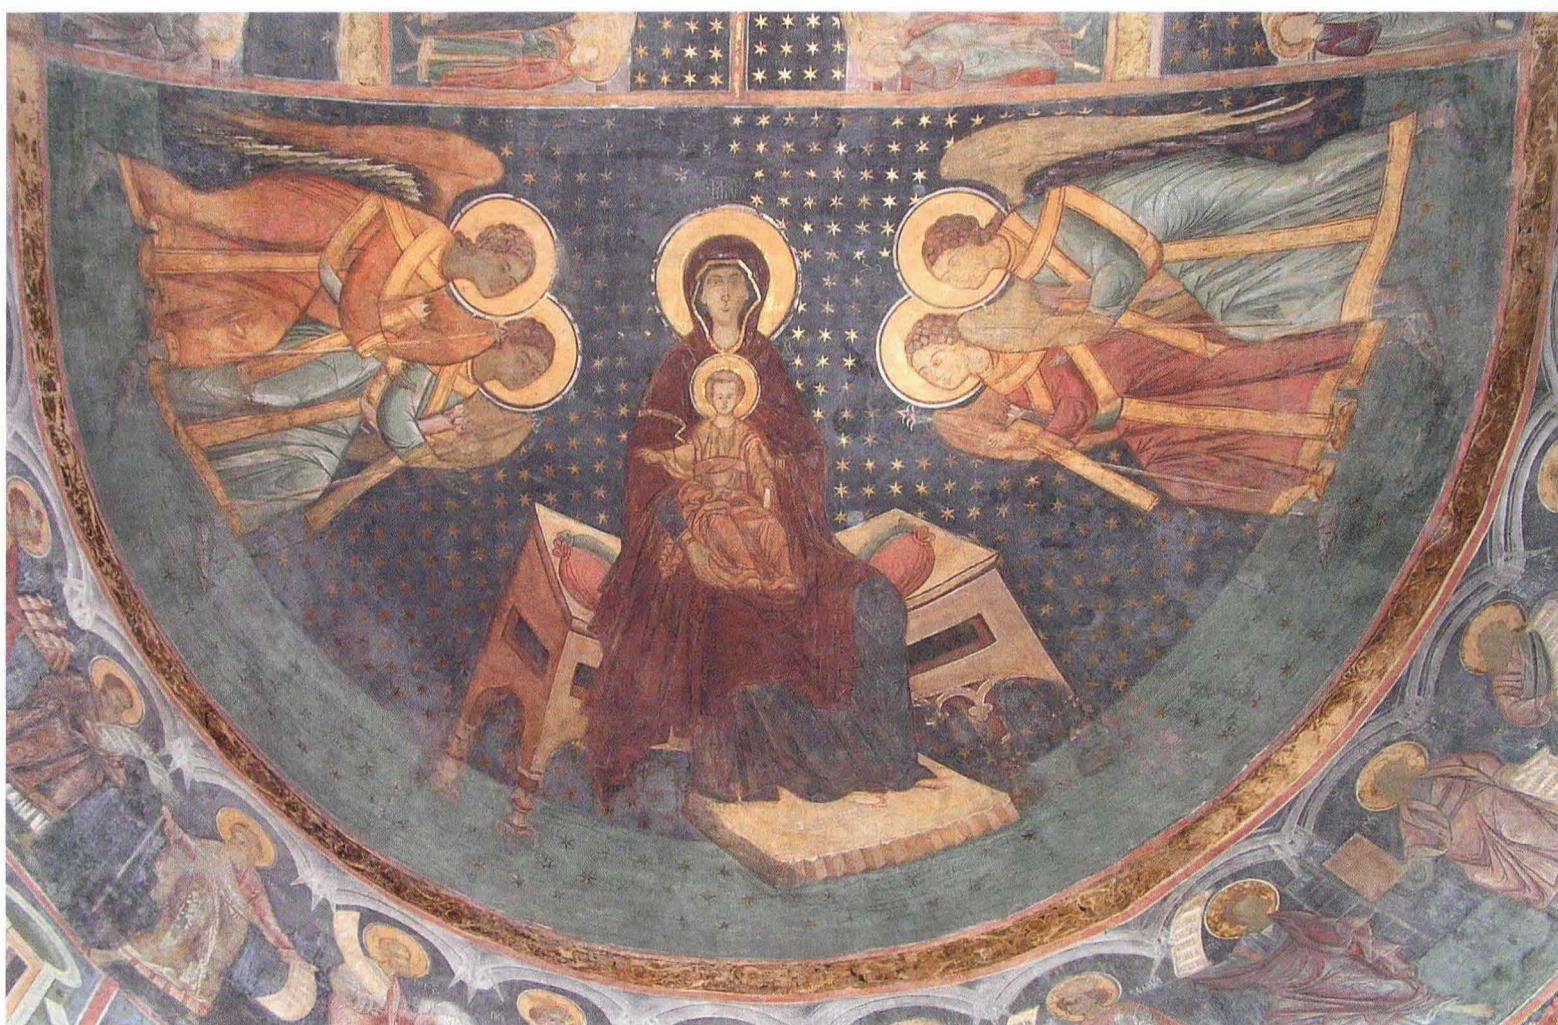
Fig. 32. The chancel vault, after restoration

The variety and complexity of problems raised by the preservation and the emphasizing of wall painting from Bălnesti, means application and accumulation of experience in definite and difficult situations encountered at this monument. The objective and unitary approach of restoration means the recognition of the original and unaltered character of the transmitted image over centuries (Fig. 32).
