Archaeological Data Concerning the History of the Evangelical Church in Dealu Frumos, Sibiu County

DANIELA MARCU ISTRATE*, DELIA MARIA ROMAN**

Keywords: Evangelical church, Dealu Frumos, Sibiu County, planimetry, cemetery.

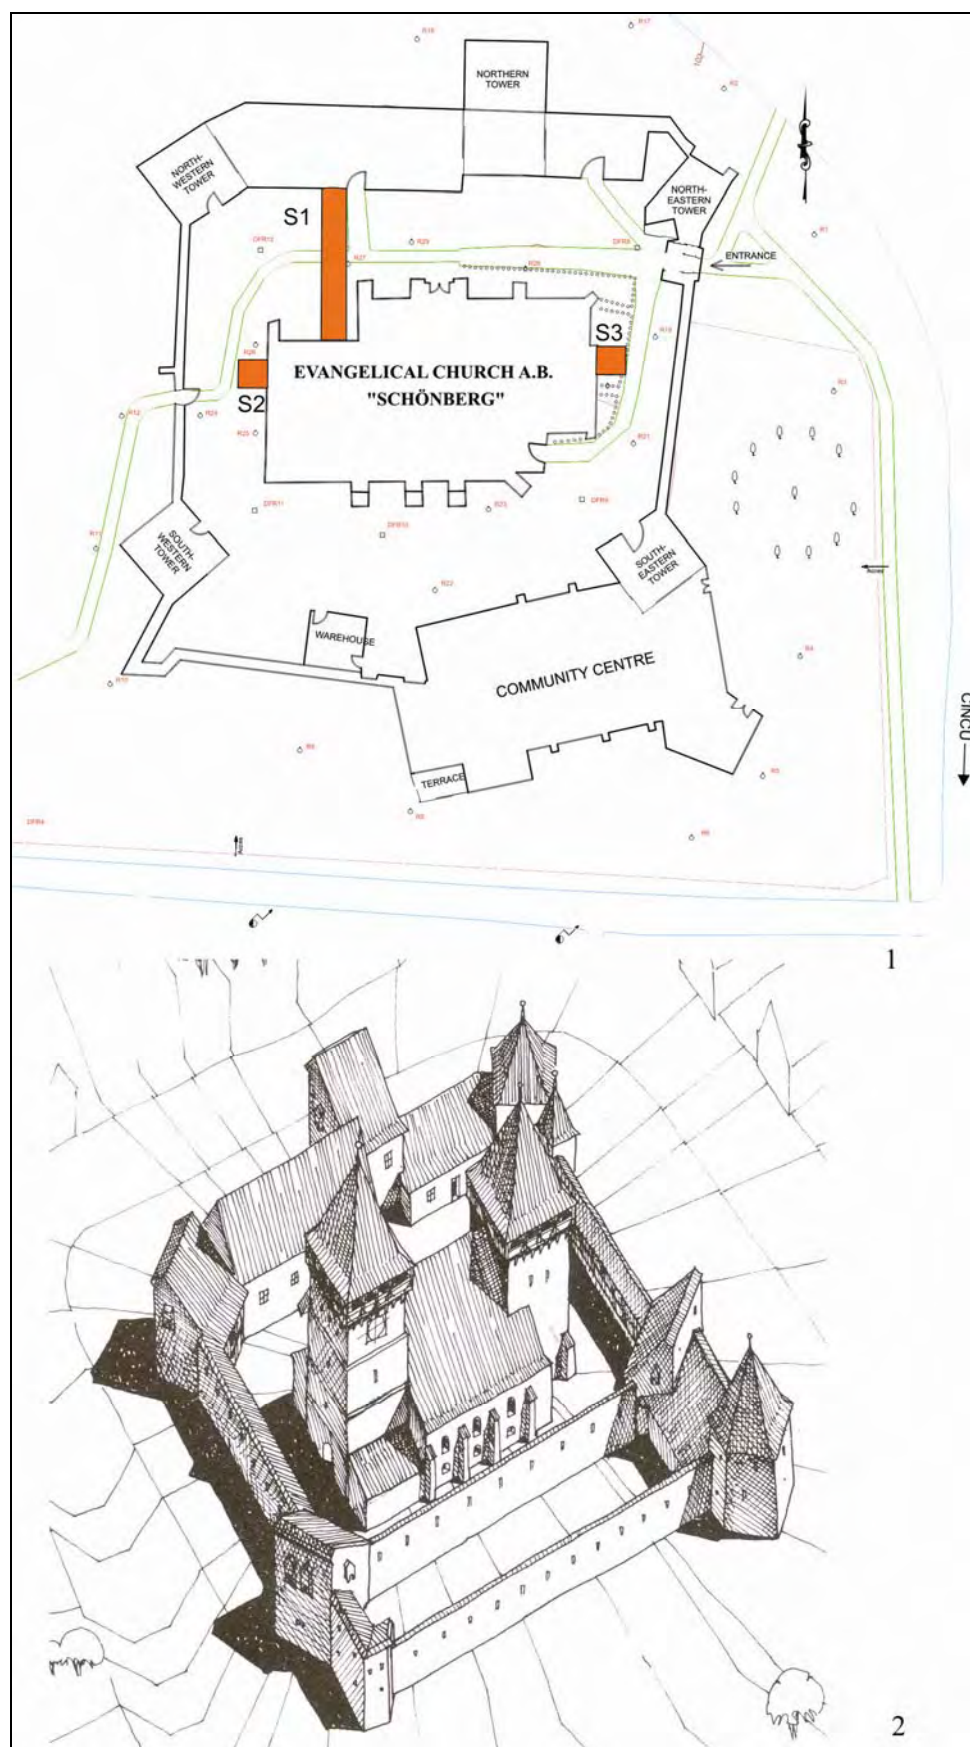
Pl. 1. 1. General plan of the fortified ensemble in Dealu Frumos with marking of the archaeological excavations.
2. Iso-metric reconstruction (apud Hermann Fabini, *op. cit.*, p. 679).

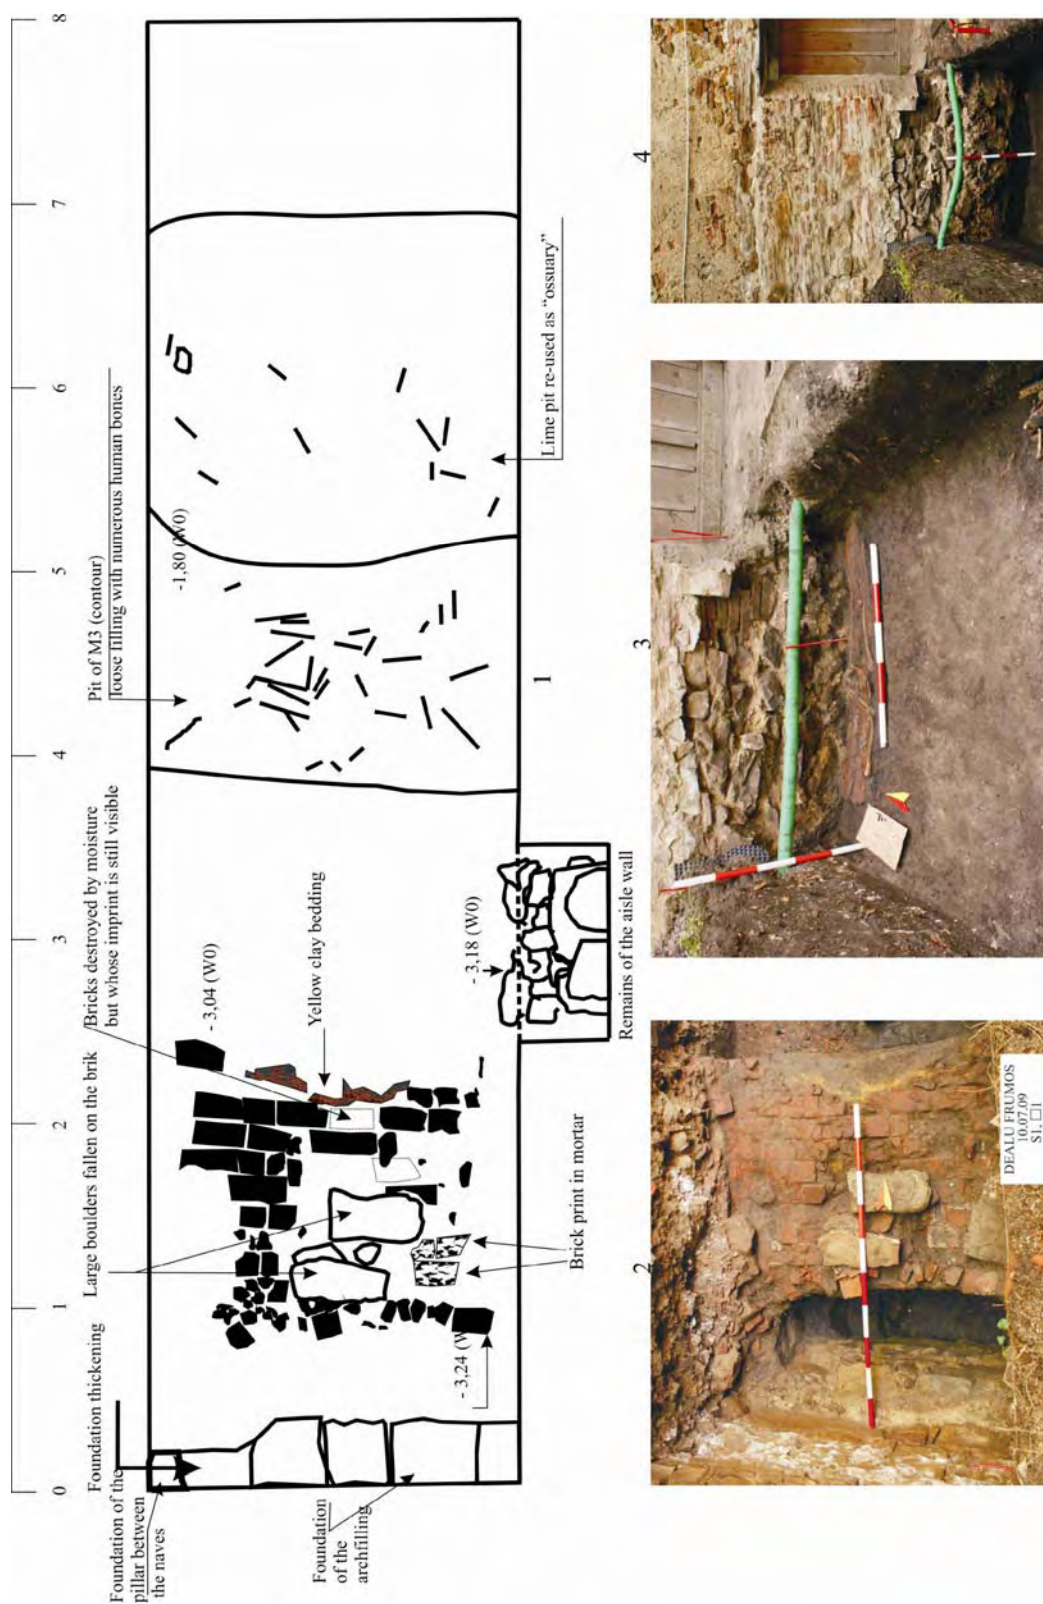
Pl. 2. 1. General plan of trench 1 with marking of the main discovered vestiges. 2. Detail of the brick floor discovered inside the ruin of the northern aisle.
3. Detail of the foundation of the old curtain wall. 4. General view toward the current building on the northern side of the enclosure.

- Pl. 2. 1. General plan of trench 1 with marking of the main discovered vestiges. 2. Detail of the brick floor discovered inside the ruin of the northern aisle. 3. Detail of the foundation of the old curtain wall. 4. General view toward the current building on the northern side of the enclosure.

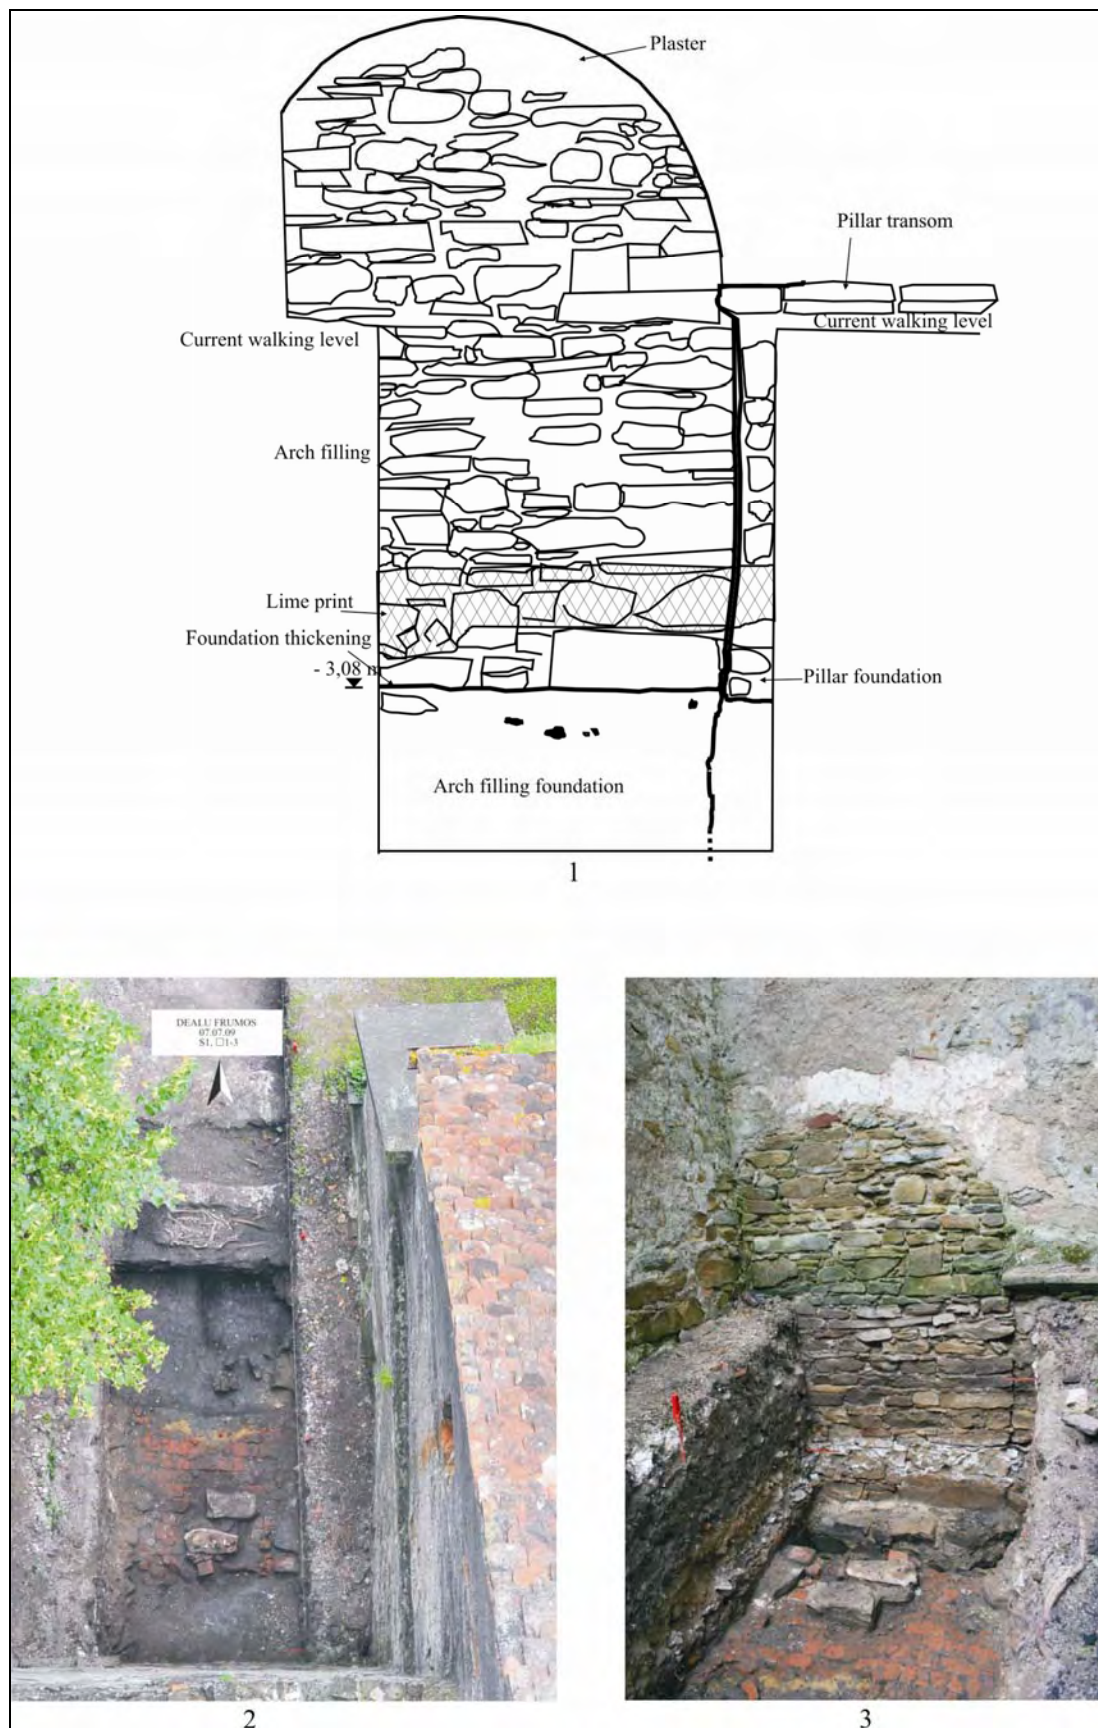
Pl. 4. 1. Current, northern face of wall of the church, next to trench 1. 2. General view of trench 1. 3. Bird's eye view of the current church wall next to the trench.

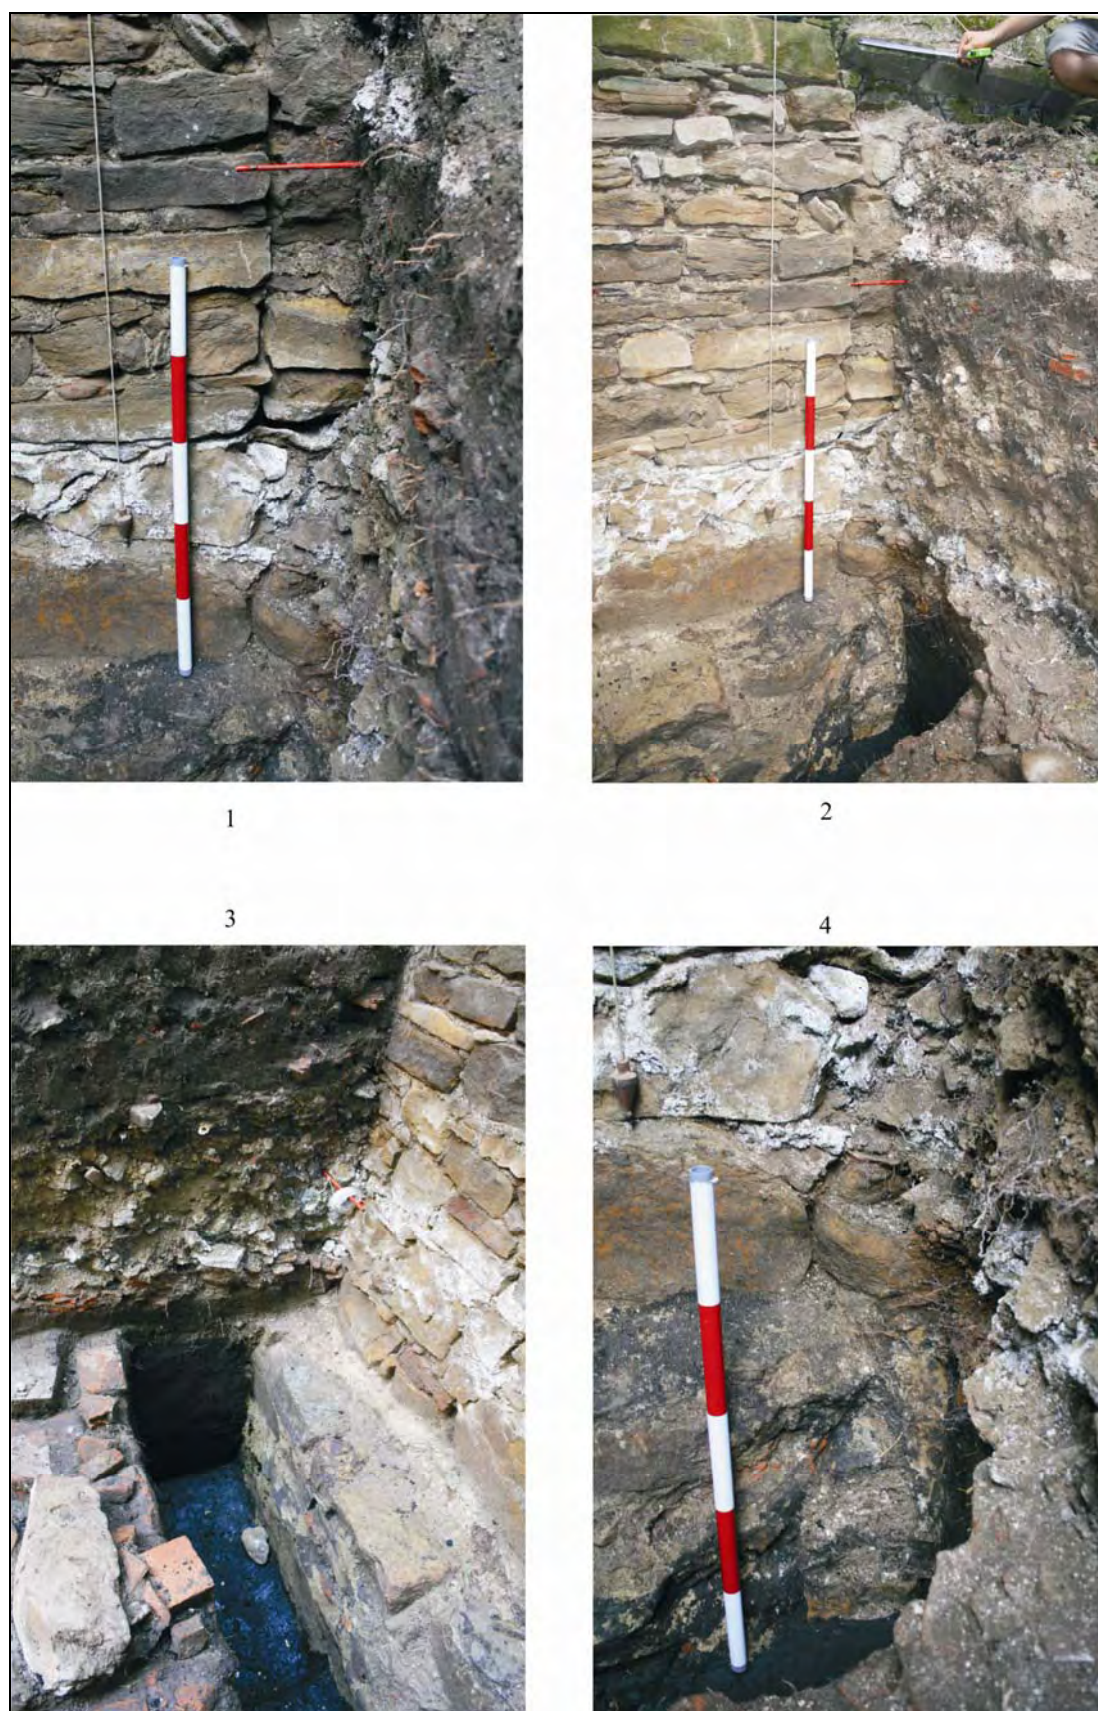
Pl. 5. 1–2. Current church wall, filling of the arch and original walling of the pillar, face of wall details.
3–4. Details of the filling walling in the area of the arch and next to the pillar.

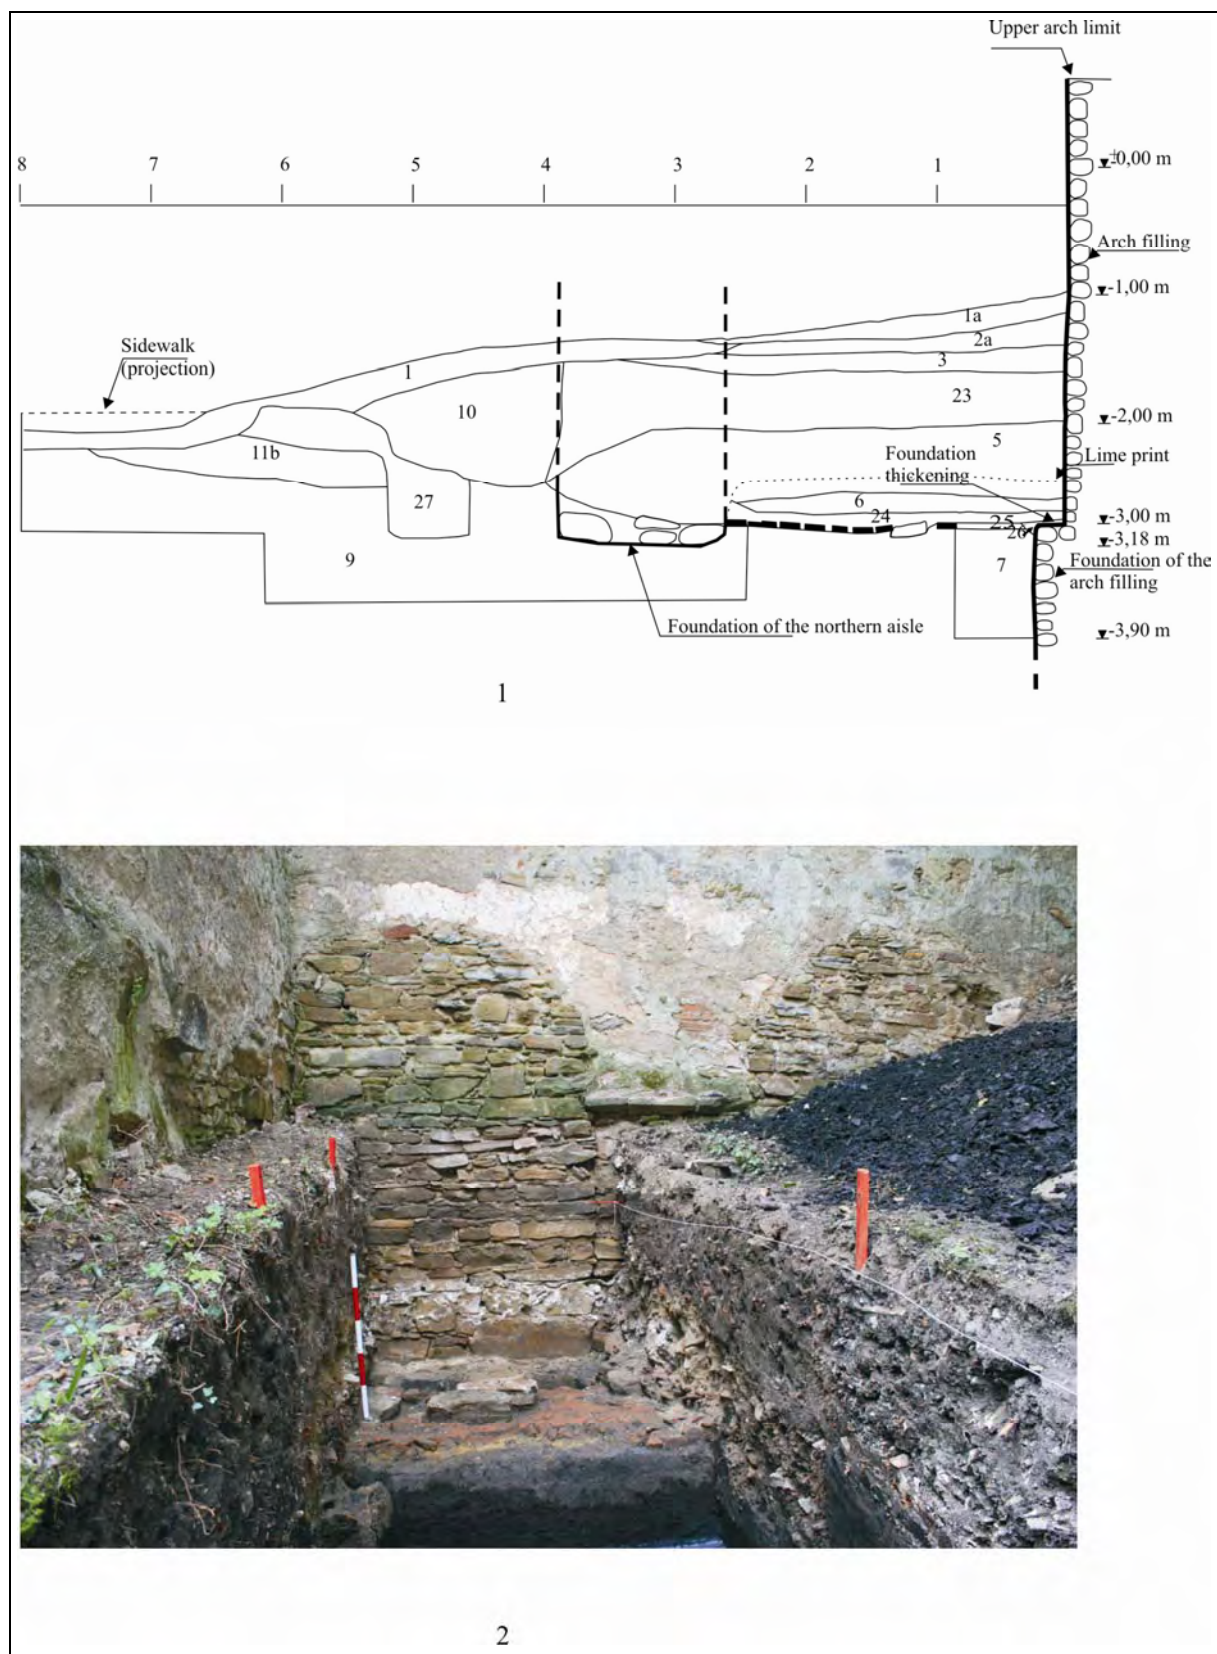
Pl. 6. 1. Eastern profile of trench 1 next to the church. 2. General view toward the current church wall, with traces of the arcade between the aisles.

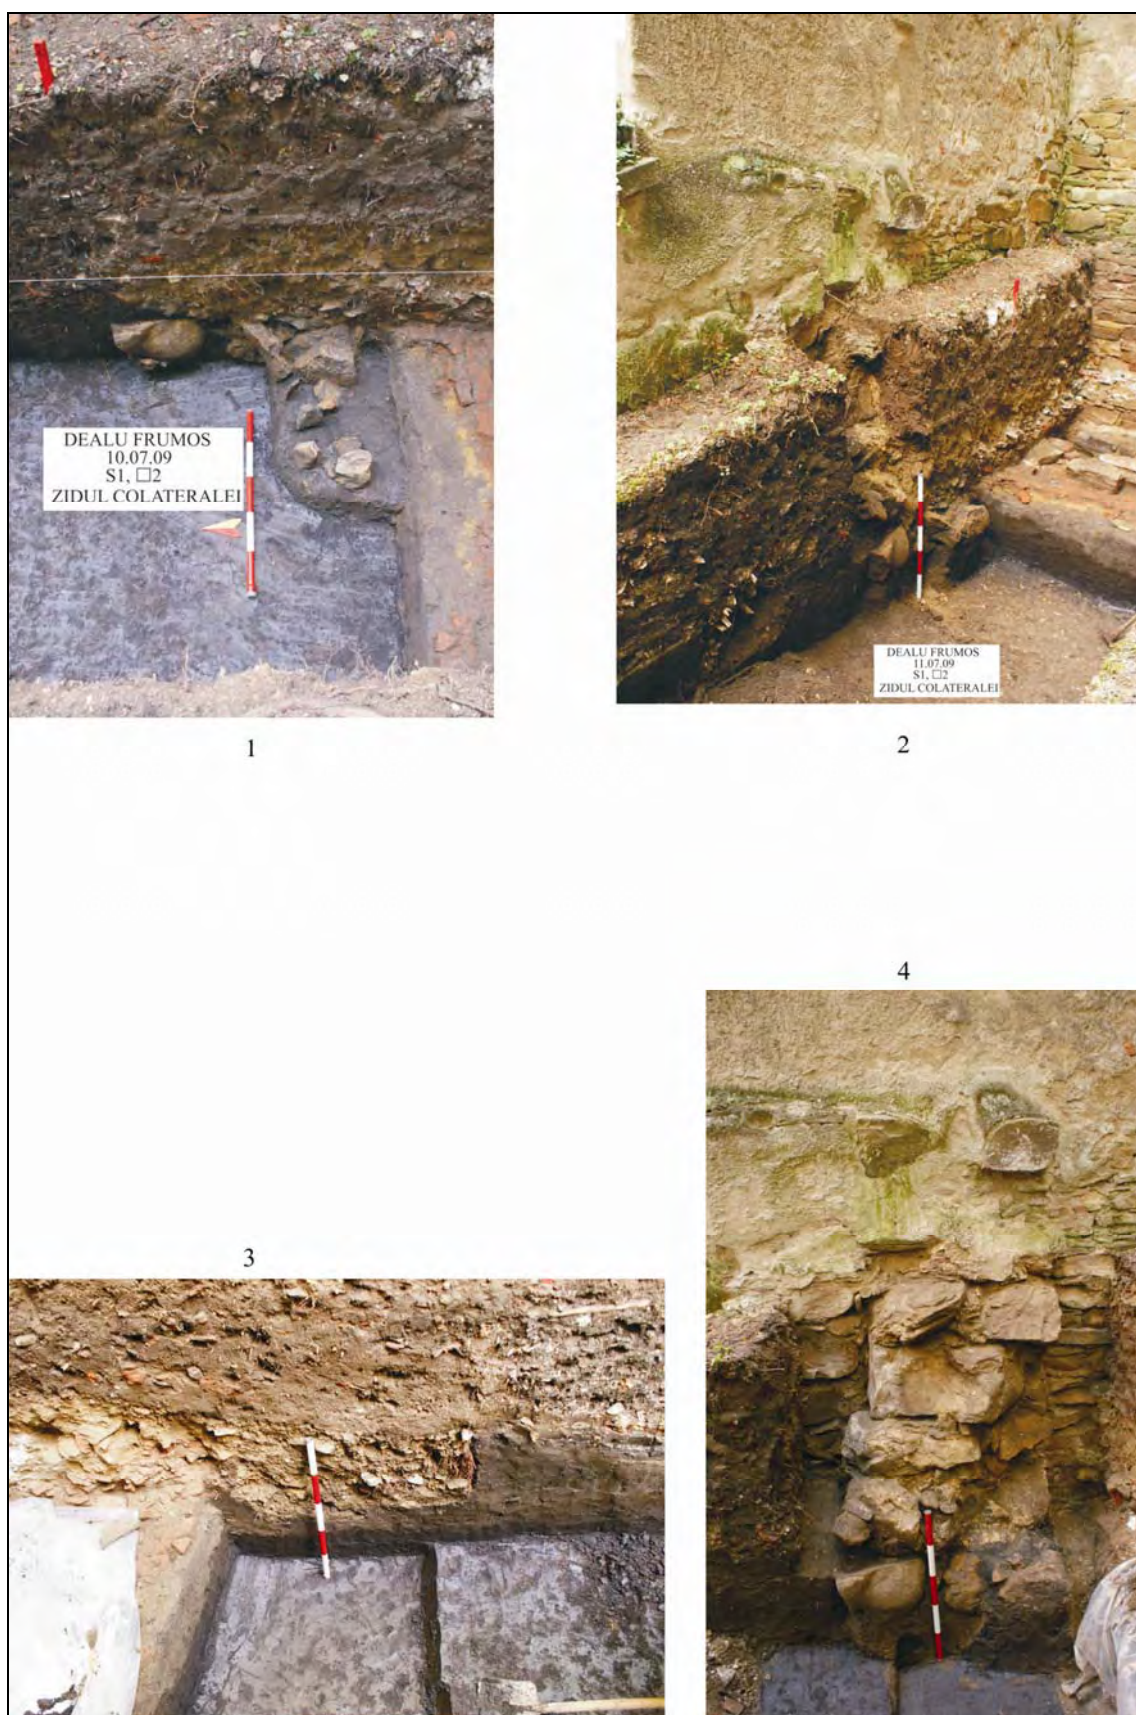
Pl.7. 1–2, 4. Ruin of the exterior wall of the northern aisle, at the end of the excavation. Preserved only few of the boulders of the foundation base. 3. Aisle foundation dismantling ditch.

- Pl. 7. 1–2, 4. Ruin of the exterior wall of the northern aisle, at the end of the excavation. Preserved only few of the boulders of the foundation base. 3. Aisle foundation dismantling ditch.

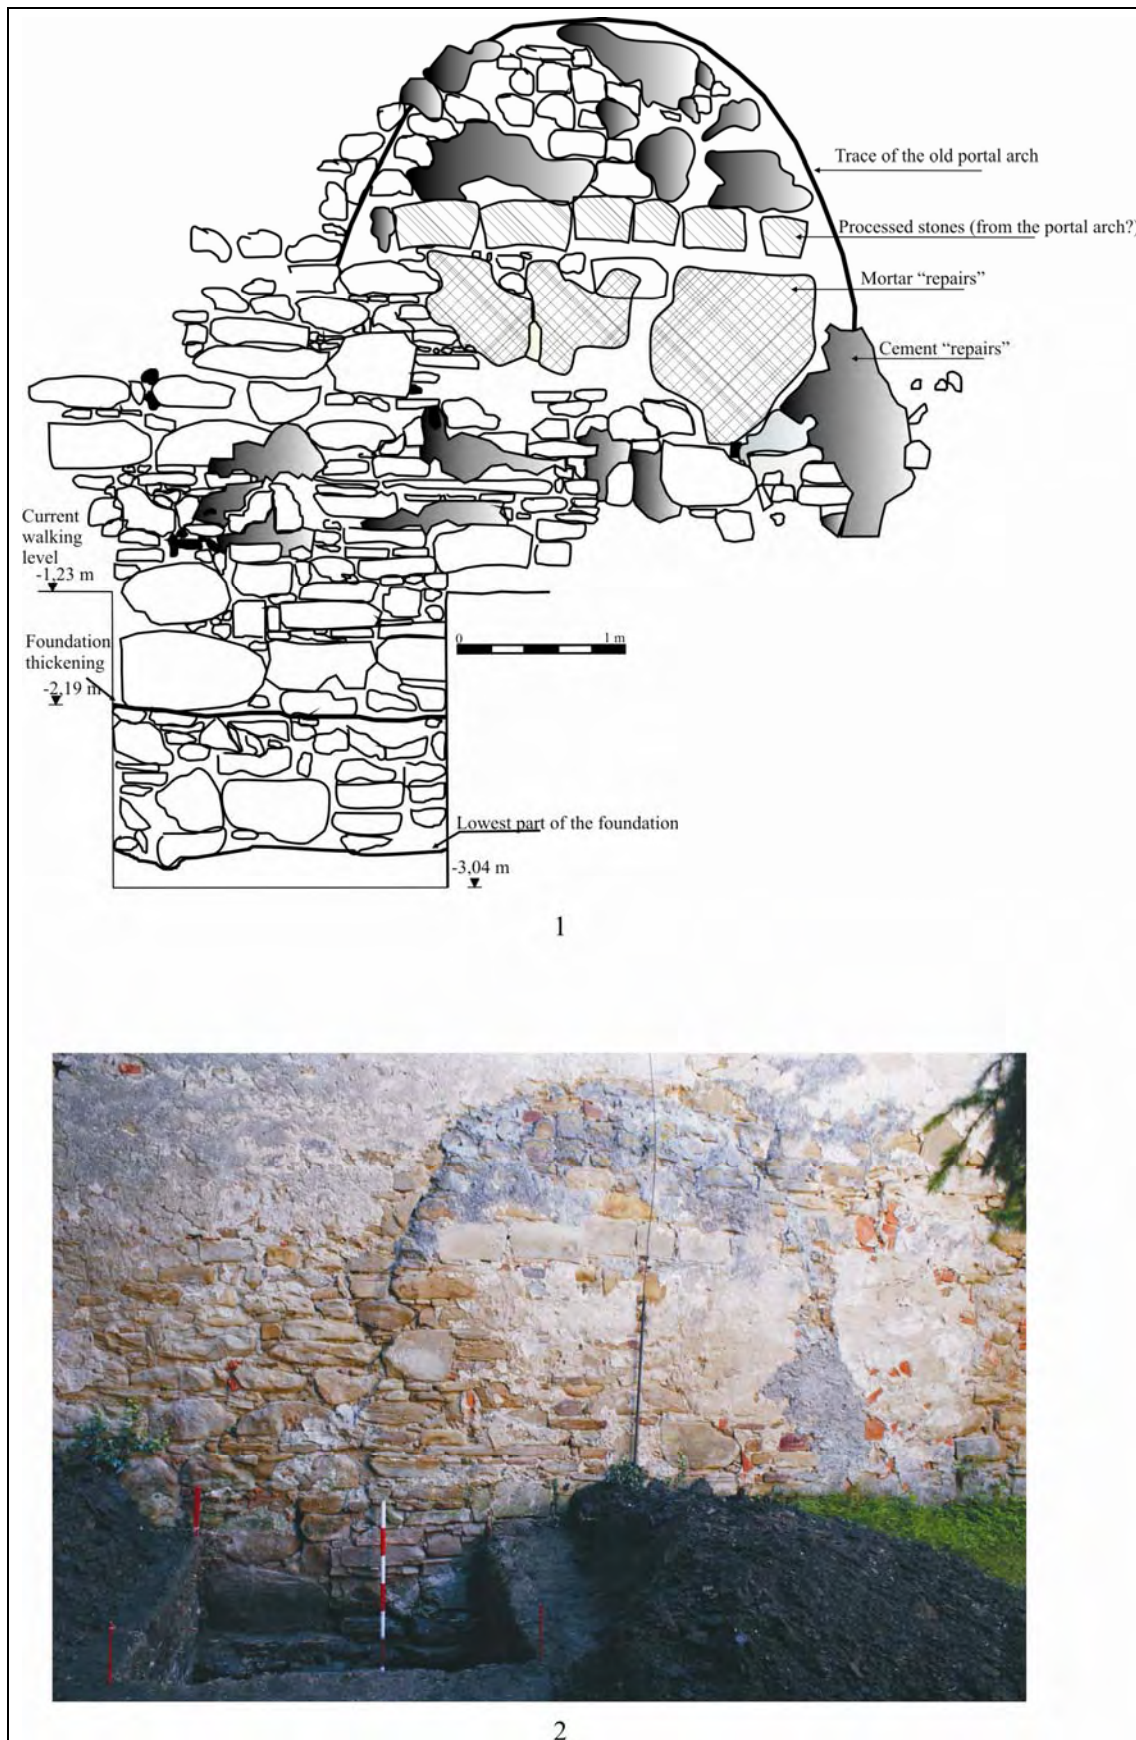
Pl. 8. 1. Current western church wall next to trench 2. 2. General view toward the western church wall, during the excavations. One can see the imprint of the supposed portal.

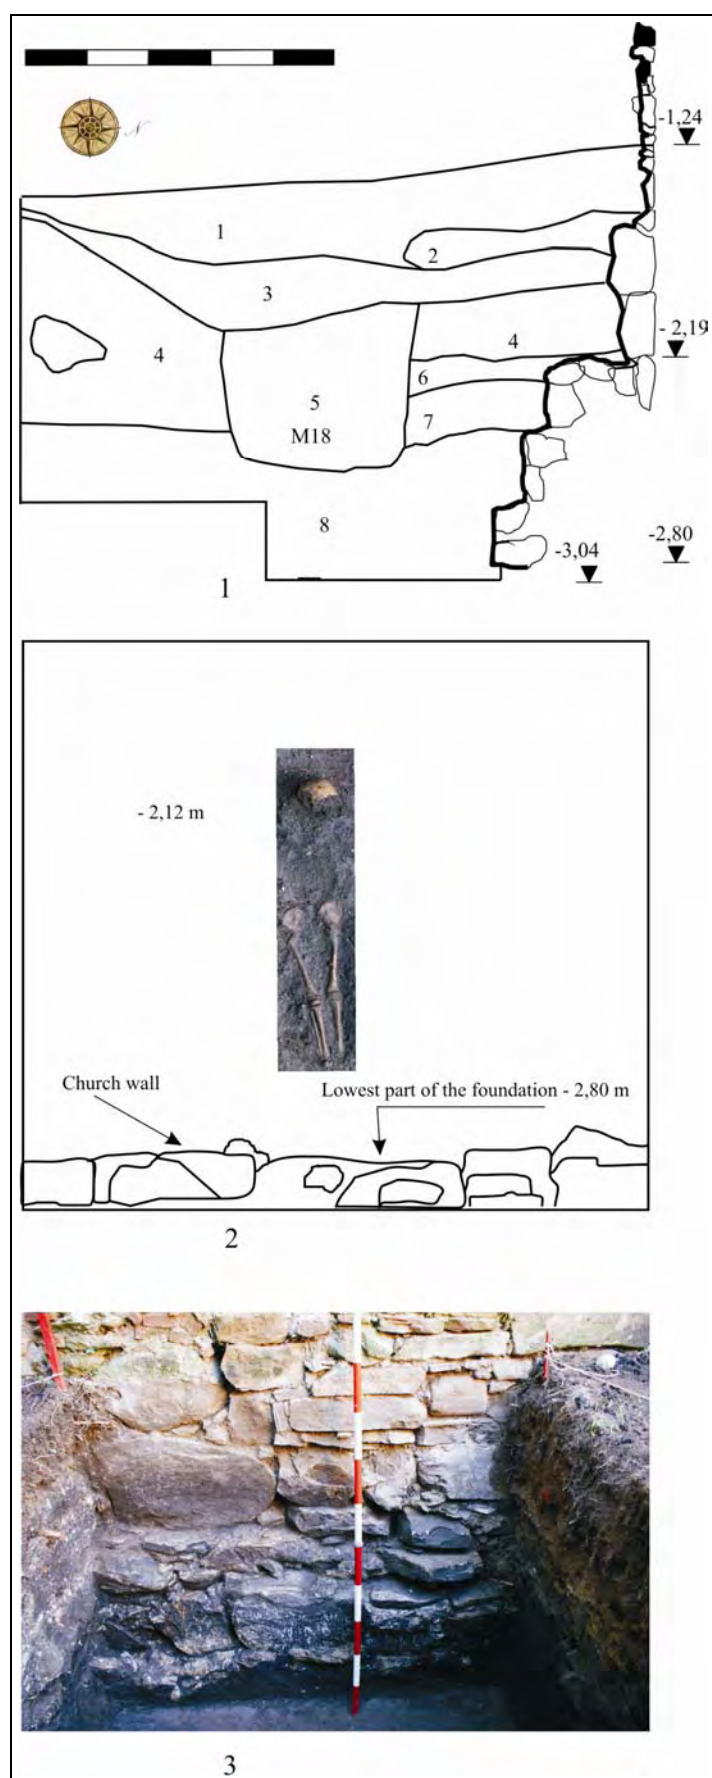
Pl. 9. 1. Northern profile of trench 2. 2. Plan of trench 2. 3. Detail of the western tower foundation base.

- Pl. 9. 1. Northern profile of trench 2. 2. Plan of trench 2. 3. Detail of the western tower foundation base.
- Pl. 10. 1. General plan of trench 3, with the apse ruin. 2–3. Photos during the excavations in trench 3.

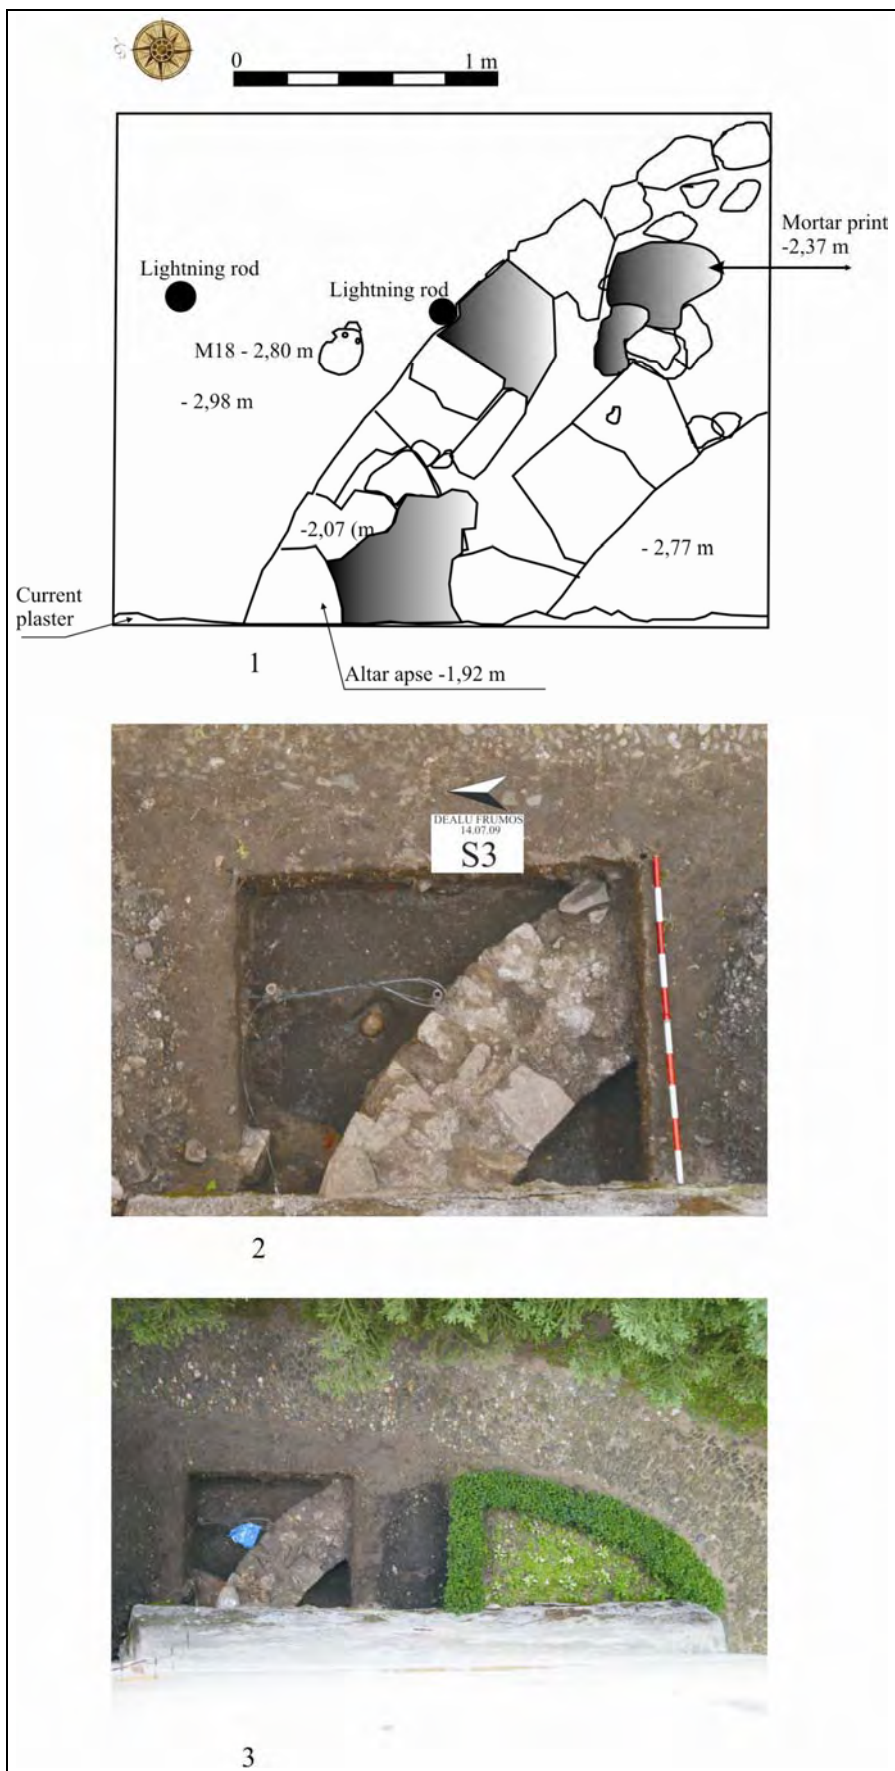
Pl. 10. 1. General plan of trench 3, with the apse ruin. 2–3. Photos during the excavations in trench 3.

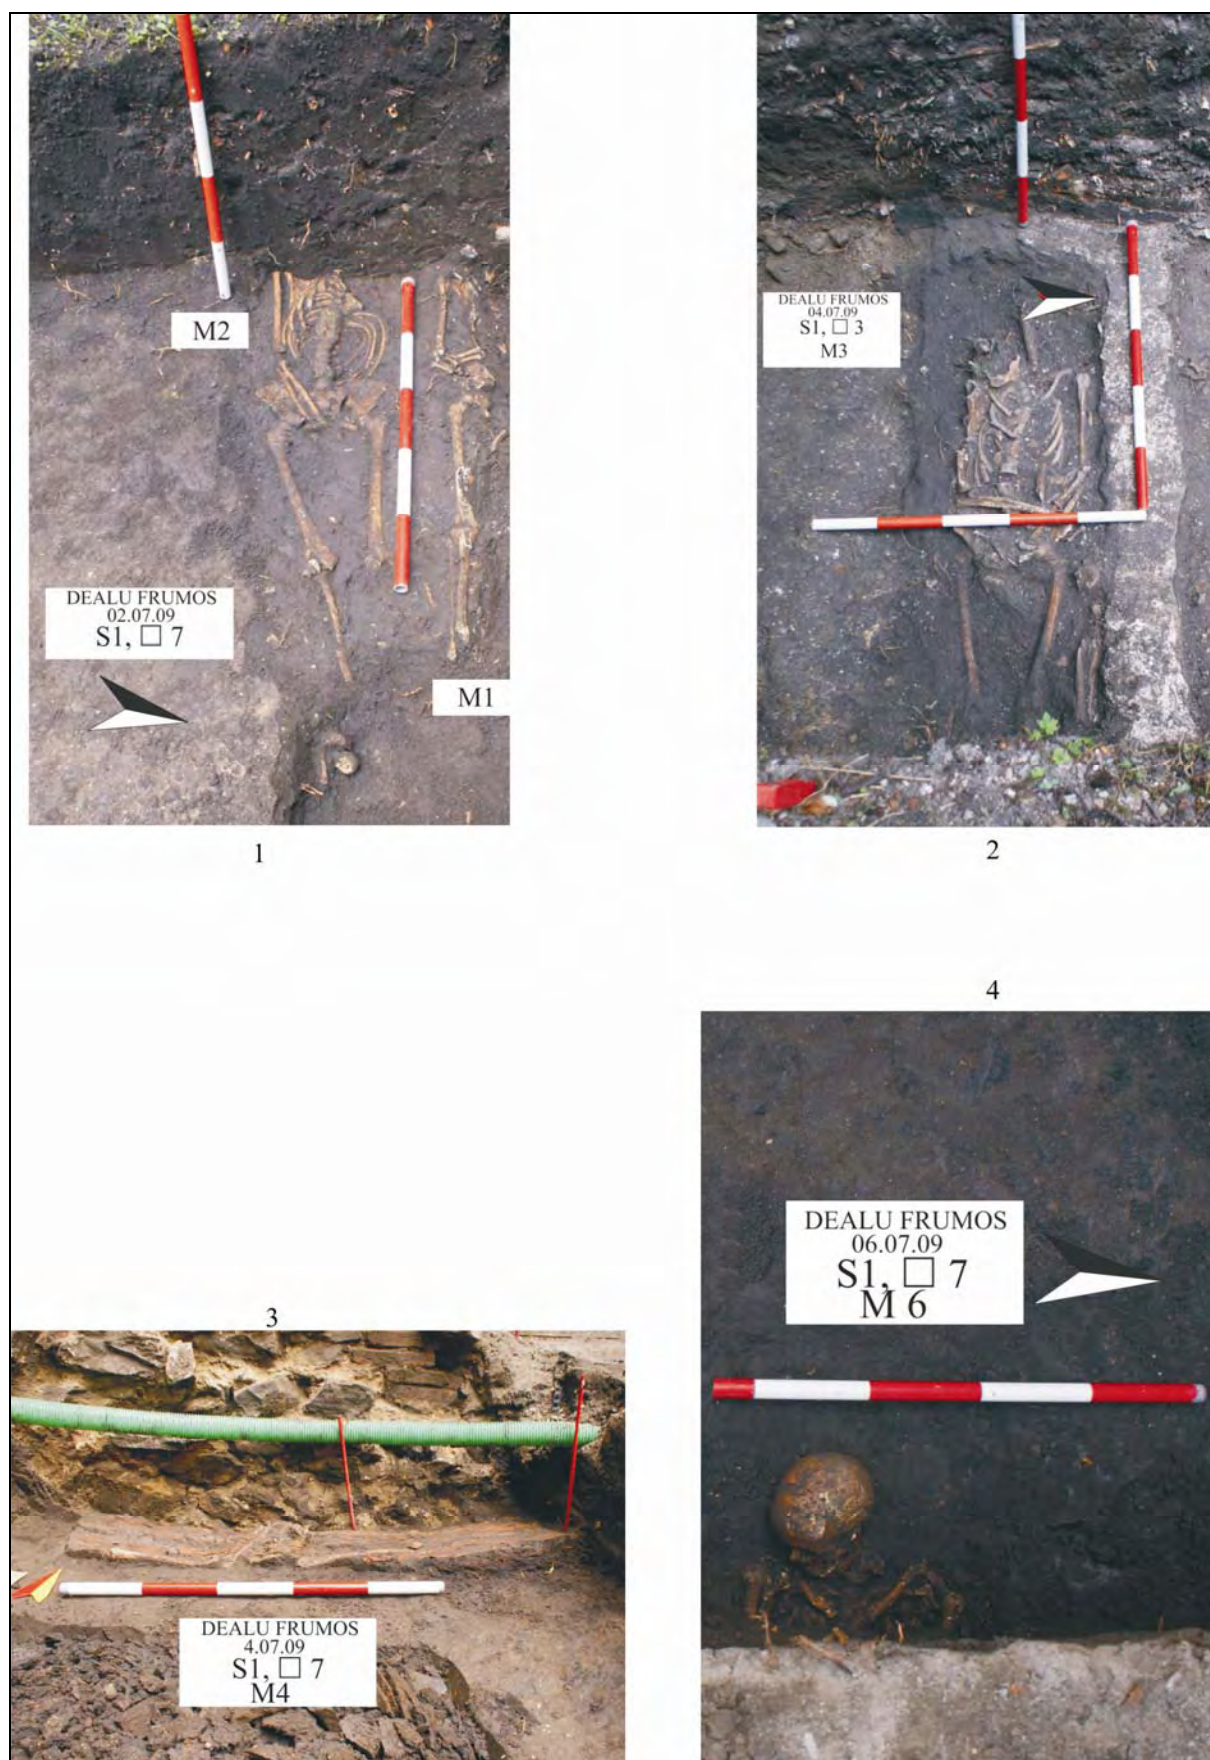
Pl. 11. Graves discovered during the excavations.

- Pl. 11. Graves discovered during the excavations.
- Pl. 12. Graves discovered during the excavations.

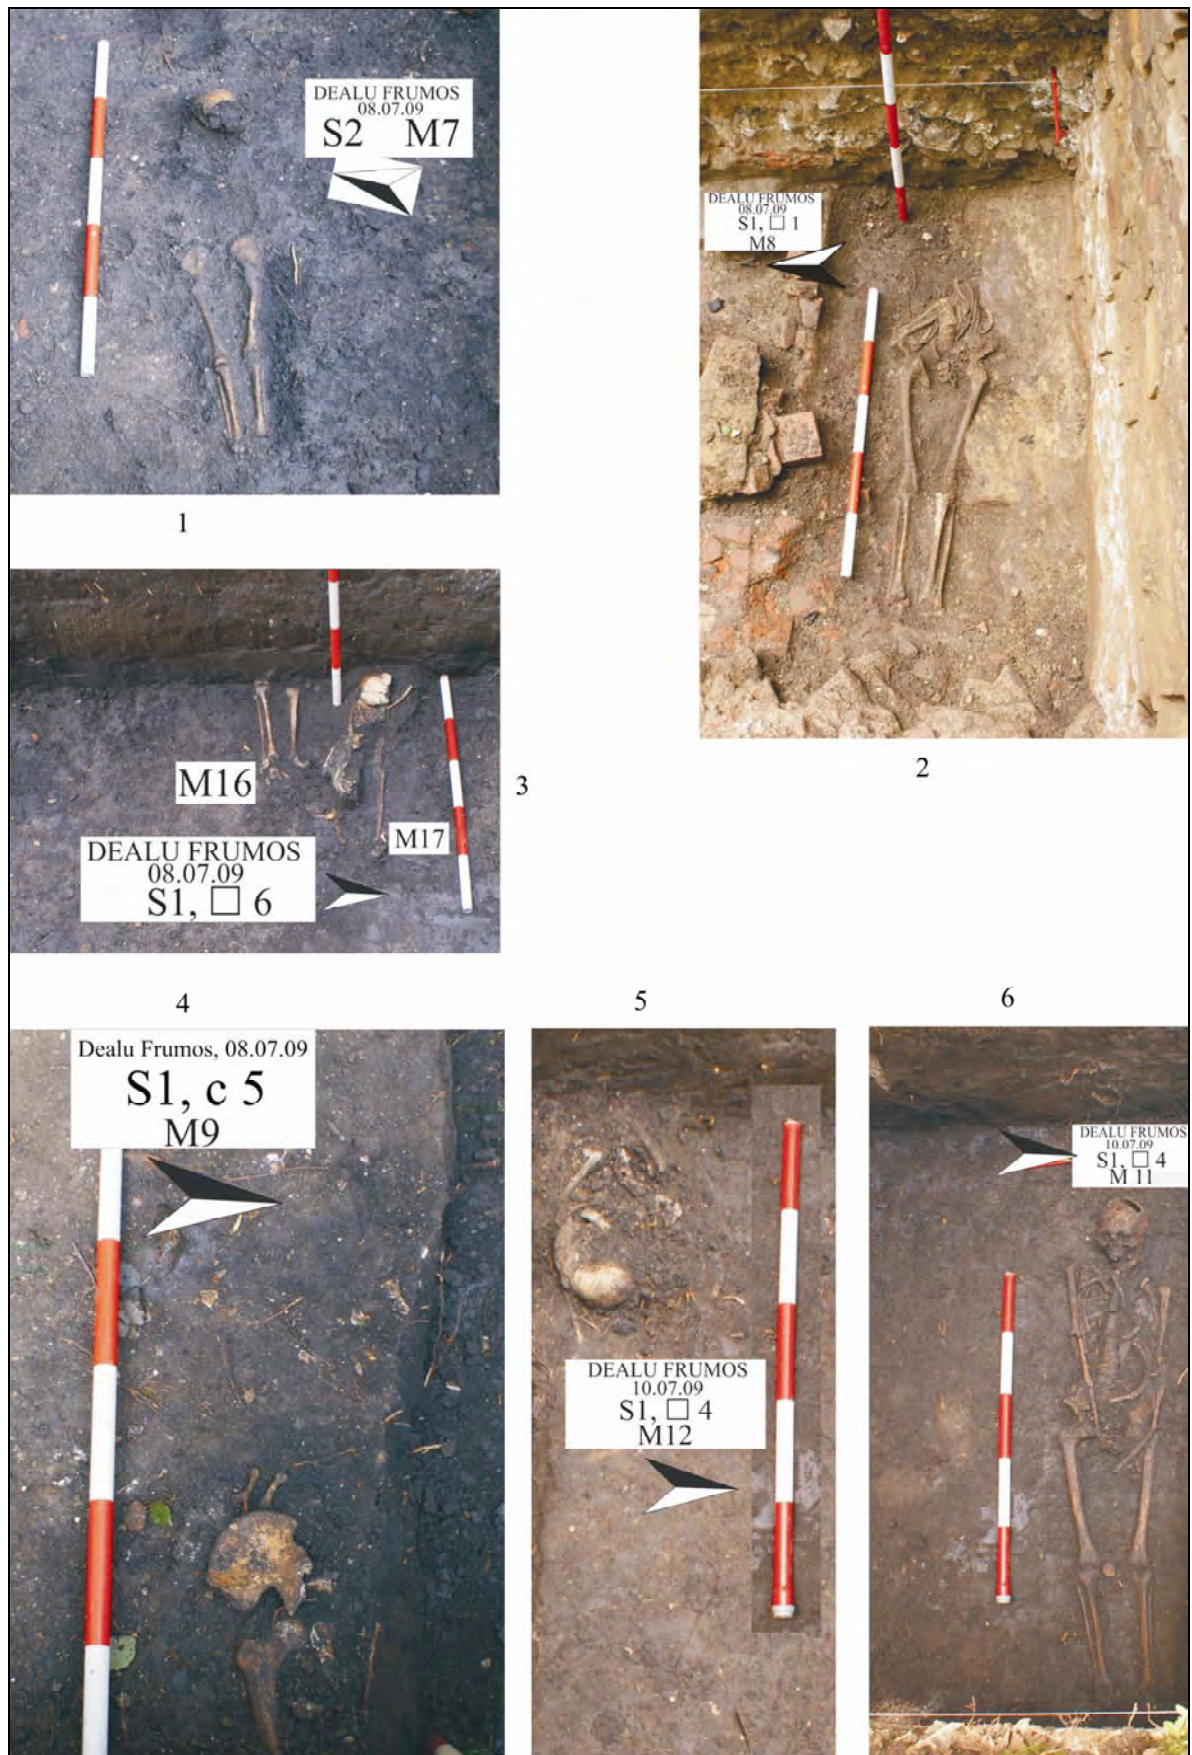
Pl. 12. Graves discovered during the excavations.
