# THE WOODEN CHURCH “SAINT HIERARCH NICHOLAS” – A HISTORICAL MONUMENT AND A SYMBOL OF SPIRITUAL CULTURE

**Tudor Arnăuț, Elena Vorotneac**

Moldova State University

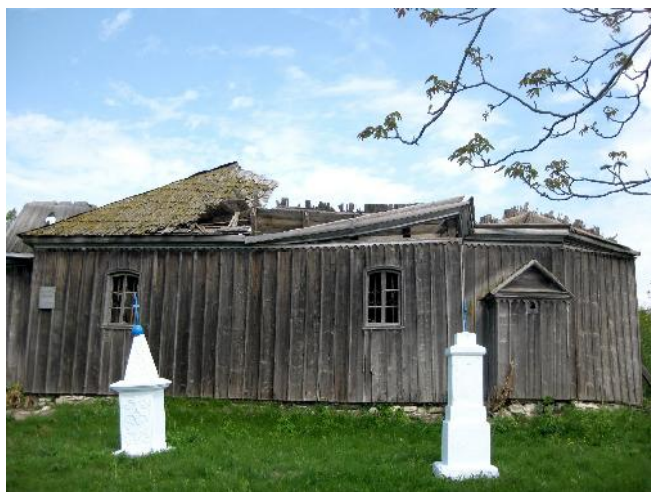
Photo 1. The demolished wooden church “Saint Archangel Michael”, Hiliuți, Râșcani

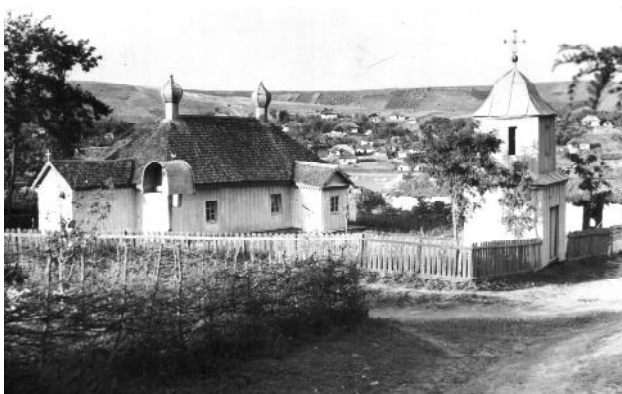
The building architecture remind of the ordinary peasant house. The construction system is a traditional one; it size – 15 000 mm x 7 000 mm, height 2 500 mm. In the exterior, the walls are from wooden planks. The scheme design is rigid and the foundation is constructed of crushed stone on the ribbon of clay mortar pillars, in which are embedded housing hardwood planks of 250-300 mm. The poles are placed at the building's corners and in the center of the longitudinal bulkhead. Inner walls, including ceiling, are plastered with clay and whitewashed.

*Photo 2. The church and the bell in 1976*

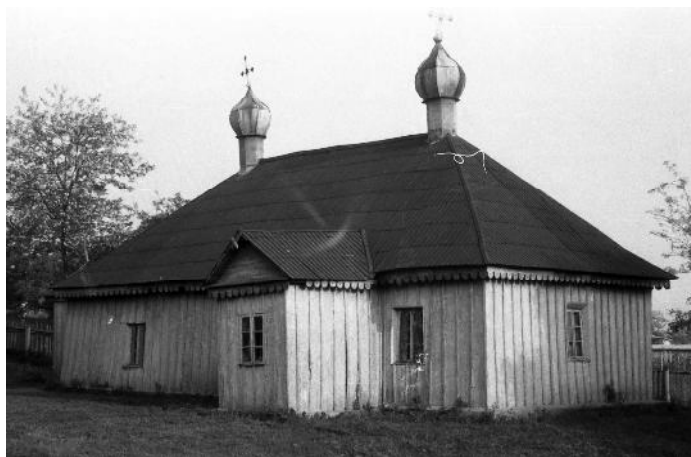
*Photo 3. The Musteața's church in 1991*

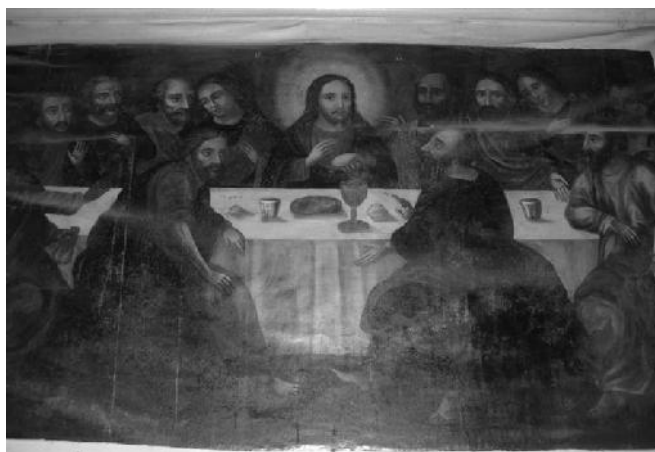
The church has been adorned, inside with al fresco paintings of a rare artistic and iconographic value. Of a great importance and value is the iconostas with its paints on canvas from the XIX-th century, representing a fragment of *The Last Supper*.

*Photo 4. The iconostas, a fragment from The Last Supper, was painted in the XIX-th century on canvas*

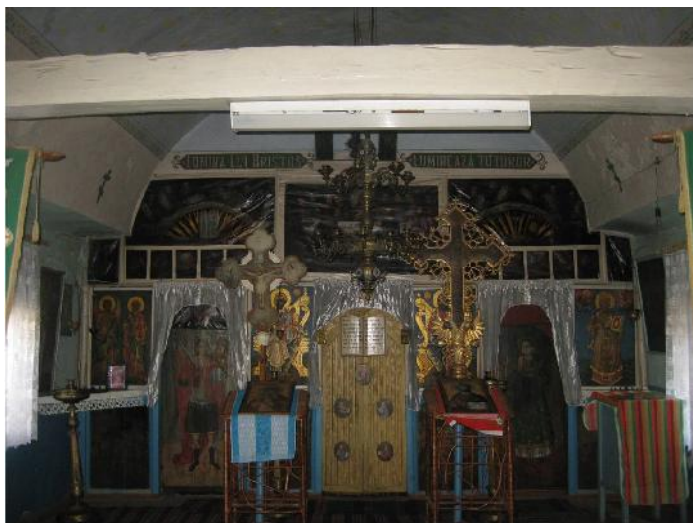
We must mention that the icons from the Deacons Doors and Royal Doors are arranged untraditionally. For example, on the Deacon's Door, from the right of the iconostas, is the icon of Saint Deacon Laurence. But on the left Deacon's Door is the icon of St. Archangel Michael (traditionally, it must be the icon of a Deacon or only the icons of Saints Archangels Michael and Gabriel).

*Photo 5. The iconostas*

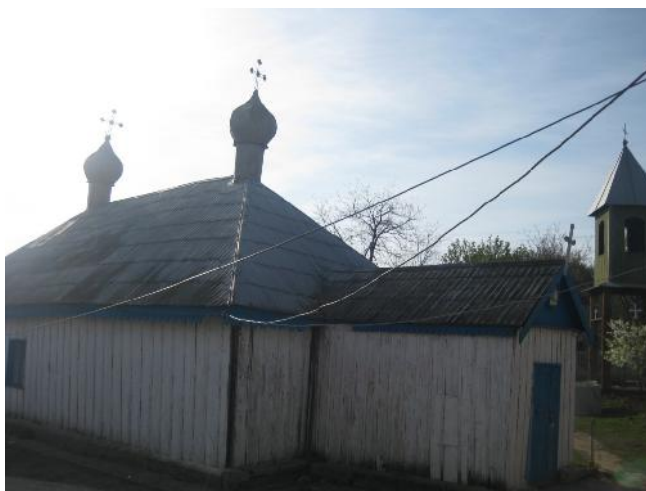
*Photo 6. The wooden church nowadays and the bell.*

Other causes of the bad condition of the wooden church are:

- the deteriorated pitching around the church;
- the rotting and warping of the piles which supports the walls;
- the rotting and warping of the cases of housing;
- the rotting of the windows boxes;

- the deteriorated foundation;
- the rotting of a great part of the planks, etc.;
