THE OTTOMAN FORTRESS FROM HÂRȘOVA IN RECENTLY DISCOVERED RUSSIAN CARTOGRAPHIC SOURCES (18TH CENTURY)

Aurel-Daniel Stănică*, Constantin Nicolae**,
Mihai Anatolii Ciobanu***

Abstract: Like all the Ottoman fortresses in Dobrudja, the fortress of Hârșova was little known until today. In the absence of an archaeological research, only a few documents, often questioned too, were the only sources that presented the image of a strong fortification.

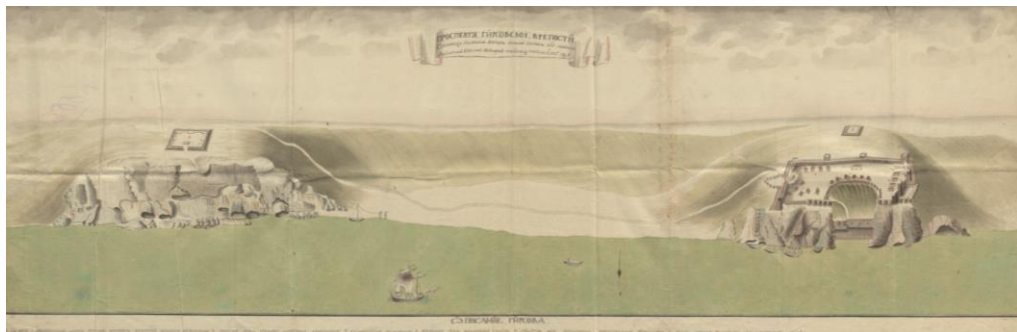
Fig. 3. Prospectus of the Hârșova fortress.

3. Complements to those noted can be found on the *Prospectus of the Hârşova fortress, located across the Danube, in Bulgaria. In what condition is it now at his conquest by the Russian army from the Turks, that is, in 1772, 102 × 38 cm.*⁵³ (*Проспектъ Гирсовскоі крепости. Состоящей за Дунаемъ в Булгаріи в какомъ состояни нне по взятъе Россіискимъ войскомъ отъ турокъ находитца, то есть от 1772-го году*).

1. The Castle ("Замокъ");
2. The blown-up wall against which the gabion reinforcement is made ("Подорванная стена противъ которой ис туровъ сделано укрепление");
3. Old gabion reinforcement against the river ("Противъ реки старое ис туровъ укрепление");

4. Soldiers' huts ("Салдатские землянки");
5. Stone wall by the river ("На берегу реки каменная стена");
6. Redoubts that are built by the Russian armies ("Редуты кои построены российскими войсками");
7. The Danube River ("Река Дунай");
8. The road to the locality of Doeni [Dăeni, n.n.] ("Дорога къ местечку Доень").

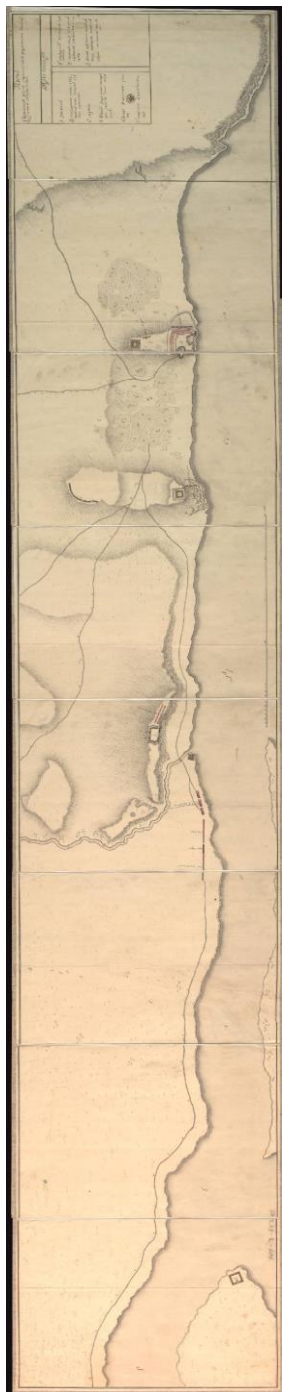
Fig. 5. The Plan of Hârșova Castle with the indication of Vorstadt.

with information specific to the year indicated, including the defensive complex of Hârșova fortress, the urban structure, the repairs made by the Russians, the position of redoubts and Russian troops. The fortifications from Gâsca Island and Privalul Băroi to Citatel Hill (Dealul Cetății) are also shown on this plan.

On plans 5 and 9, where a broader perspective on the fortress and the immediately adjacent area is used, the roads to the important localities nearby (Doeni-Dăeni) or further away (Siliștră, Babadag) are shown. It is interesting that the exit from the fortress is through the west, where the walls were broken by the explosion of a projectile, which we mentioned above, where a redoubt defended frontward by gabions is built. This detail suggests that the fortress was practically destroyed and was reduced, in the new circumstances, only to the western perimeter arranged by the Russian occupiers.

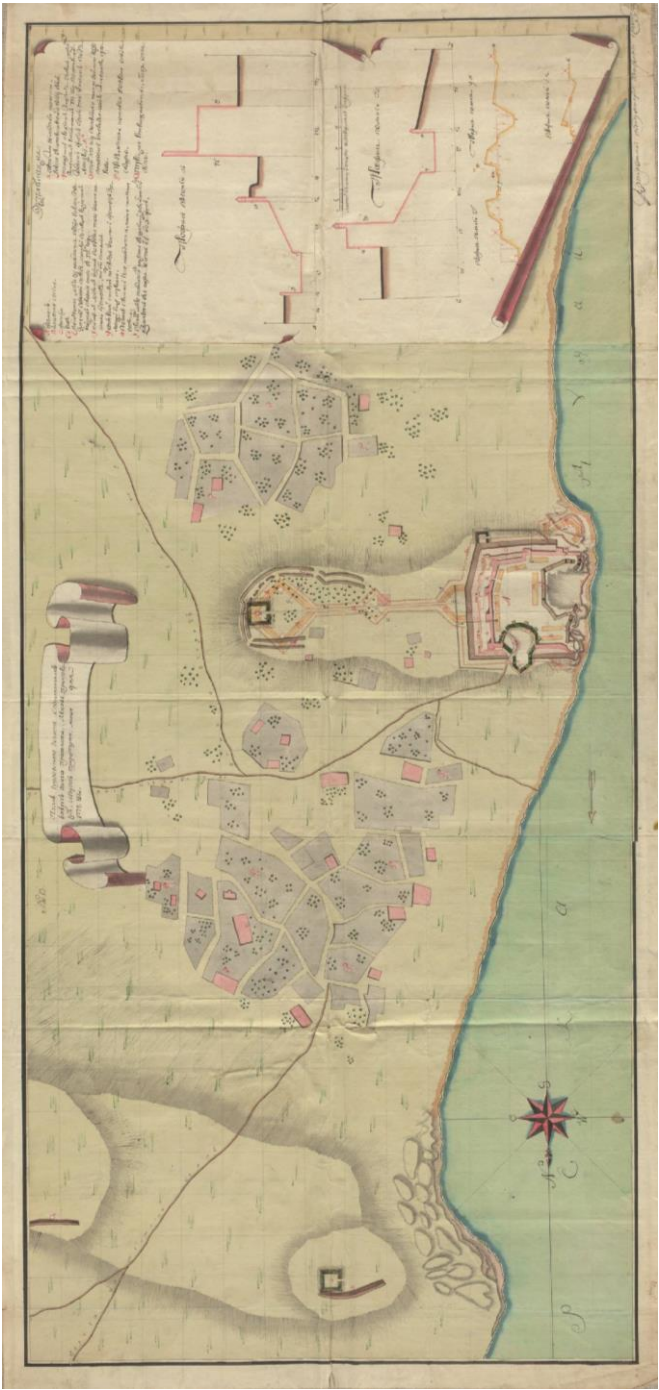
Fig. 9. The Plan of Hârşova Castle showing the project around it, and the new constructions follow in the report.

9. The ninth cartographic document is the Plan of Hârşova Castle showing the project around it, and the new constructions follow in the report. May... day 1774 (Планъ

P. The suburbs that were burned during the siege ("Предмѣстїи которыи во время осады сожжены");

Q. The Turkish entrenchments, but now they are levelled ("Турецкии ретранжаменты, н^ые жъ оныи скрыты").

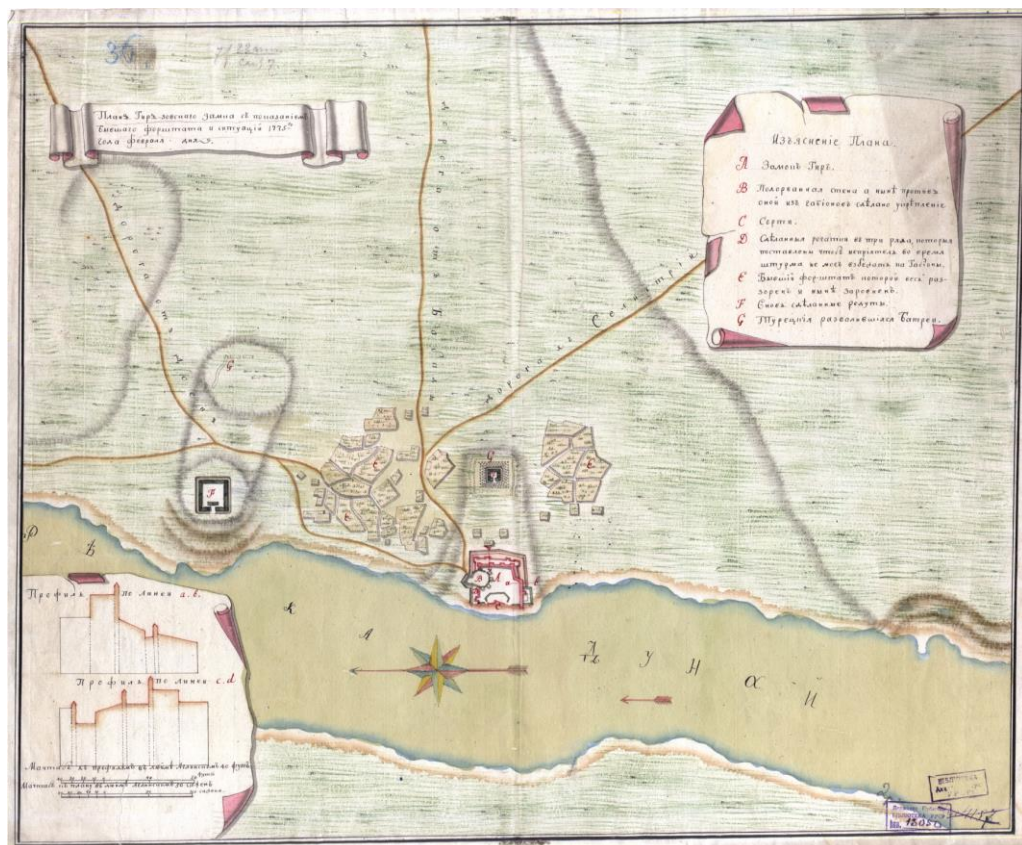
Fig. 10. The Plan of Hârşova Castle with the showing of the former suburb and the situation of the year 1775, February.

10. The tenth document is the *Plan of Hârşova Castle with the showing of the former suburb and the situation of the year 1775, February*, 48 × 58 cm (*План Гирзовскаго (!) замка с показанием бывшаго форштата и ситуаций 1775-го года февраля... дня*)⁶², which is in Kiev. Otherwise, we consider that in Romanov times both plans found by us in Kiev were in Odessa, being part of the Collection of maps and plans of the Museum of the Imperial Society of History and Antiquities established in 1839.

The town plan suggests an attention to detail and accuracy, which involved the input of military engineers, who resorted to field measurements.
