TOWARDS A HISTORICAL GEOGRAPHY OF EXTREMA SCYTHIAE MINORIS

A land survey of the south-east shoreline of the Dunavăț Peninsula. Results and perspectives

Mihail ZAHARIADE*

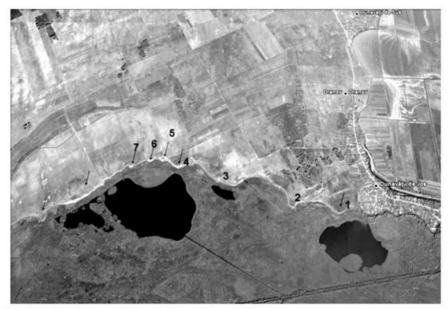
Fig. 1 - The SE coast line of the Dunavăț Peninsula. The arrows indicate the places where the presence of anthropic occupation in antiquity has been identified. The figures show the existing promontories where important agglomerations of artifacts have been detected.

The area investigated encompassed a territory of ca. 5 km in length starting with a point located at the westernmost house of the Dunavățul de Jos village (44° 58′ 55″ N and 29° 13′02″ E). To the south of this segment a dense concentration of deltaic vegetation (mainly reed) is marked by two existing lakes, the so-called "Lacul Satului", ca. 73.75 ha in surface and the Carabaev Lake ("Ghiolul Carabaev"), to the west, with a surface of ca. 171 ha (Fig. 1)².

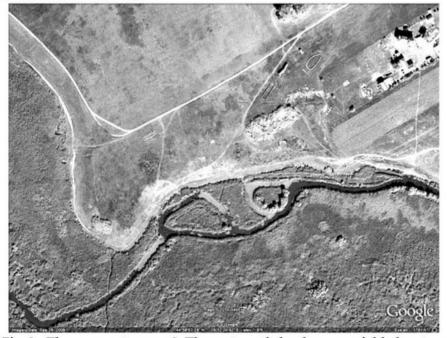
- **2. Prmt 2** (Fig. 2) Coordinates: 44° 58′ 56″ N; 29° 12′ 13″ E; promontory ca. 500m WSW from the Julian monastery of old Russian rite; 80m protruding shore line towards south; flat surface, with sporadic traces of calcareous and grit stones; no archaeological artifacts; no clear indication of ancient human occupation on this promontory; no buildings or other structures top the area. (Fig. 3).

Fig. 2 - The promontory no. 2. The systematic land survey yielded no trace of anthropic occupation. To the right lies the Julian monastery of Old Russian rite.

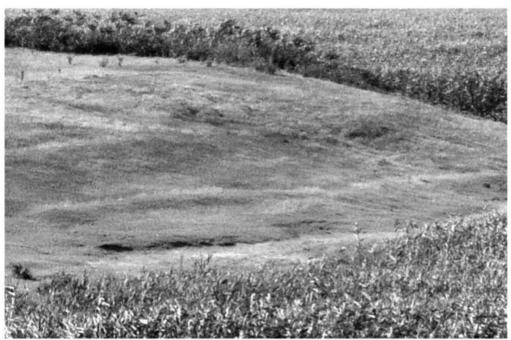
Fig. 3. Ground view of the surface of the promontory no. 2.

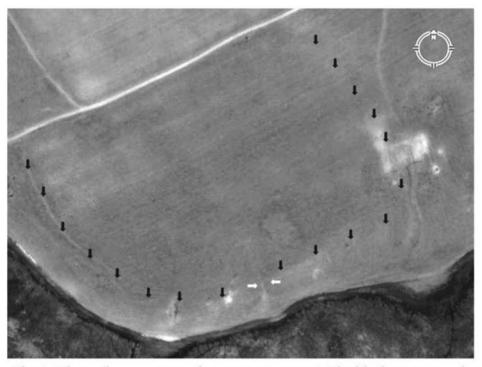
- 3. SEDP II Prmt 3. (Fig. 4). A 7.50m wide at the base surrounding earthen wall goes along to the SW and SE. It is doubled by a ca. 1 m deep ditch to the NE and NW in their present day state of preservation; slight traces of earthen wall and ditch to the NW; the wall and ditch appears much flattened but still visible to the NE; a ca. 3.50 m wide opening is plainly visible at the mid way of the SE side and two others of ca. 2.50m in width are possible on the SW side; the structure

describes a rectangular enclosure, 283m on the ENE-WSW and 206m on the WNW-ESE axes.

Fig. 4 - The enclosure area on the promontory no. 3. The black arrows mark the turf wall; the white arrows mark the 3 m wide opening in the southern wall.

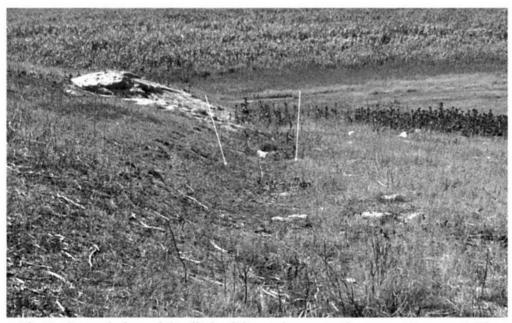
Fig. 6 - Ground view of the ditch of the enclosure on the promontory no. 4. The white arrows mark the lines of the ditch.

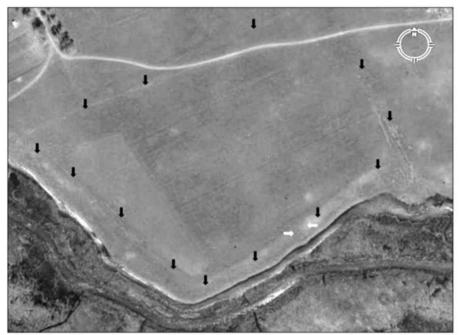
Fig. 7 - The square turf and timber enclosure on the promontory no. 4. The black arrows mark the turf wall. The ditch surrounds the wall to the exterior. The ca. 3m wide gate which opens to SE is highlighted by white arrows.

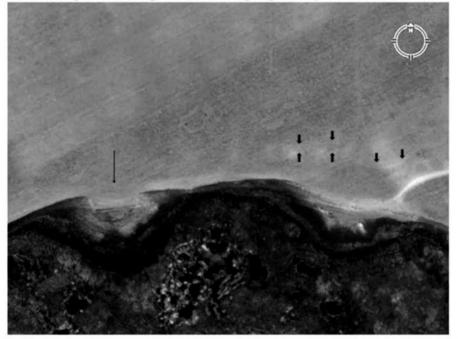
- 5. SEDP III Prmt 5 (Fig.8). Coordinates: 44° 59′ 08" N; 29 11′ 28" E; a 50m in length and ca. 12m in height promontory; it looks surrounded by a square enclosure of which only the W and N sides are slightly visible; some calcareous stones have been found at the surface:

- 6. SEDP IV Prmt 6 (Fig 8). Coordinates: 44° 59′ 26" N; 29° 10′ 33" E; at 170 m to the W from Prmt 3; a 48 x 27 m and 5m high mound, seriously destroyed by some modern interventions, sticks out of the surrounding terrain; the field is not ploughed; there are no archaeological artifacts at the surface; except the supposed rectangular enclosure of Prmt 5, there is no visible indication of ancient occupation.

Fig. 8 - Promontories no. 5 and 6. The black arrows indicate the possible line of a turf wall on the promontory no. 5 and an enclosure on the promontory no. 6.

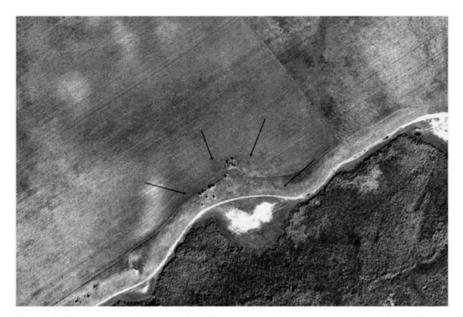
- 7. SEDP V Prmt. 7 (Fig.9). Coordinates: 44° 59′ 19″ N; 29° 10′ 51″ E; at ca. 500 m west of SEDP IV prmt. 6 the shore line turns SW, describing a possible maritime bay; from the most recessed point of the bay towards NW and N, on a slightly protruding promontory of ca. 115 x 61m, significant quantities of hewn stones, crumbled bricks and tiles, traces of charcoal are visible; at 50m W from this point a 60 x 70 m area which seems to have served as lime quarry; a remarkable concentration of Late Roman pottery. The dispersal of the artifacts covers a large area to the NW and W.

Fig. 9 - The promontory no. 7. The occupation on this place is indicated by a significant amount of artifacts (hewn stones, fragments of bricks and tiles). No stone or turf structure has been detected as yet. The black arrows indicate the aproximative spreading of the artifacts in the area.

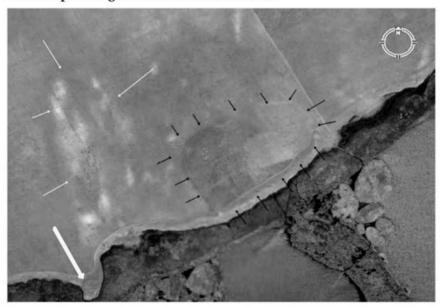
- 8. SEDP VI (Fig 10). Coordinates: 44° 59′ 02" N; 29° 09′ 40" E. At ca. 700 m W of SEDP IV, on the very border of the lake, at +30m from the water surface a plateau of 480 x 310 m in size; a 2 m in height mound, highly suspected to be artificial; it is E-W oriented, with its W half slightly curved; stone blocks, fragmentary roofing tiles and 5-6th century fragments of pottery are in abundance at the surface; the N side of the plateau is bordered by an earthen wall, at present 0.60-0.80 m in height (Fig. 11). The country road on the border of the lake runs along the S side of the structure. The satellite view shows some structures in the NW corner of the plateau and two parallel roads, ESE-WNW oriented.

Fig. 10 - The large plateau on the coast line (SEDP VI). The stone fort and its civil settlement situated to the N. The nearness to the fort is noticeable. The black arrows show the perimeter of the presumable occupation area; the white arrows show the civil settlement of the stone fort A; the white bold arrow shows the position of the stone fort A.

SEDP V remains the largest occupational area identified on the SE shore of the Dunavăț Peninsula. Its surface sticks out of the surrounding terrain at a considerable height over the water surface (+30m), a place which exceptionally overlooks the entire shore line to the E and W. The place is highlighted on the ground by a brown soil which contrasts with the bare yellowish lime soil around it. The surface of ca. 14, 88 ha rectangular area is the largest of all enclosures surveyed in 2007. The satellite image indicates the existence of two parallel possible roads in running through the middle of the enclosure, although traces of them remain only scarcely visible. The flattening of the surface is now in full swing and the comparison of two different satellite images of 2008 and 2010 shows how the plough operations in depth can modify a surface under investigation. According to the 2008 satellite image, in period when agricultural interventions were less active, the surface was highlighted on the ground in almost its initial rectangular layout, while after the area was ploughed much of the soil was dispersed to such a degree that modified much of the apparent the contour of the previous agglomeration.

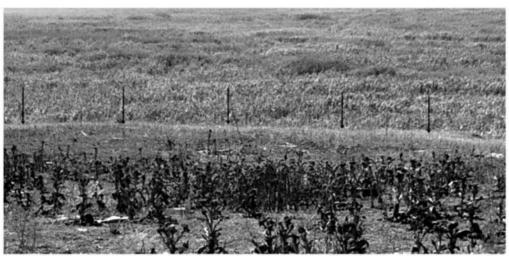
Fig. 11 - Ground view of the turf wall surrounding the large size occupation area at SEDP VI. The black arrows indicate the line of the turf wall.

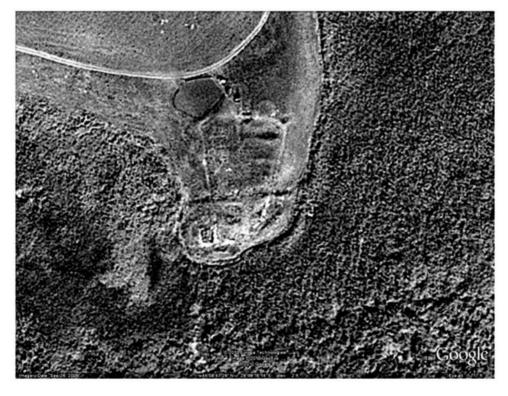
Fig. 12 - Stone fort A (SEDP VII).

9. SEDP VII The Stone fort A (Fig. 12). The thus far most known point, "Cetatea Zaporojenilor", lies on a promontory, at ca. 5 km along the shore line from the Dunavăţu de Jos village, part of the Murighiol Commune. A stone fort was identified at mid 19th century and partially investigated (see n. 4) through archaeological diggings and surveys for the first time by the French archaeologist and epigraphist E. Desjardin. The fort was described by P. Polonic and presumably visited by J. Weiss in 1909 or 1910. C. Moisil seems also to have seen the fort which he describes shortly. The systematic research was resumed between 1986 and 1989 by the undersigned and prof. Al. Barnea. The results, still awaiting a complete study, are unfortunately parsimonious and their publication released thus far in short information offered in the annual chronics of archaeological excavations in Romania are partial and limited.
